UNITED STATES ENVIRONMENTAL PROTECTION AGENCY
REGION 8

ACTION MEMORANDUM

SUBJECT: Approval and Funding for a Removal Action and Exemption from the 12-month and \$2-million Statutory Limits for a CERCLA Removal Action at the Nelson Tunnel/Commodore Waste Rock Pile Superfund Site in Mineral County, Colorado

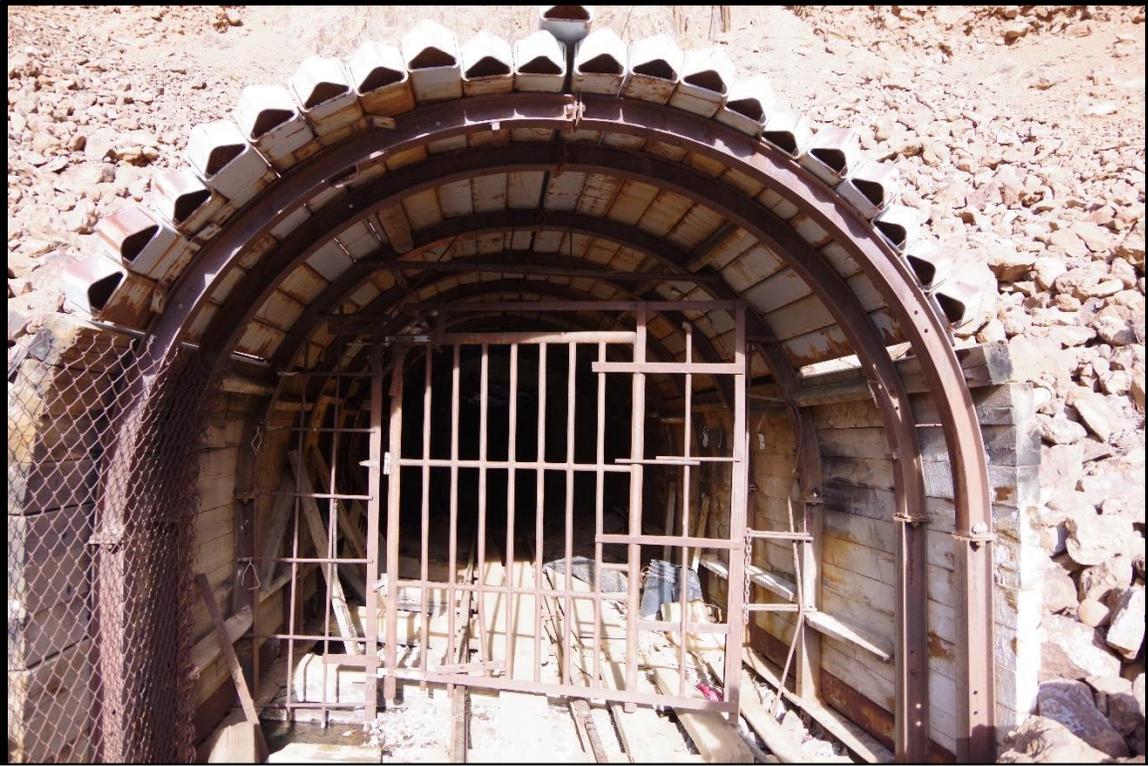
Photo 5: Portal Gate to be replaced

Rehabilitation in this segment will consist of scaling, mucking, debris removal, ditch cleaning, track repair, replacement of the portal gate, and the installation of two air doors. The Manhattan Drift and another smaller room, near station 12+00, can serve as storage during construction.

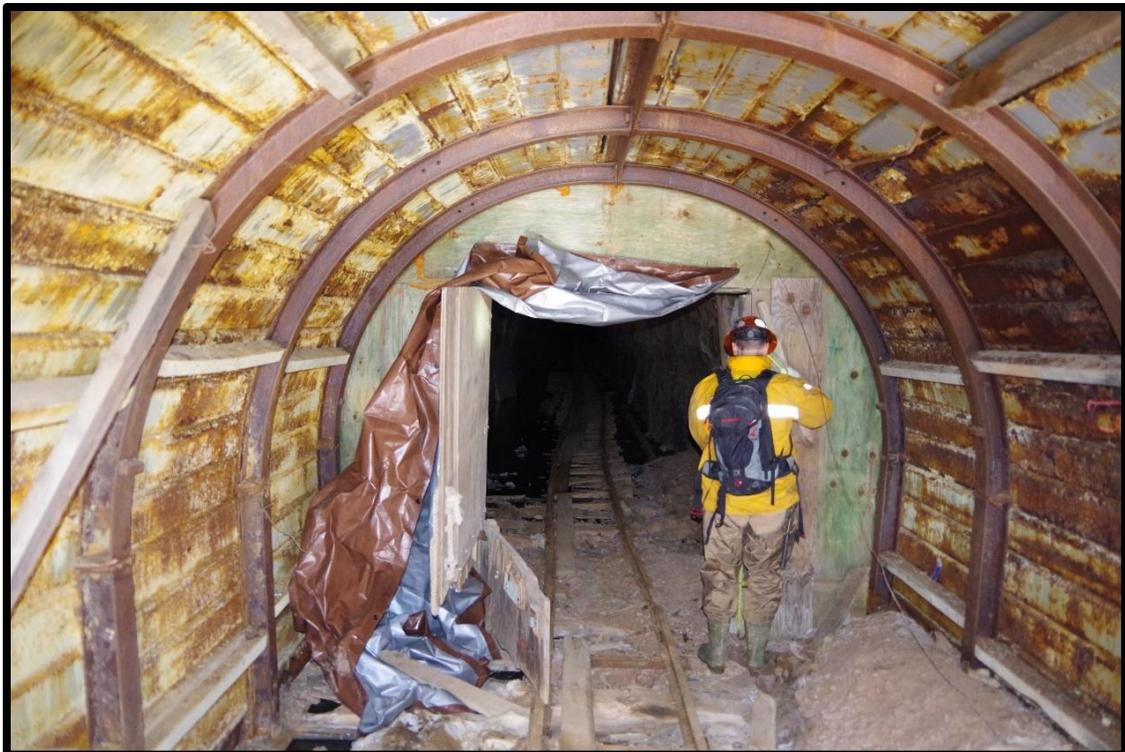
Photo 6: First Air Door to be replaced

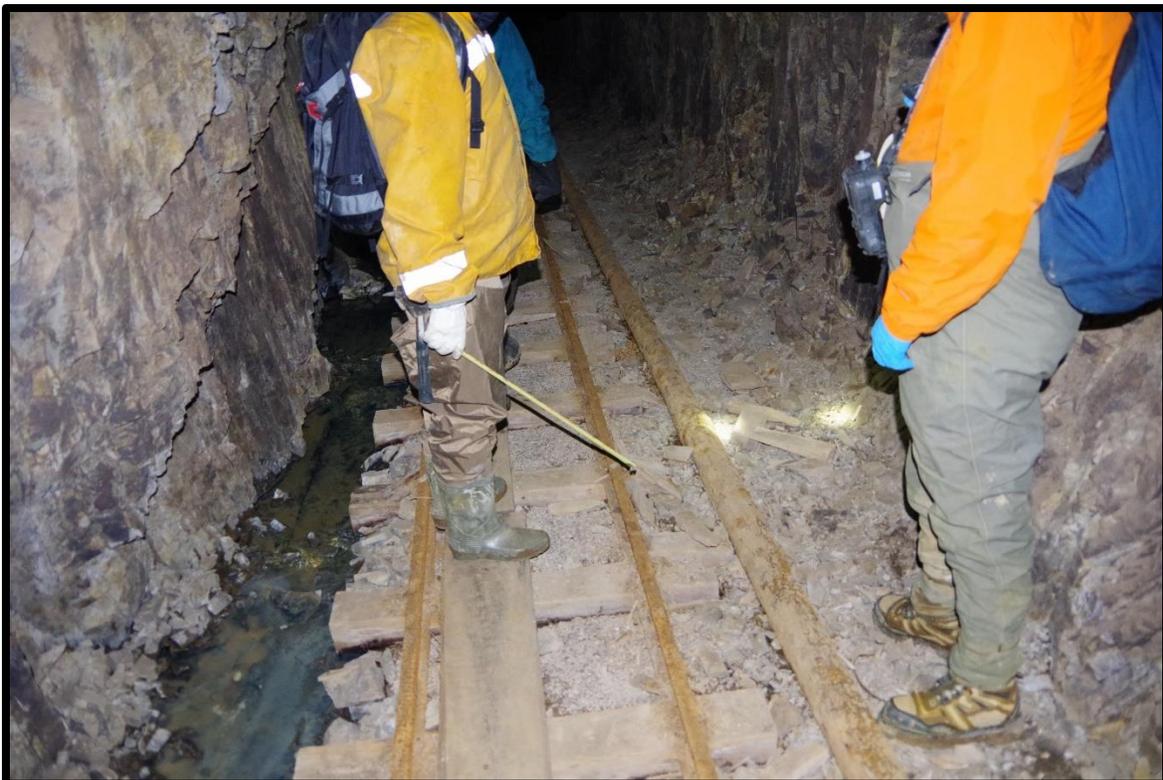
Photo 8: Typical rail, ditch, and invert in Commodore 5 Cross Cut

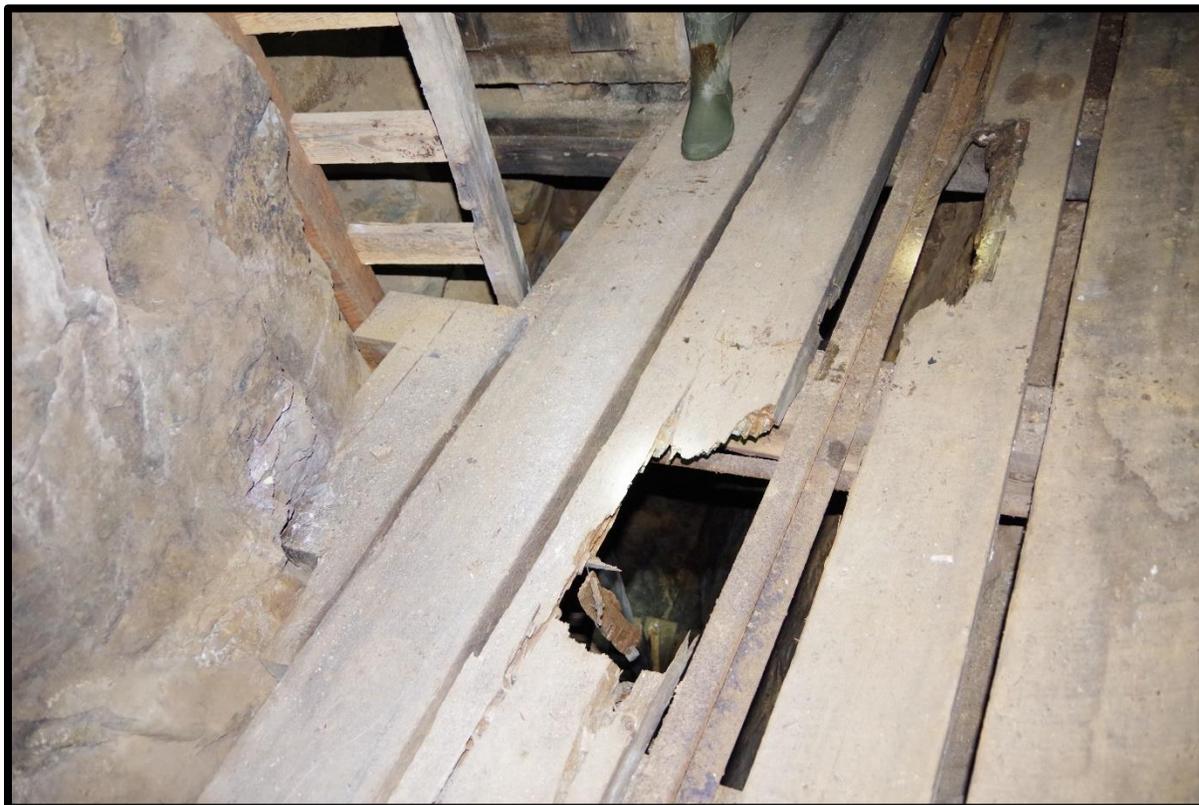
Photo 17: Daylight Winze with rotten wood cover

Significant work is also needed at the Daylight Winze and the raise above it. Due to its importance of acting as the last drain into the Nelson Tunnel, the Daylight Winze should be fully rehabilitated by scaling, bolting, and installing new ladders and landings made of non-decaying or corroding material such as fiber reinforced plastic (FRP). This work would take place above the Nelson Tunnel without impacting the impounded mine pool areas. A cover capable of supporting vehicle traffic and allowing water inflow should also be installed. We anticipate the cover consisting of a concrete collar with coated steel beam supports and grated FRP cover.

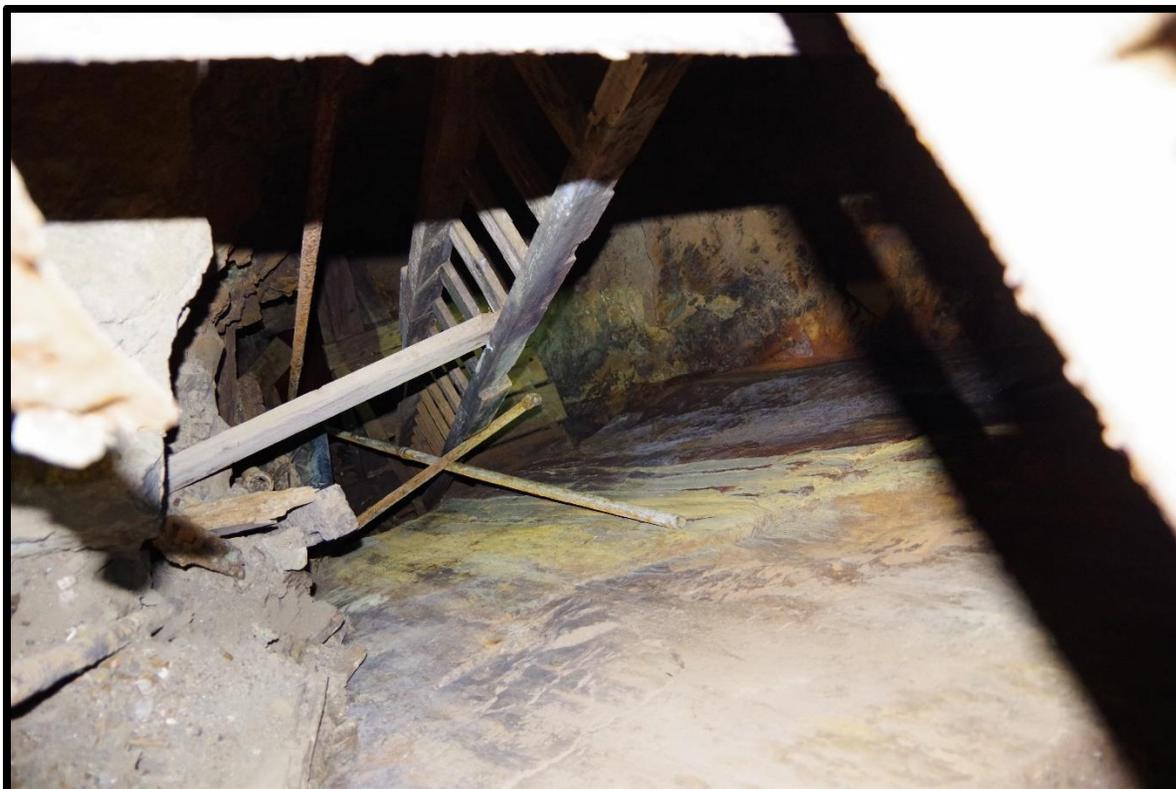
Photo 18: Looking down Daylight Winze: Note smooth footwall, ladder, and landing

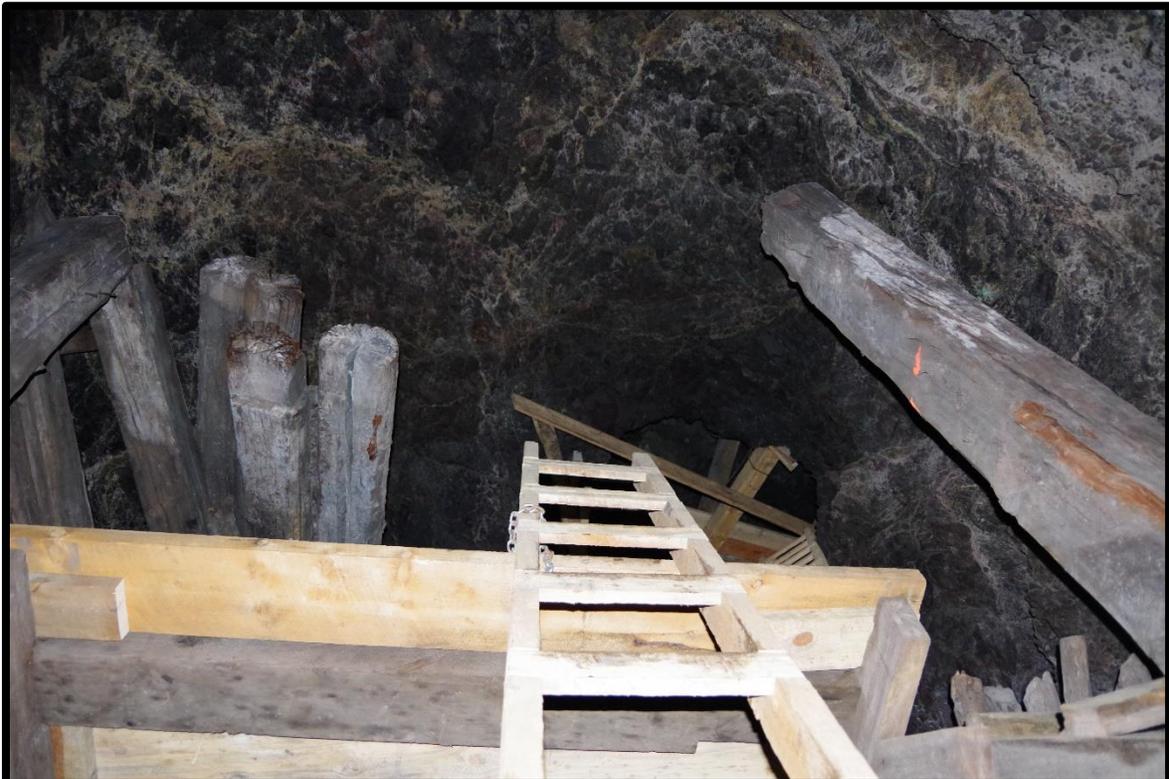
Photo 27: Bachelor Shaft looking up

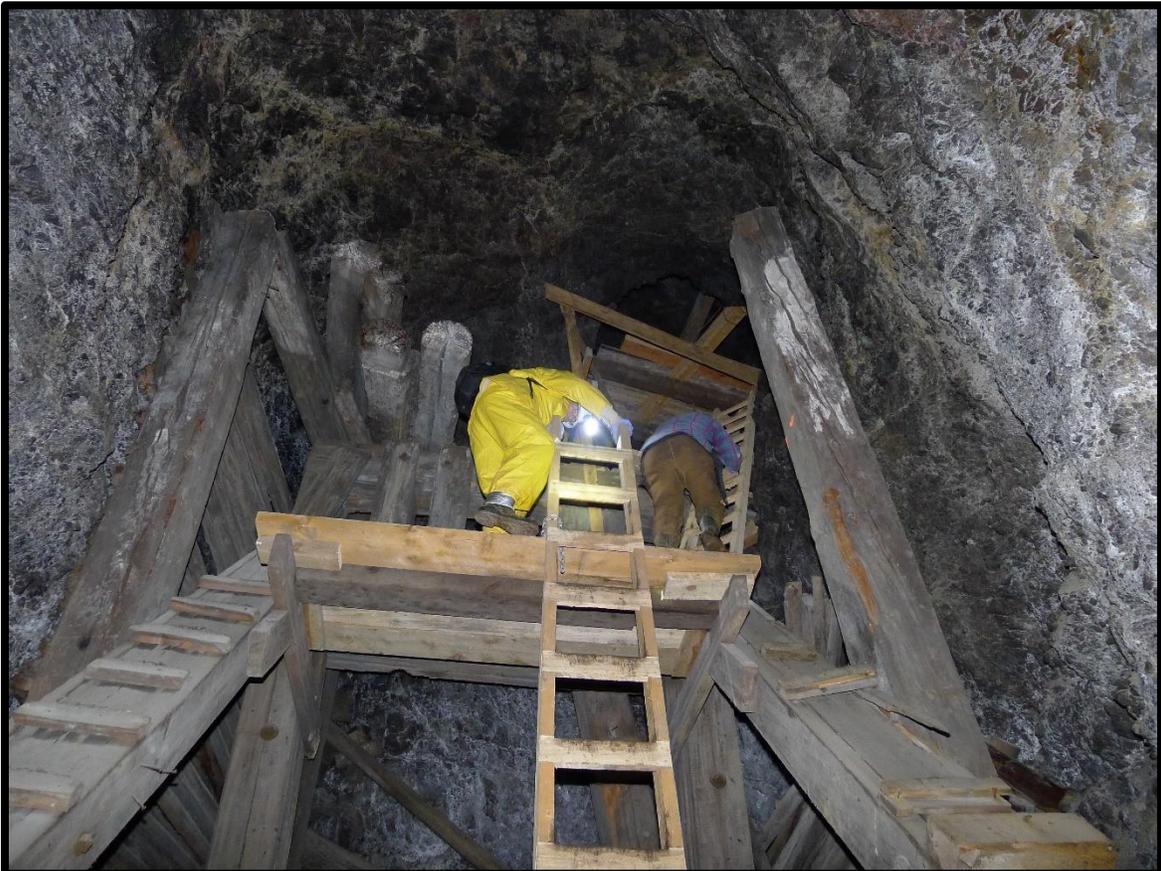
Photo 28: : Bachelor Shaft looking up to second landing

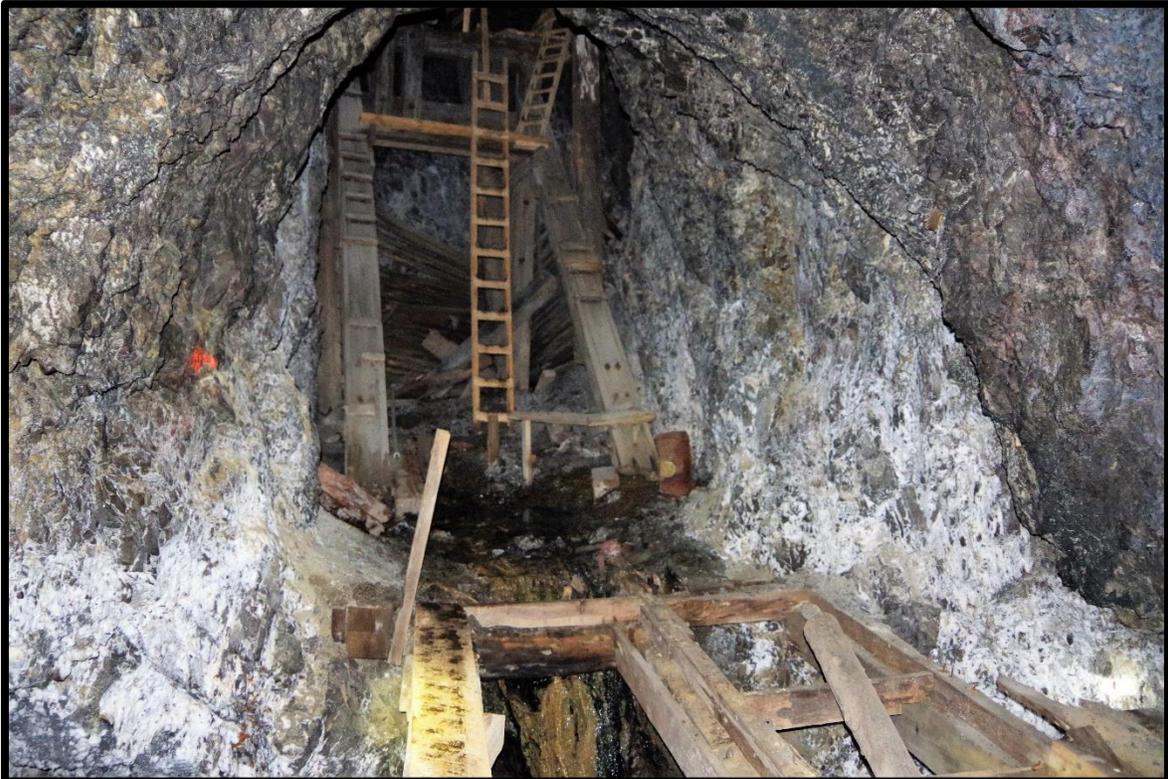
Photo 29: Bachelor Shaft bottom and second landing seen from far side of Nelson Tunnel

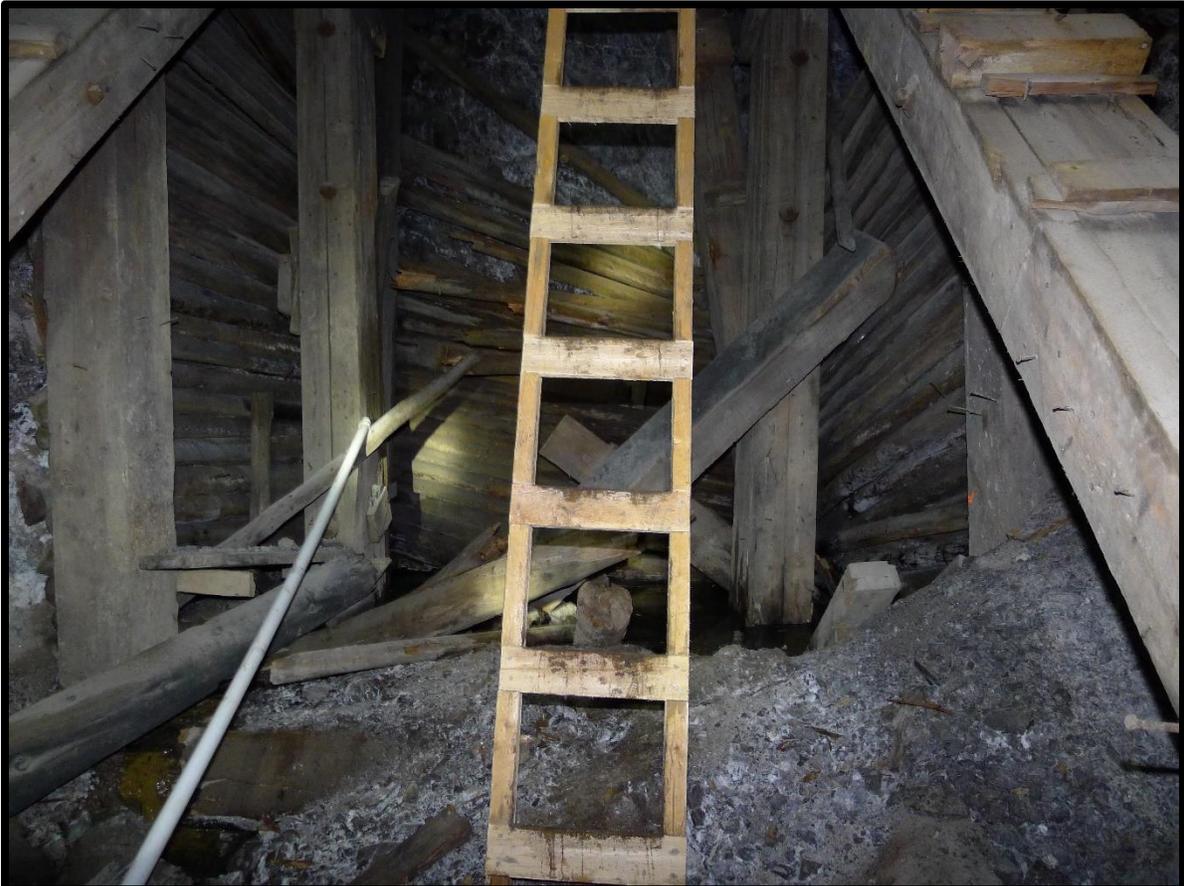
Photo 30: Bachelor Shaft at Nelson Tunnel landing

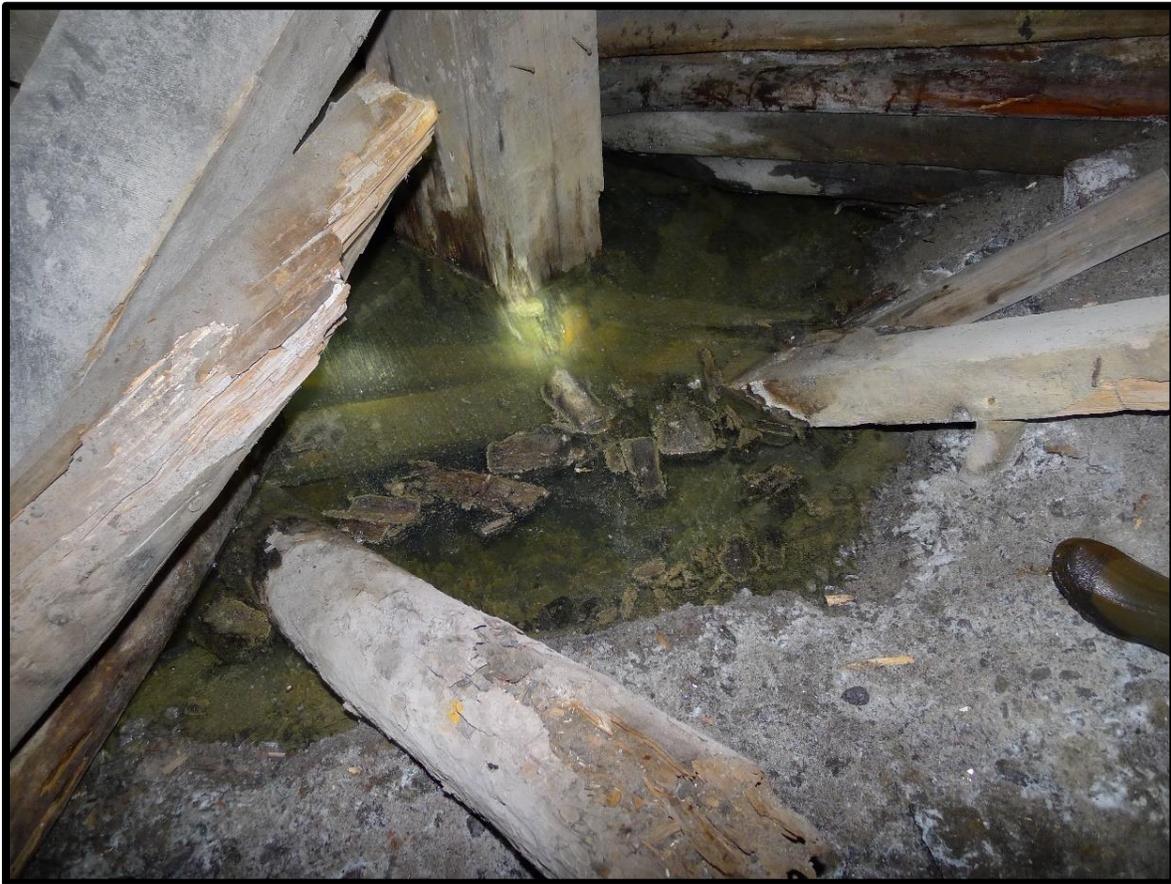
Photo 31: Collapsed Timbers at Bachelor Shaft Nelson Tunnel landing

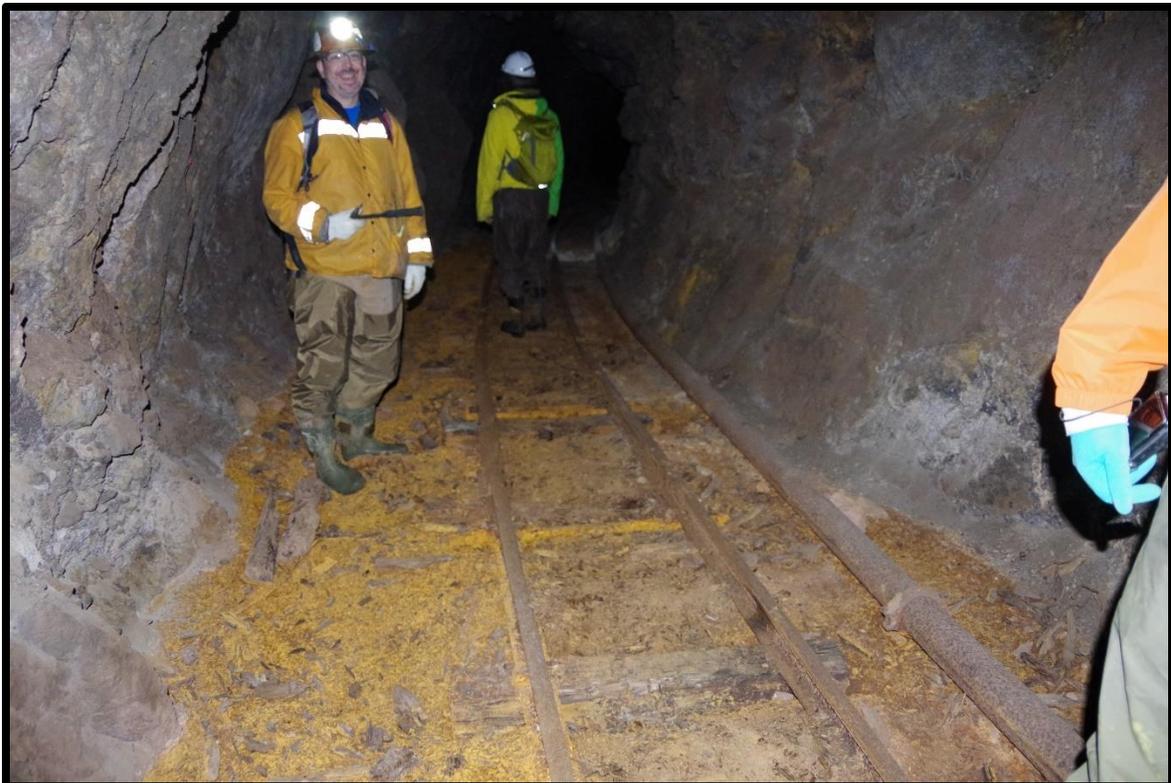
Photo 32: Decayed rail ties near 25+00; Note staining from water

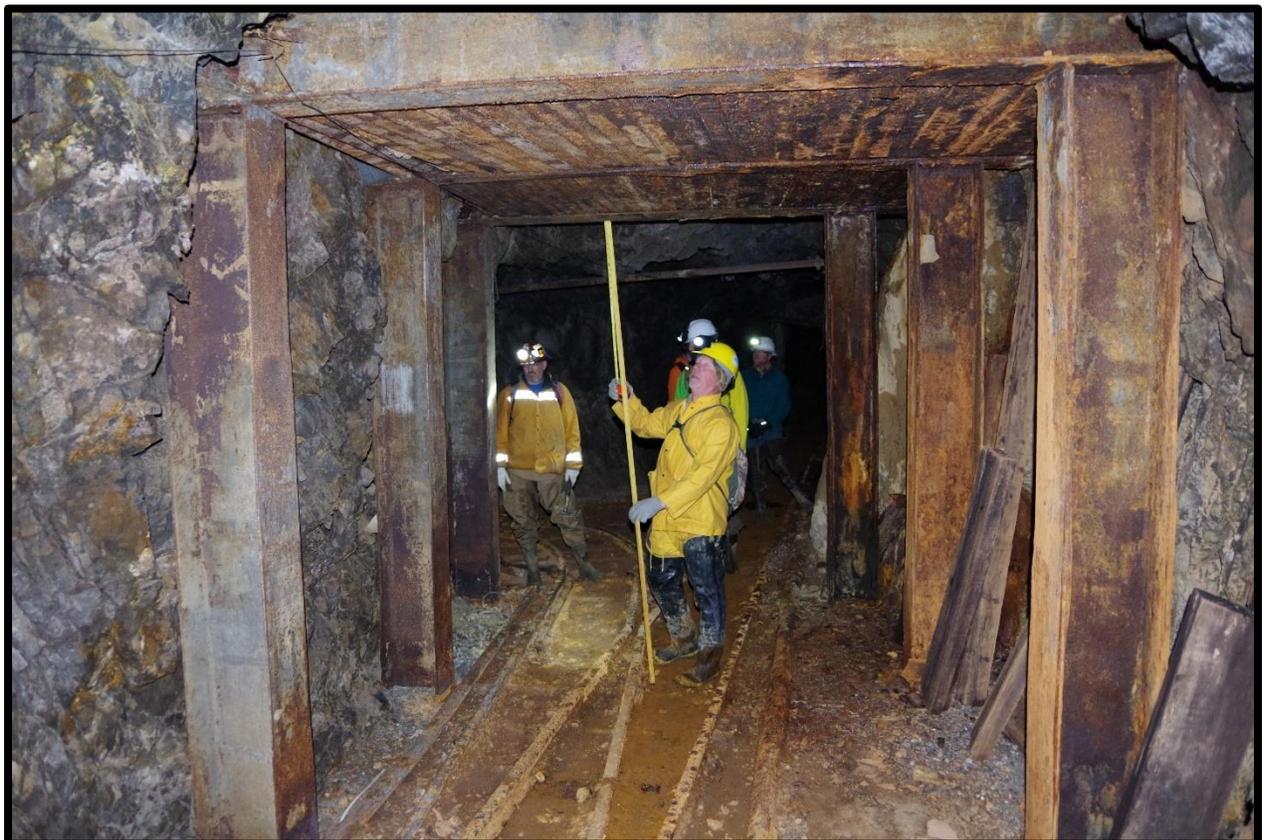
Photo 33: Measuring Archimedes Raise dimensions 26+64

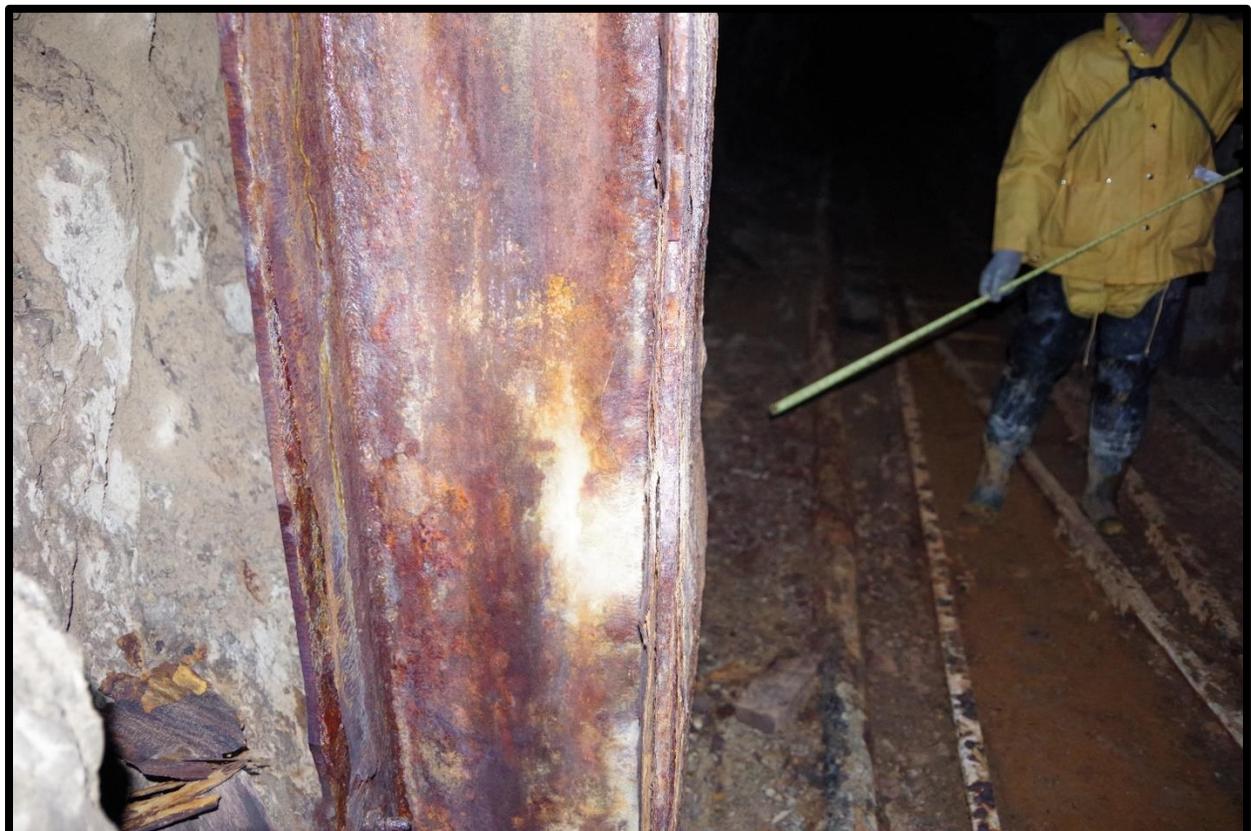
Photo 34: Close up of Archimedes Raise steel posts; Note corrosion and delamination

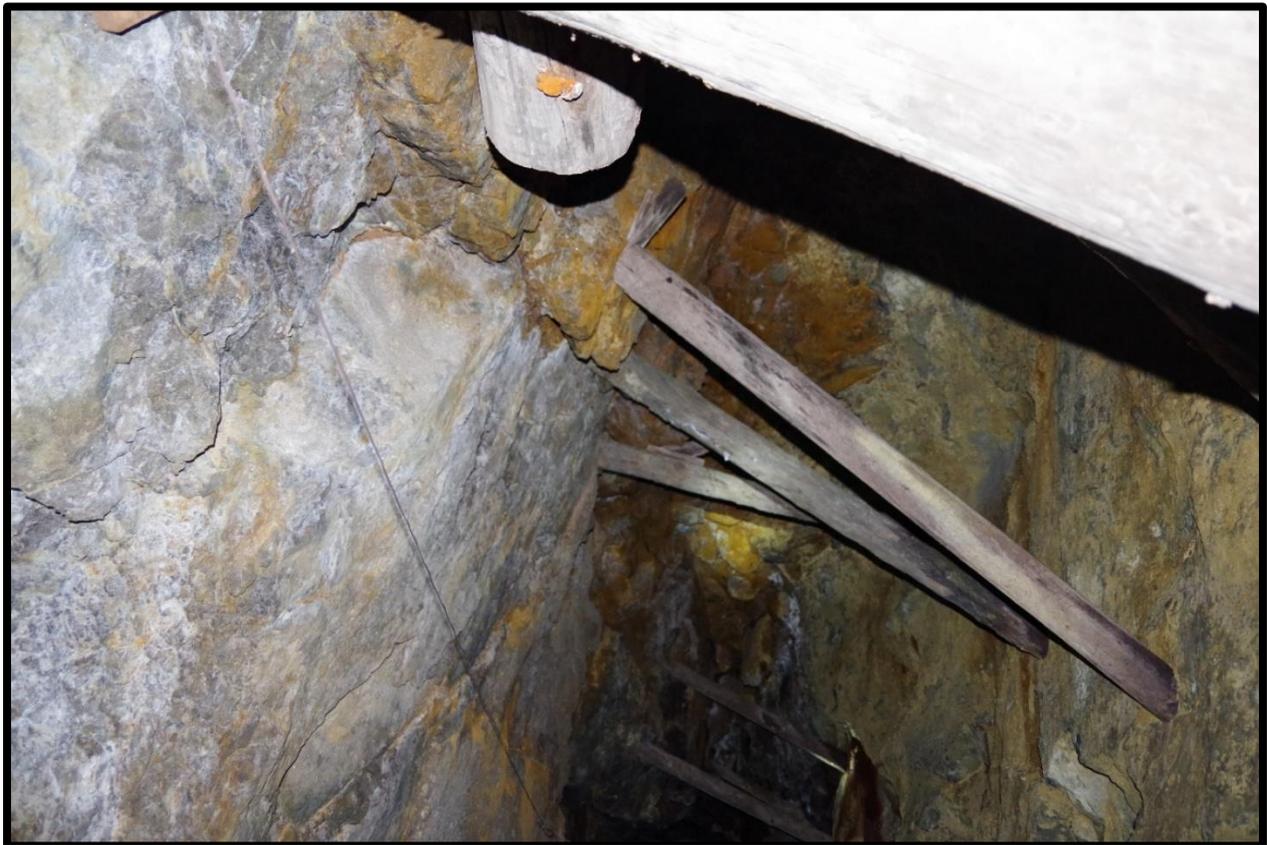
Photo 35: Typical timber stulls; Note hanging wall, Amethyst vein, and foot wall

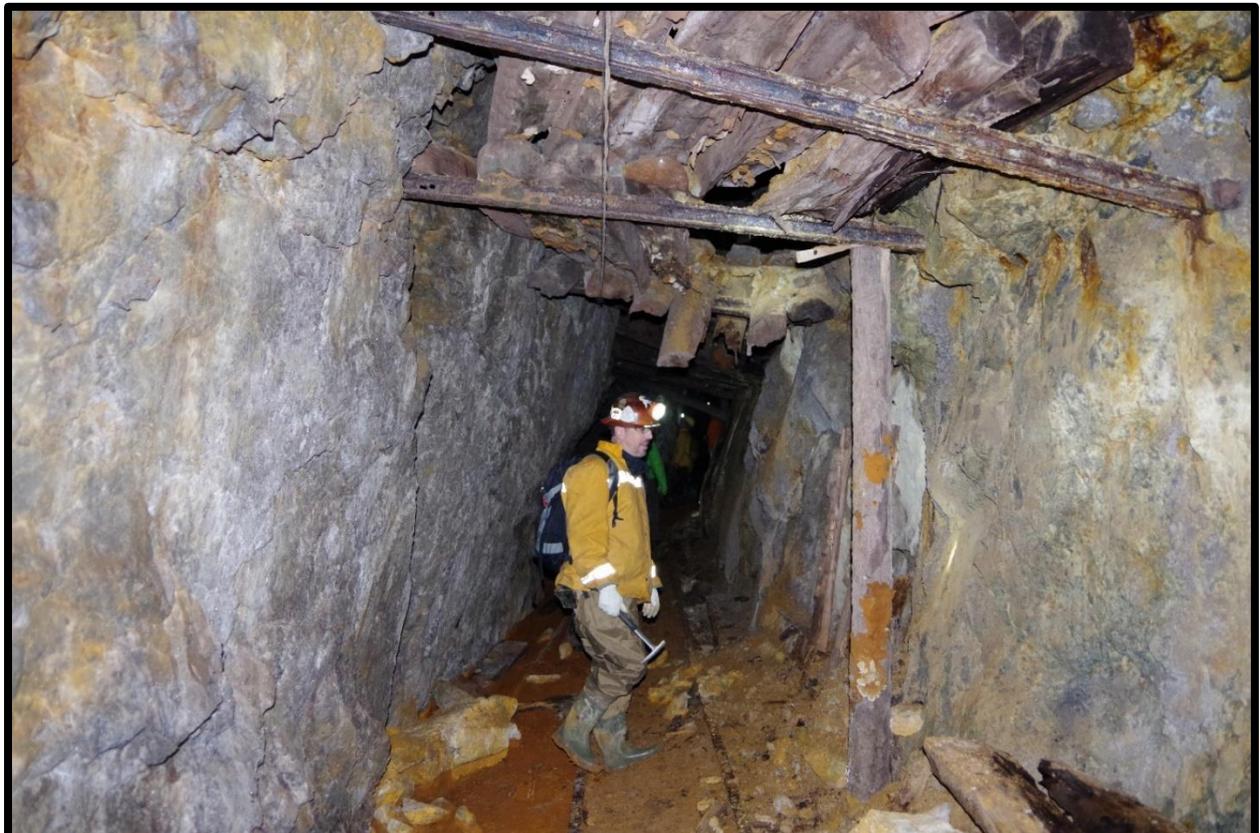
Photo 36: Steel rail stulls with rotten timber lagging 30+50

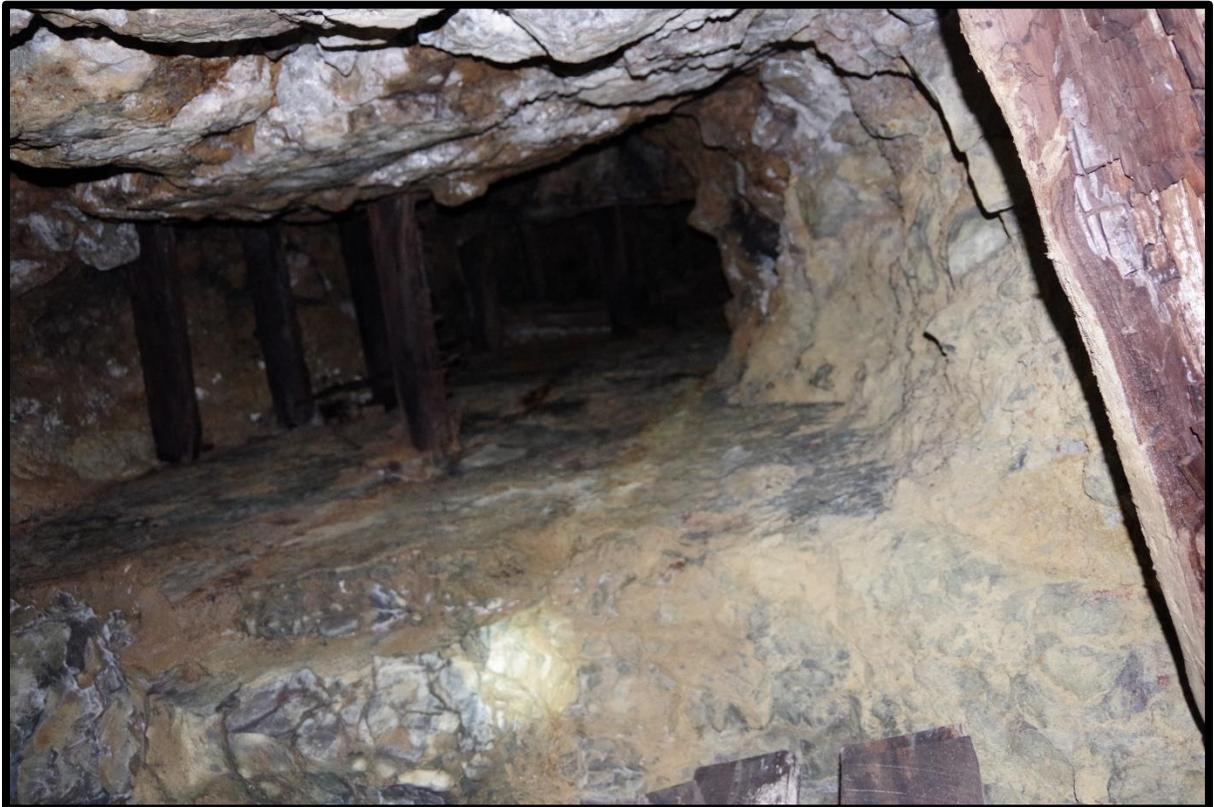
Photo 37: Looking up raise at 30+20

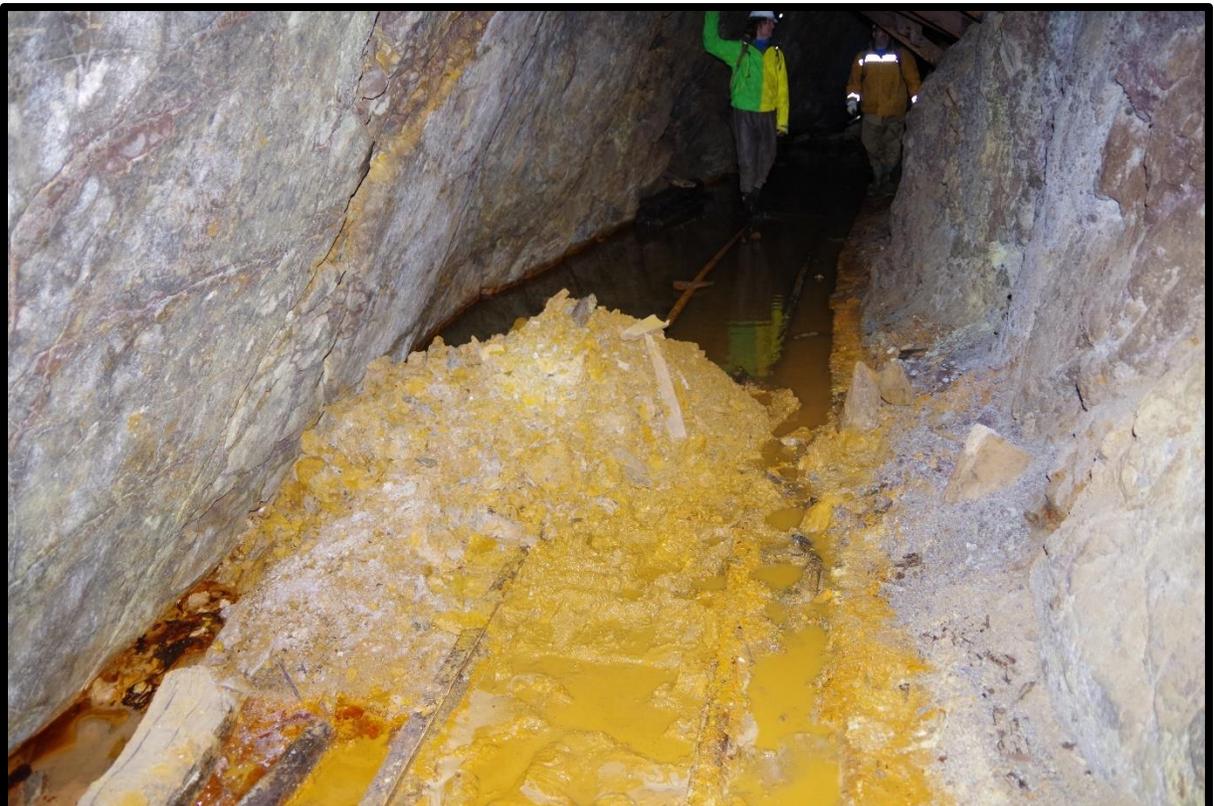
Photo 38: Debris from actively raveling raise near 32+00; Note water backed up behind

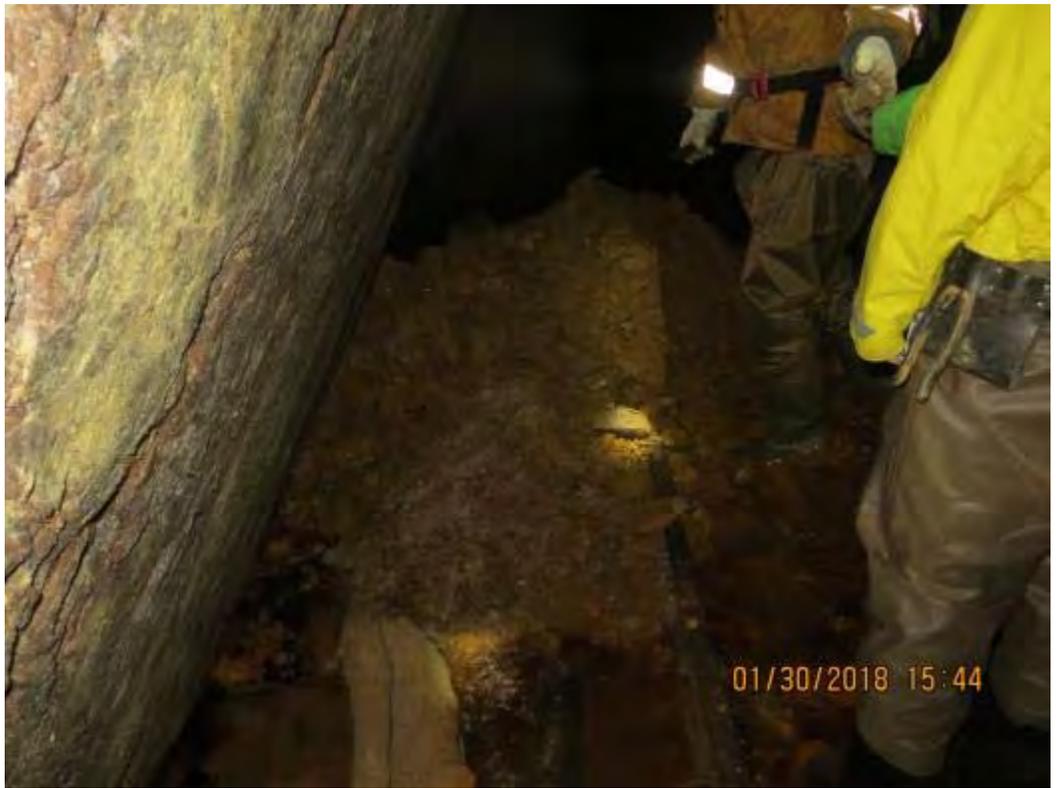
Photo No. 13	Date: 01/30/2018
Photo Coordinates	
Lat	--
Long	--
Direction Photo Taken: Northeast	
Description: Roof fall material in the tunnel. DRMS noted that this is fresh material since the last entry in November 2017.

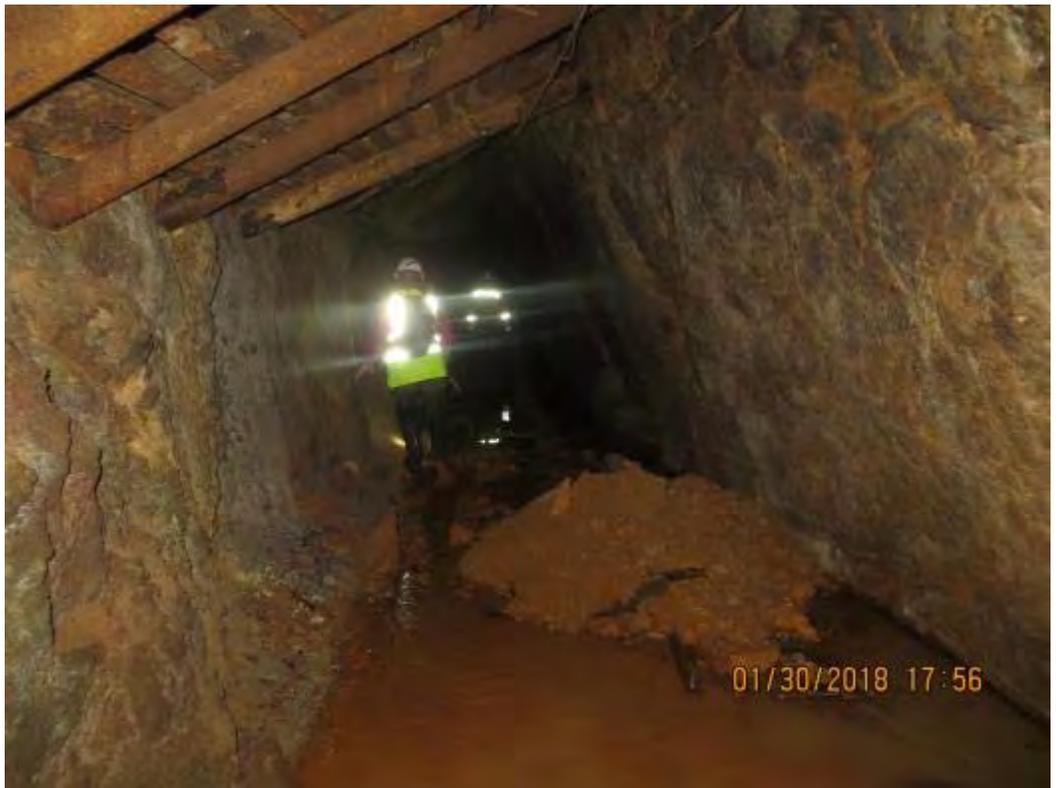
Photo No. 14	Date: 01/30/2018
Photo Coordinates	
Lat	--
Long	--
Direction Photo Taken: Southeast	
Description: Looking back at fresh roof fall material. Note small amount of water retained behind roof fall.

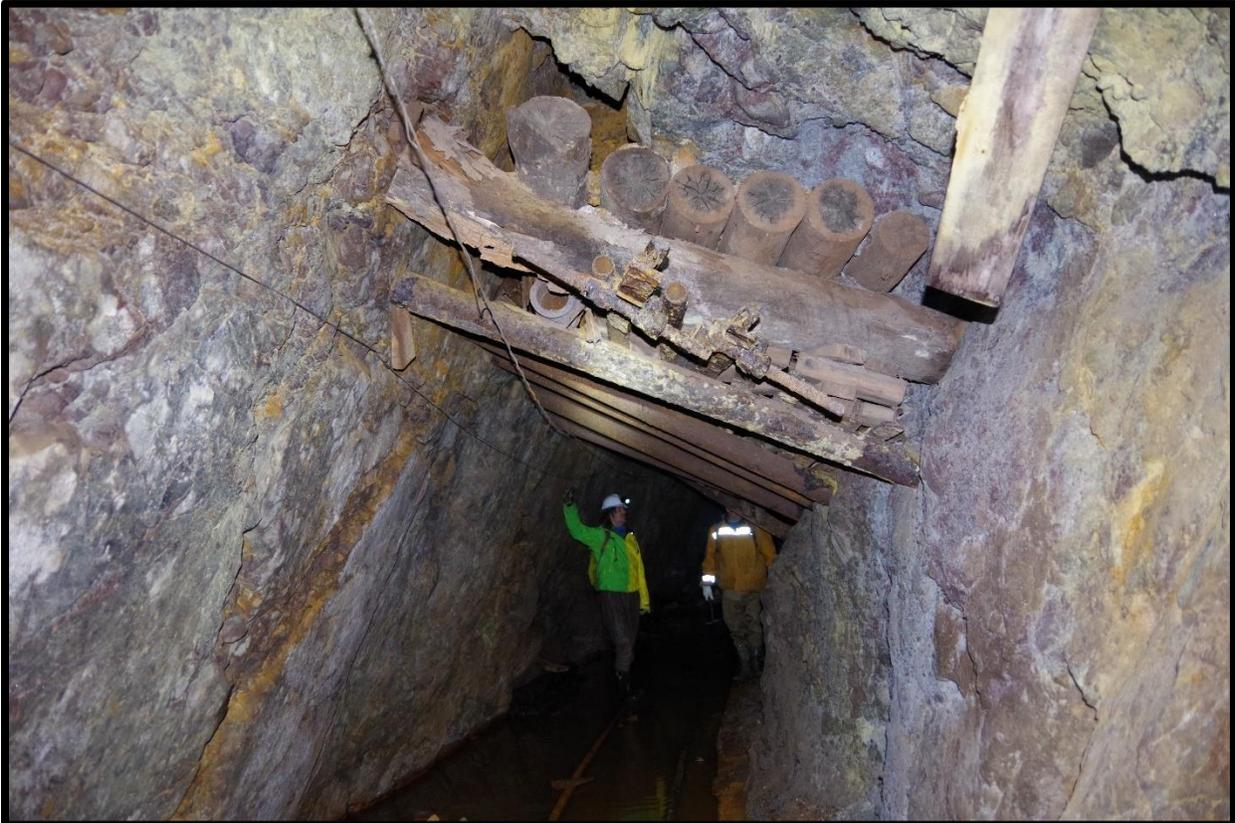
Photo 39: Steel pipe stulls near 32+20; Note pipe cribbing

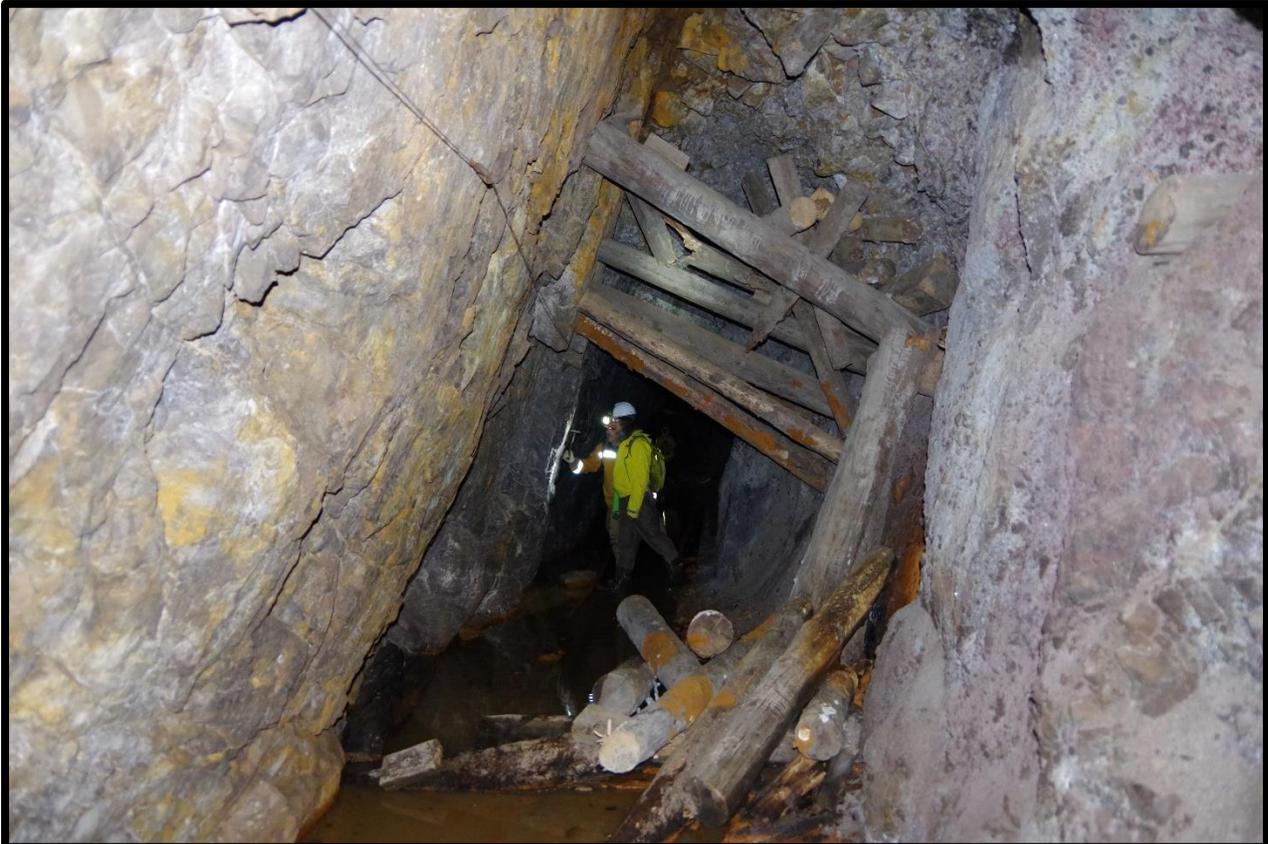
Photo 40: Failed timber stulls near 32+80

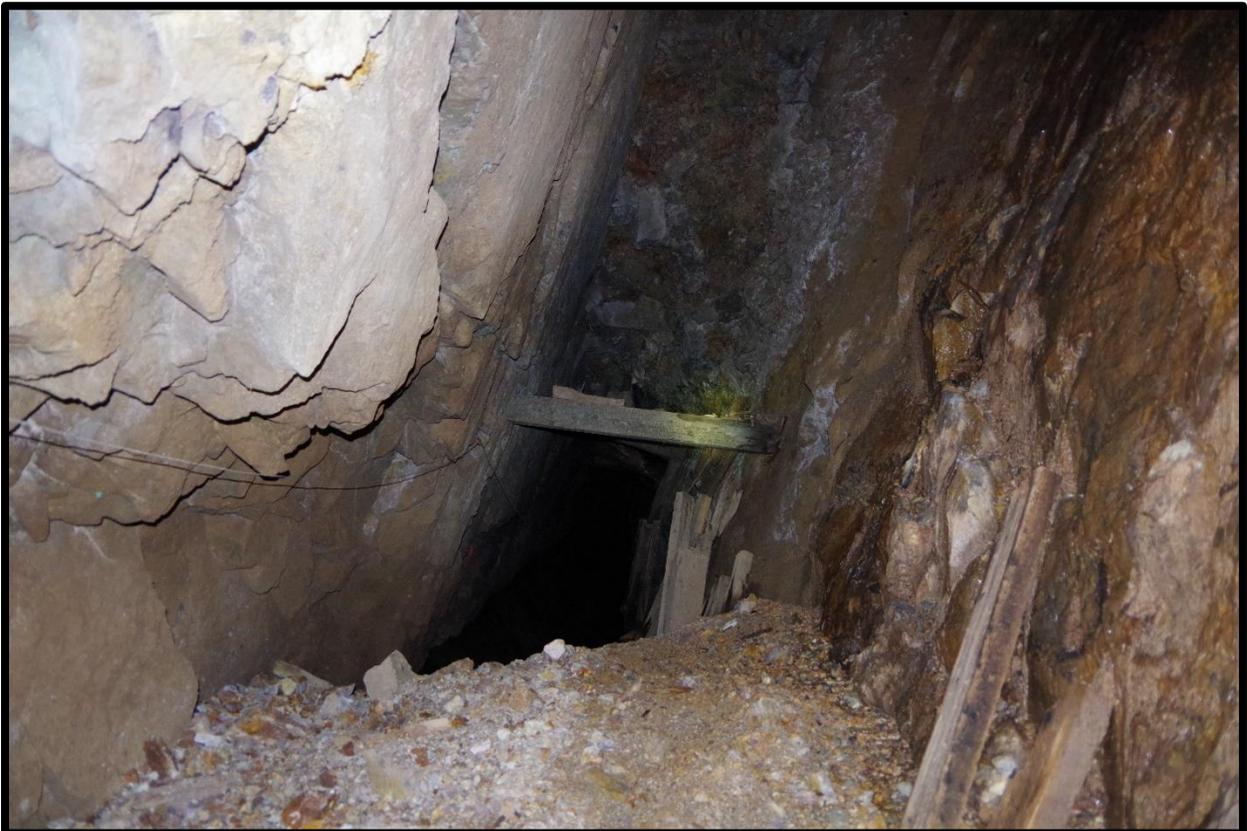
Photo 41: Debris pile at very active 44 Raise 36+82

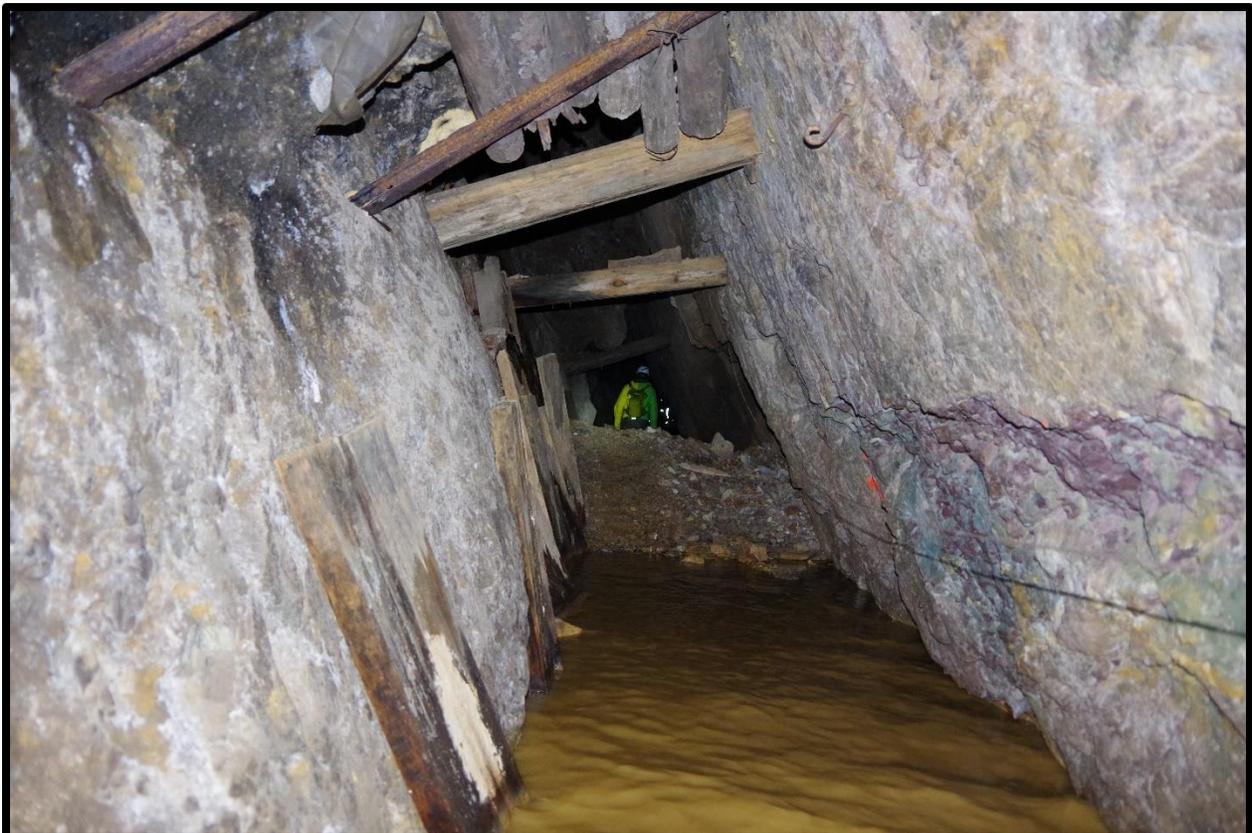
Photo 42: Debris pile at 44 Raise 36+82 looking outby; Note water ponded behind pile
