UNITED STATES ENVIRONMENTAL PROTECTION AGENCY
REGION 8

ACTION MEMORANDUM

SUBJECT: Approval and Funding for a Removal Action and Exemption from the 12-month and \$2-million Statutory Limits for a CERCLA Removal Action at the Nelson Tunnel/Commodore Waste Rock Pile Superfund Site in Mineral County, Colorado

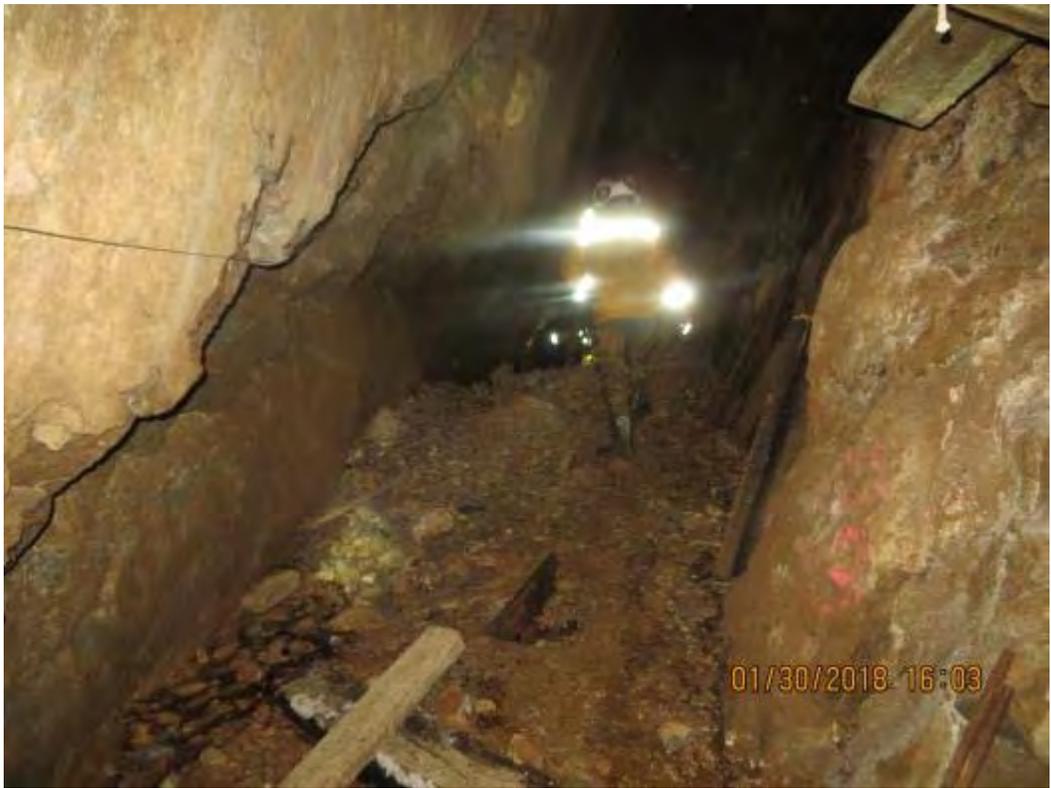
Photo No. 17	Date: 01/30/2018
Photo Coordinates	
Lat	--
Long	--
Direction Photo Taken: Northeast	
Description: In tunnel roof fall at the 44 Raise. This fall is acting as a coffer dam and is holding back water. If this were be removed the water would flow outby to the Daylight Winze, and back into the Nelson Tunnel.

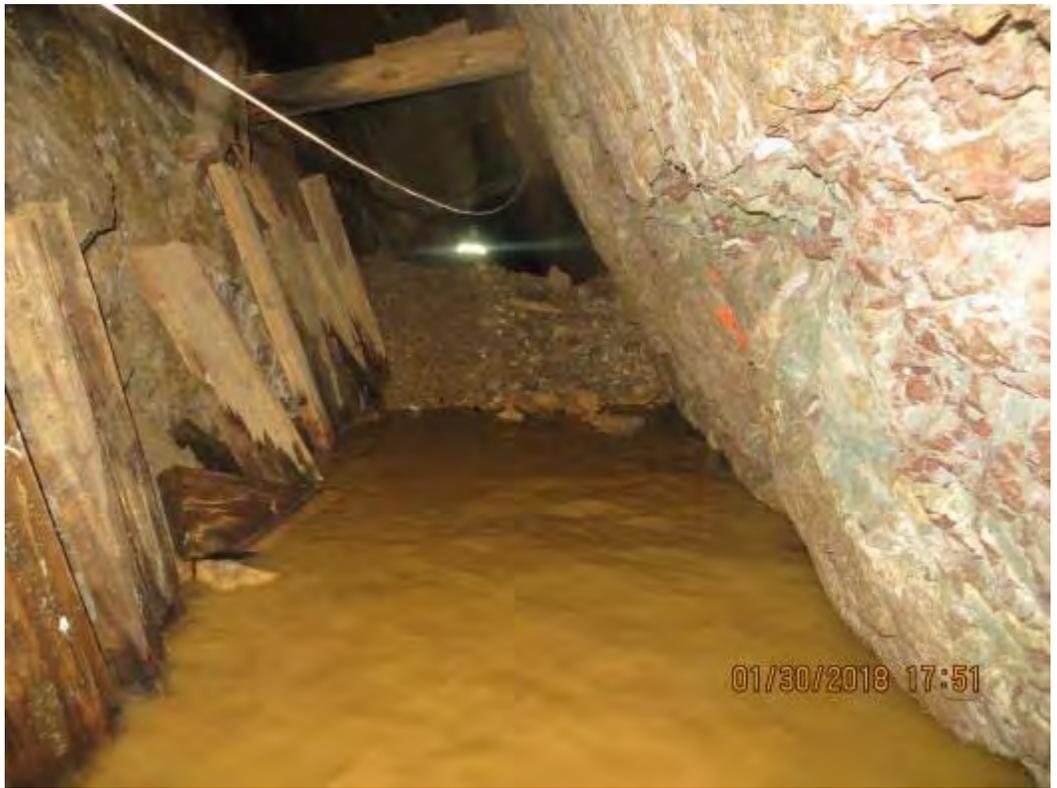
Photo No. 19	Date: 01/31/2018
Photo Coordinates	
Lat	--
Long	--
Direction Photo Taken: Southeast	
Description: Looking outby at the roof fall at the 44 Raise. Note the water built up behind the roof fall.

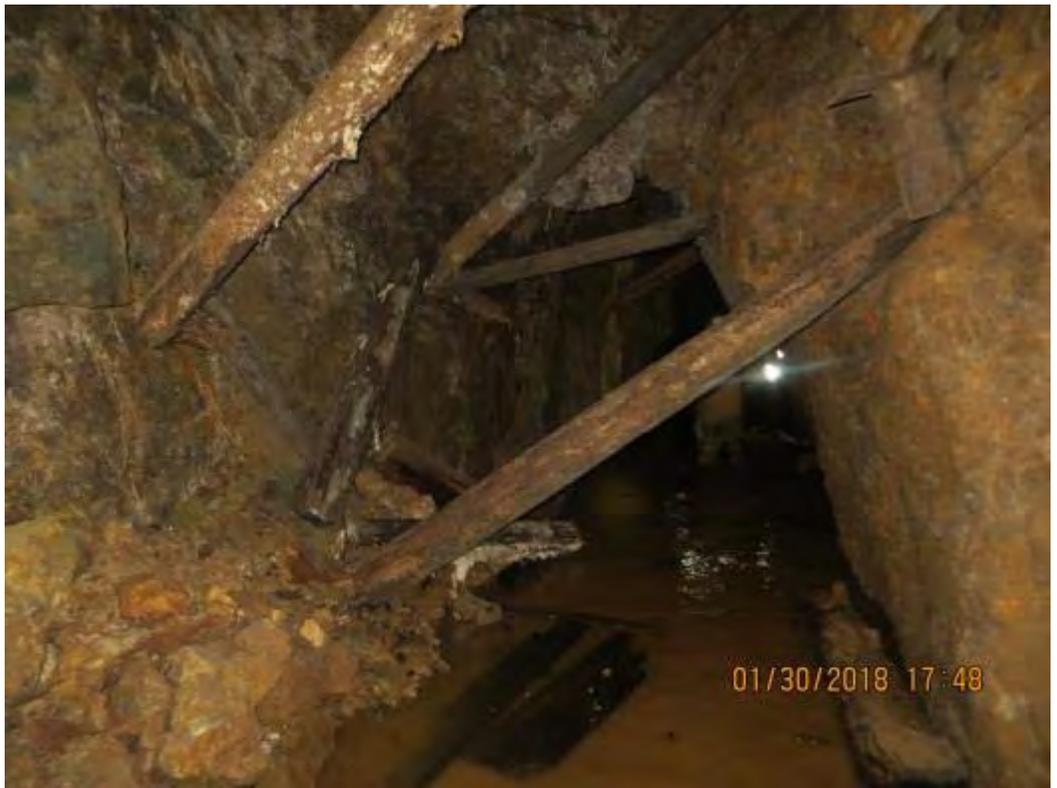
Photo No. 20	Date: 01/30/2018
Photo Coordinates	
Lat	--
Long	--
Direction Photo Taken: Southeast	
Description: Area inby the 44 Raise where stope timbers and roof fall have occurred.

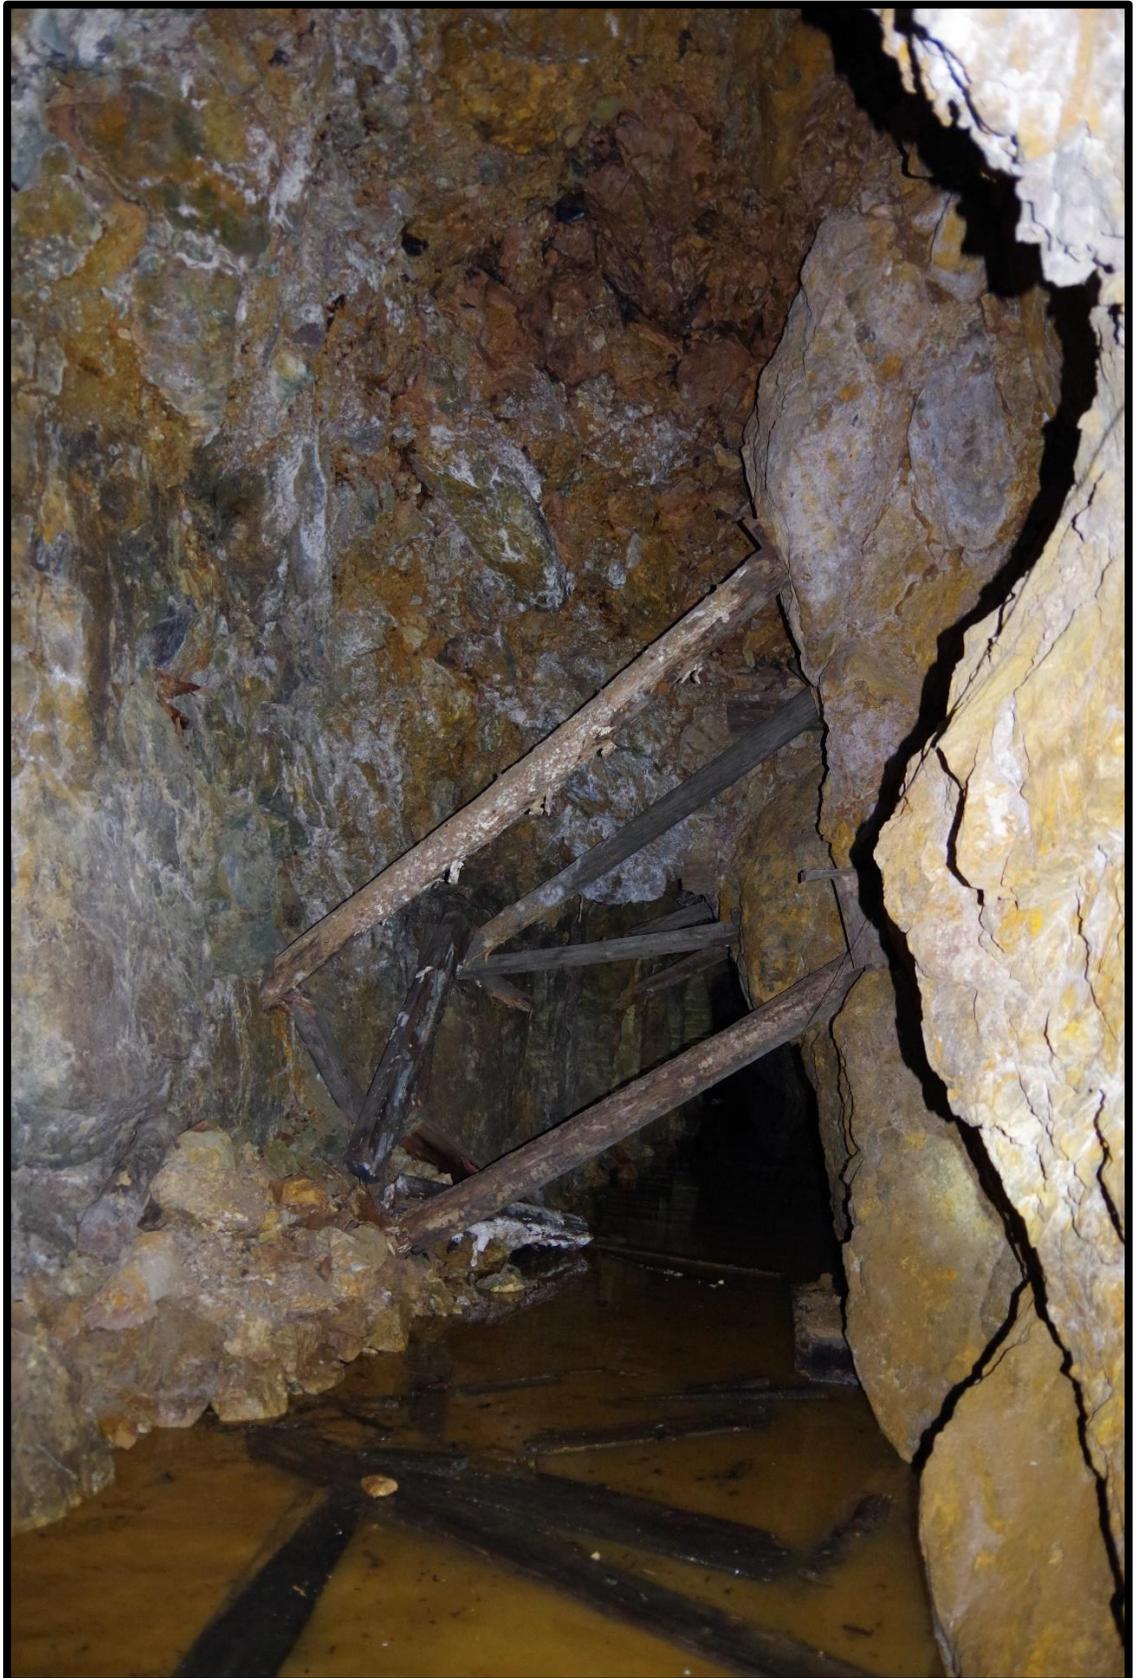
Photo 44: Large loose slabs in hanging wall near 38+10; View is outby

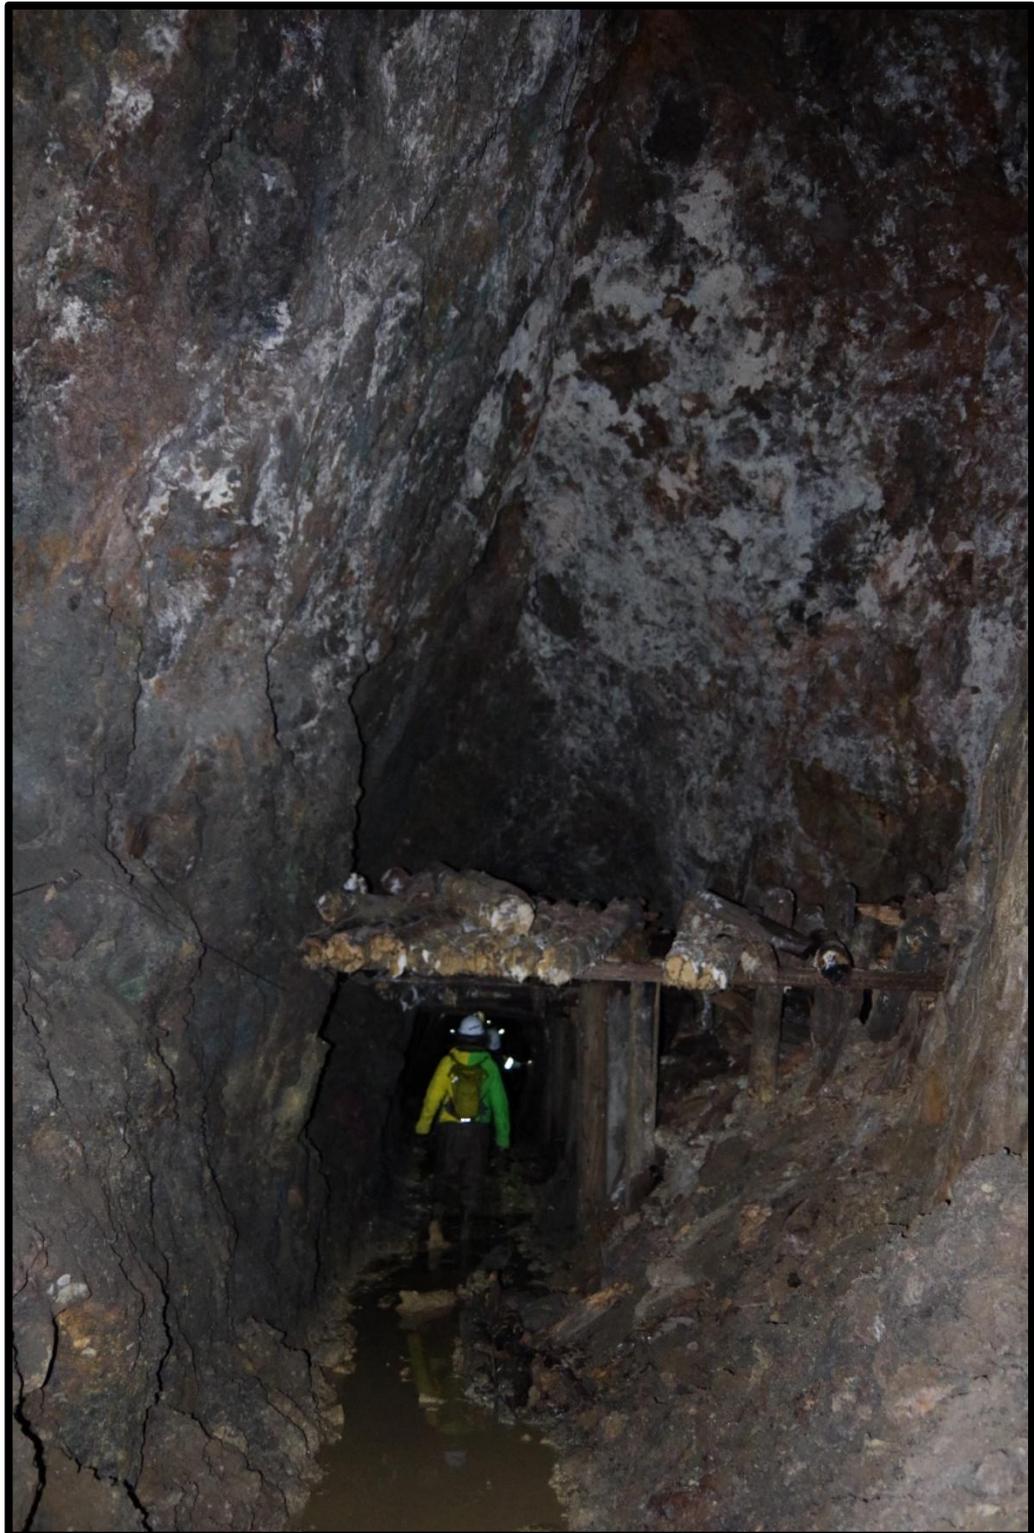
Photo 50: Cathedral near 43+50; Note loose muck in right rib and rotten timber lagging

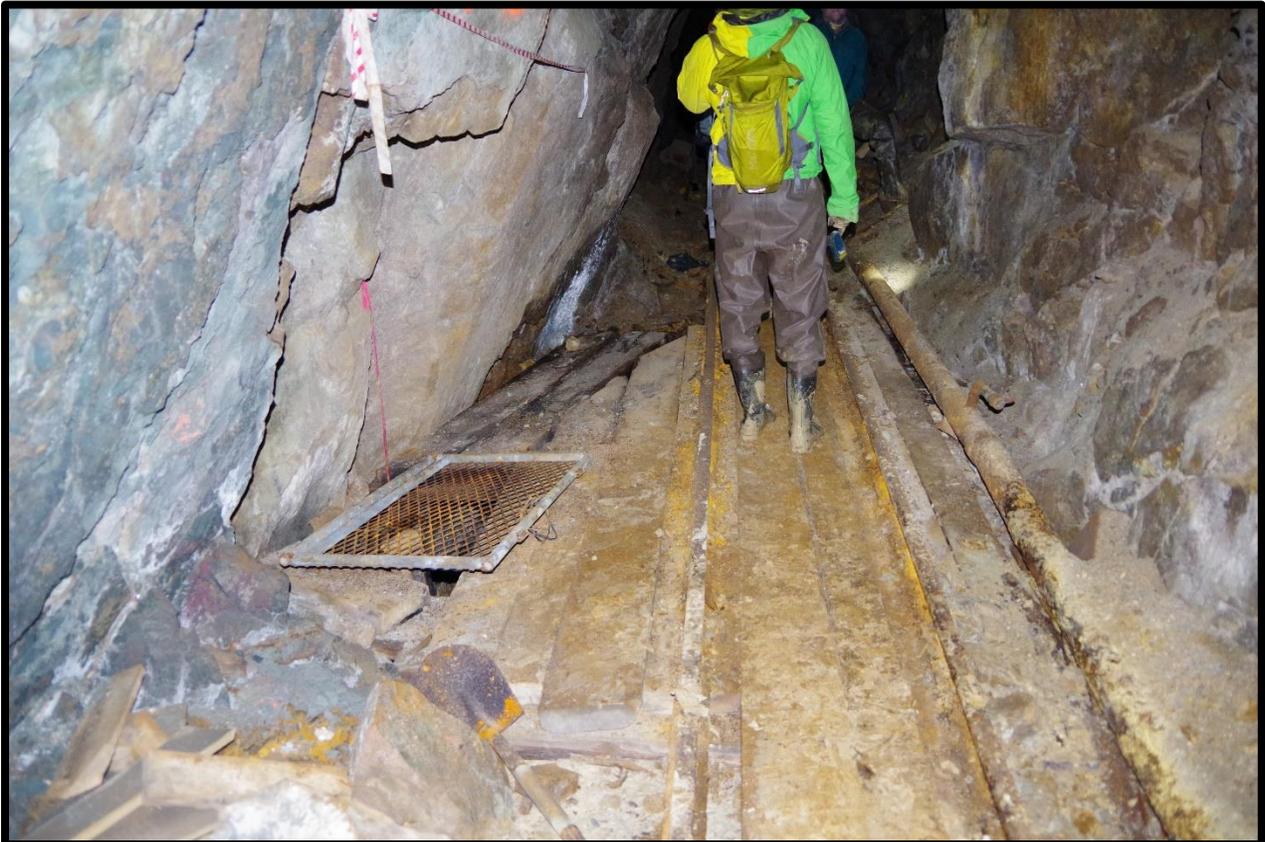
Photo 53: No Name/Y02 Winze 44+60

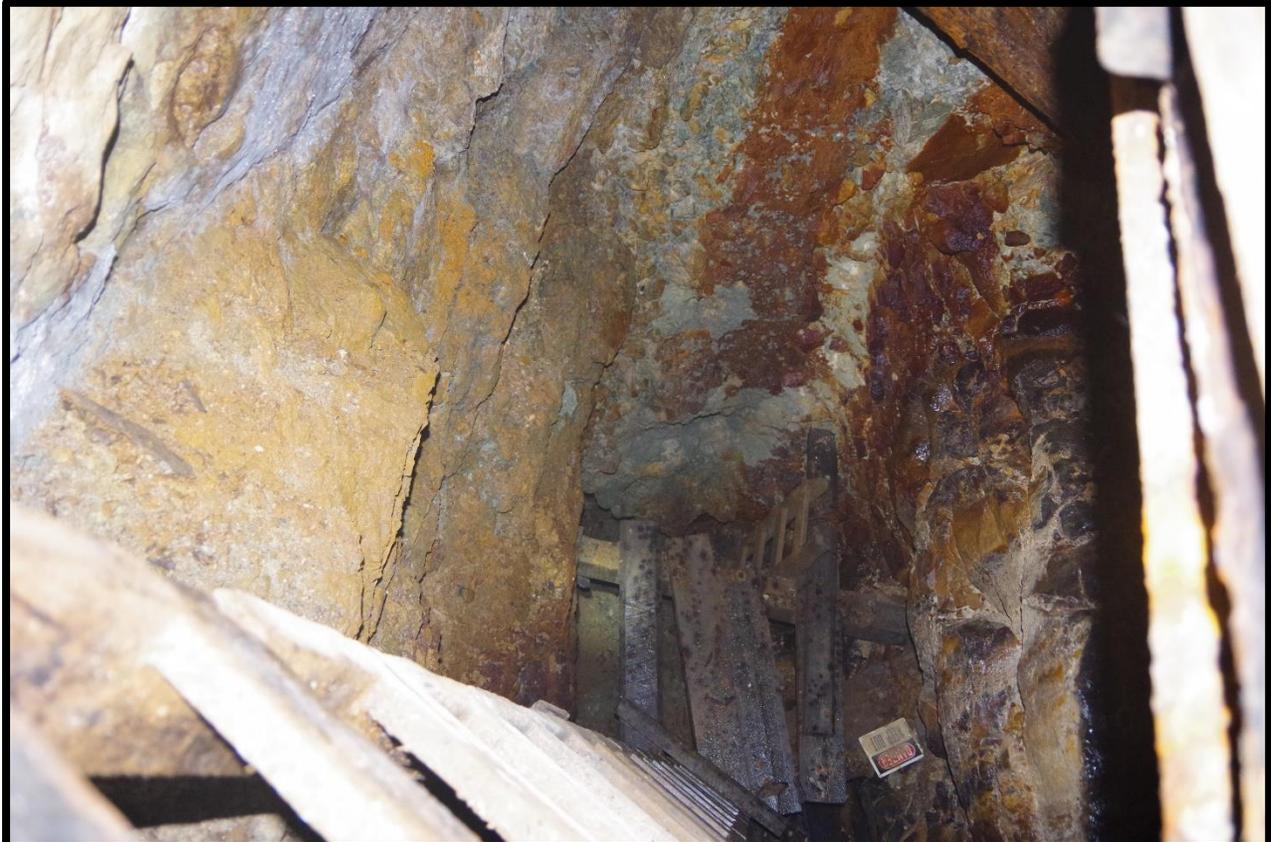
Photo 54: Looking down No Name/y02 Winze

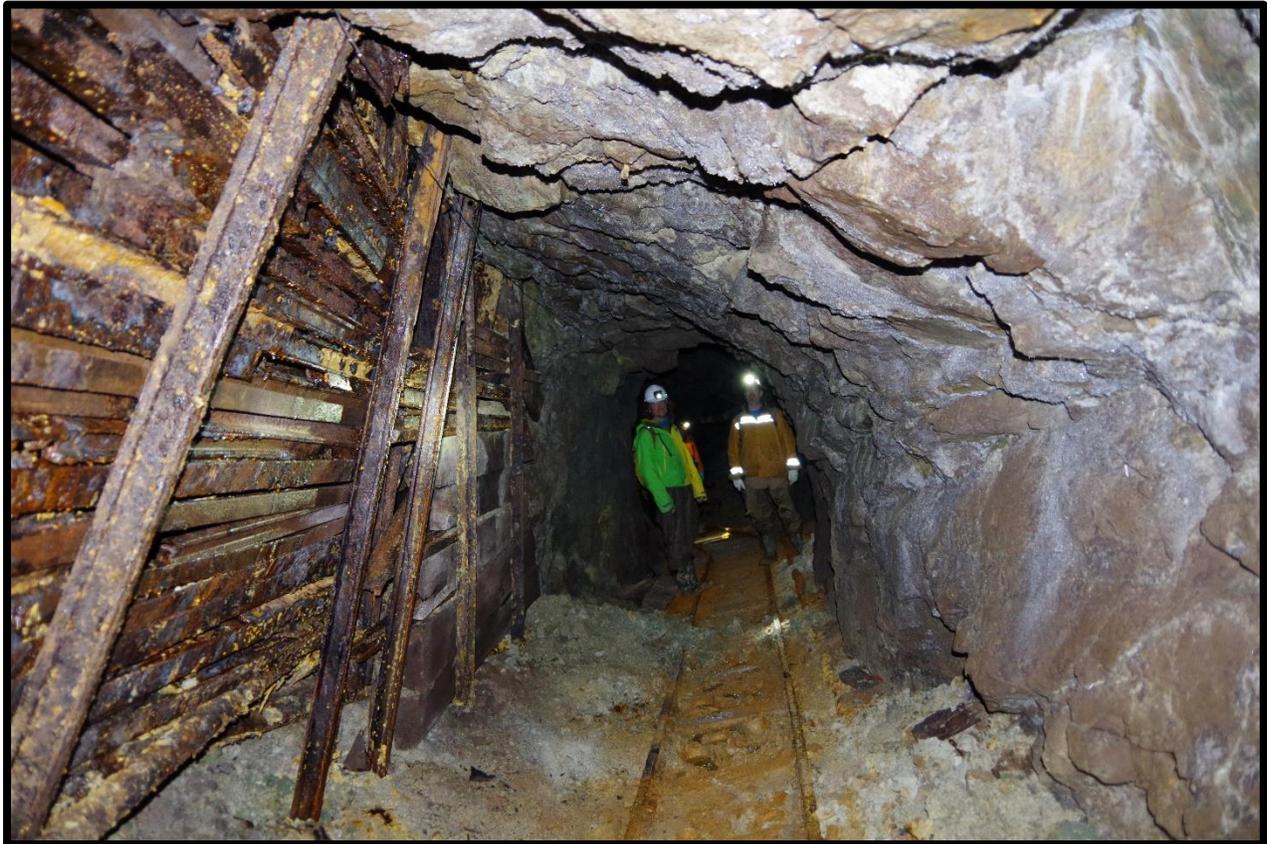
Photo 57: Area of clay gouge in left rib near 47+10; Note heavy steel rail lagging

The area of greatest concern for keeping the "overflow" from the Del Monte Raise to the No Name/Y02 Winze open is a section of clay gouge between stations 47+10 and 47+40. It is supported by rail posts, rail lagging, and wood lagging. If the lagging fails in this area, the drift would likely be blocked, leading to higher water pressures and water volume in the upper mine pool.

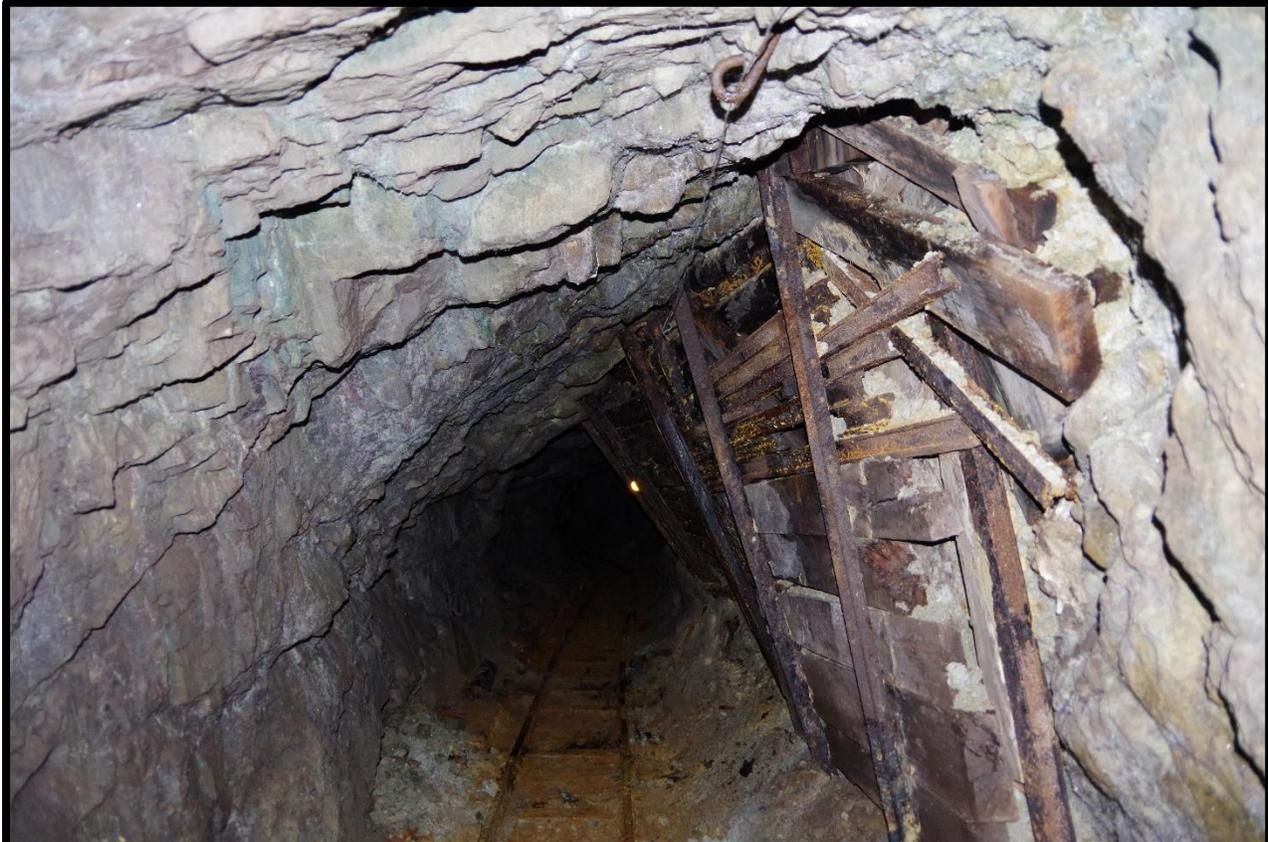
Photo 58: Area of clay gouge in left rib near 47+10 looking outby; Note timber lagging

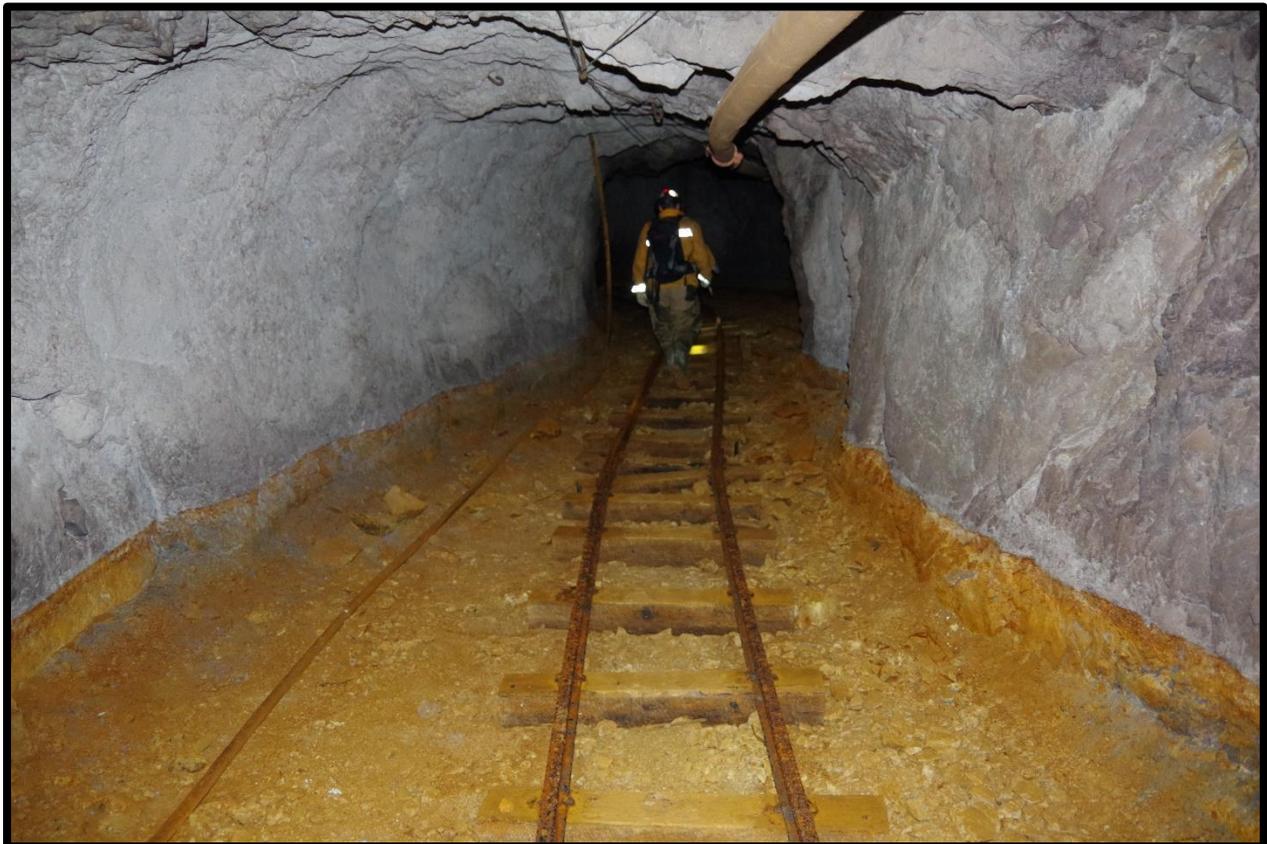
Photo 59: Typical draft near 50+00; Note high water line from upper mine pool overflow

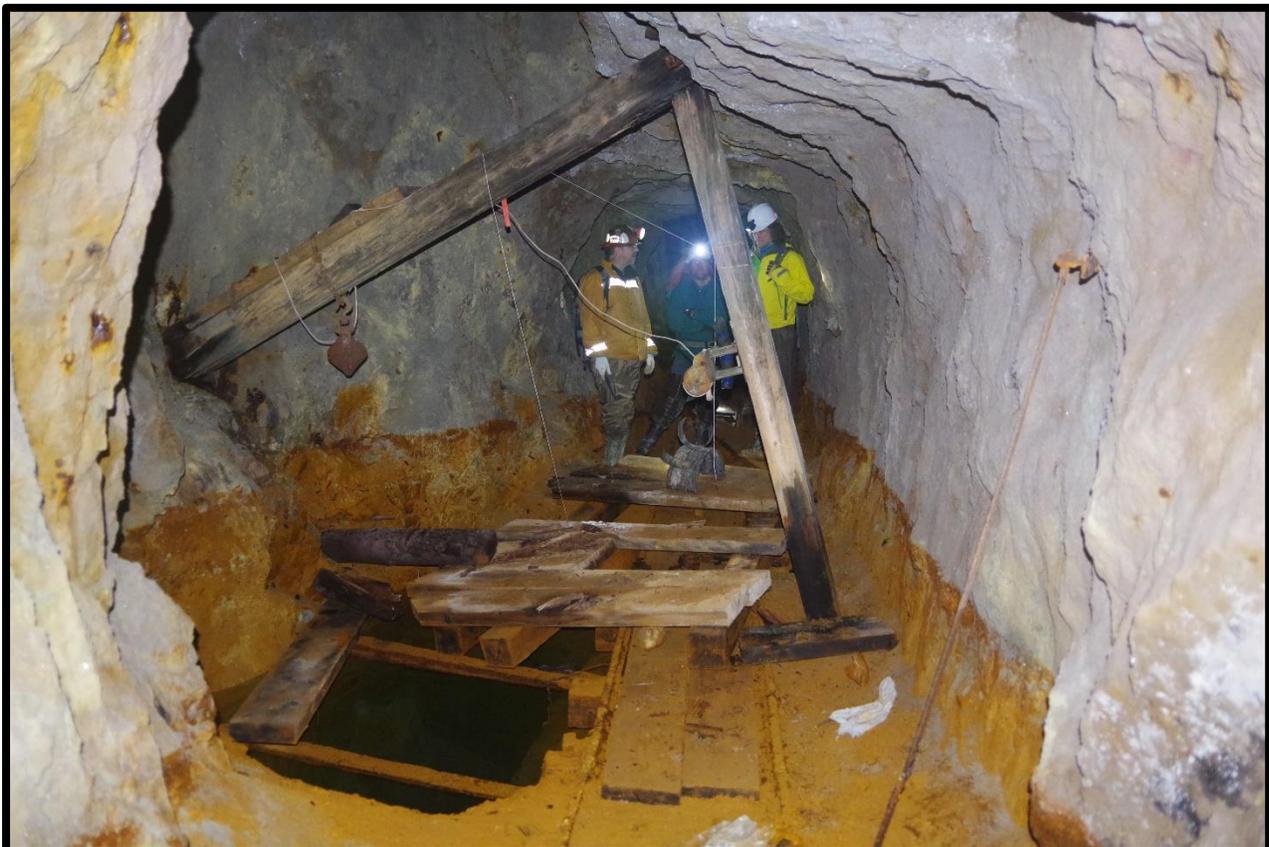
Photo 60: Del Monte Raise 53+15; Note sampling platform

The collar at the Del Monte Raise should have an elevated platform installed above the high water line to allow safe and efficient sampling without hindering the flow of the mine pool. This platform would also be made of FRP or similar material.
