Telluride Valley Floor

U.S. Environmental Protection Agency, in conjunction with U.S. Forest Service, is conducting a joint Removal Action at the Telluride Valley Floor Site, which is located in Telluride, CO.

Telluride Valley Floor/Boomerang Road Time-Critical Removal Action Site Work
Update

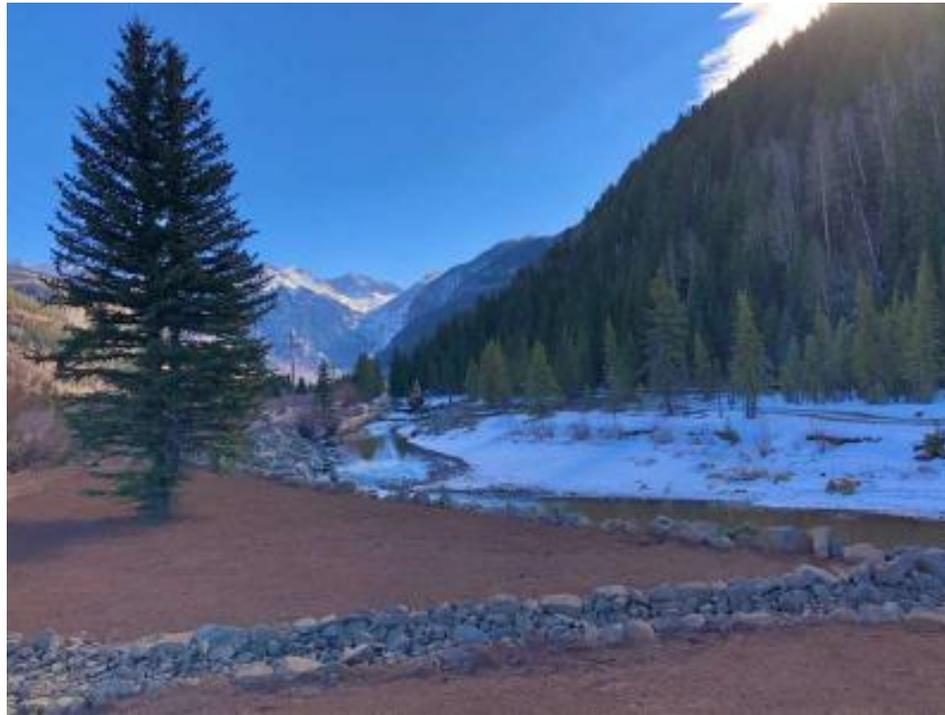
Completed North Riverbank Lining and Arm

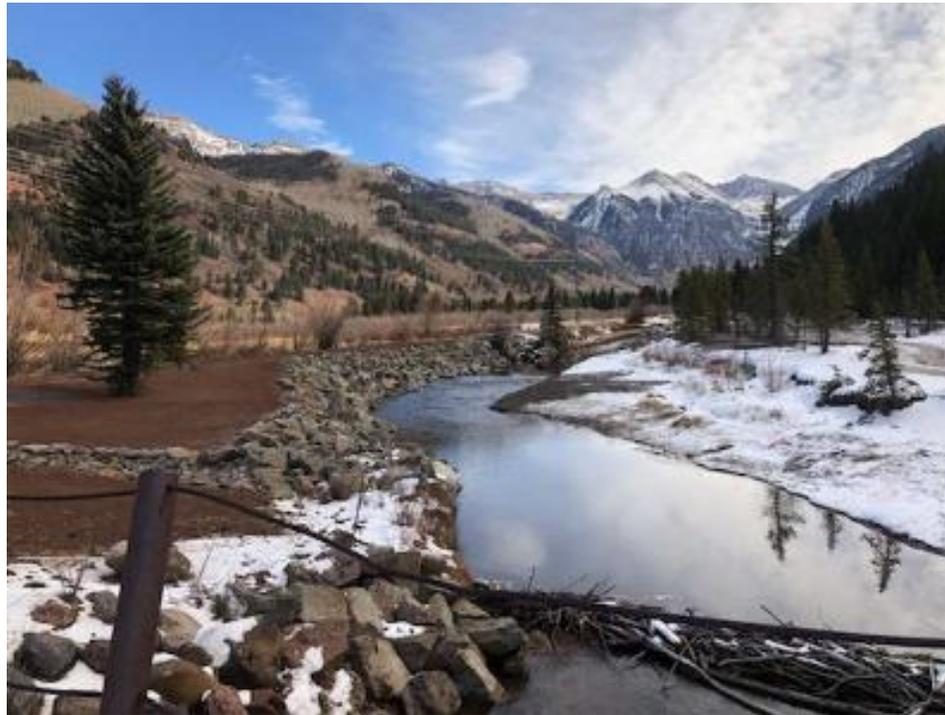
Installed Drainage Controls

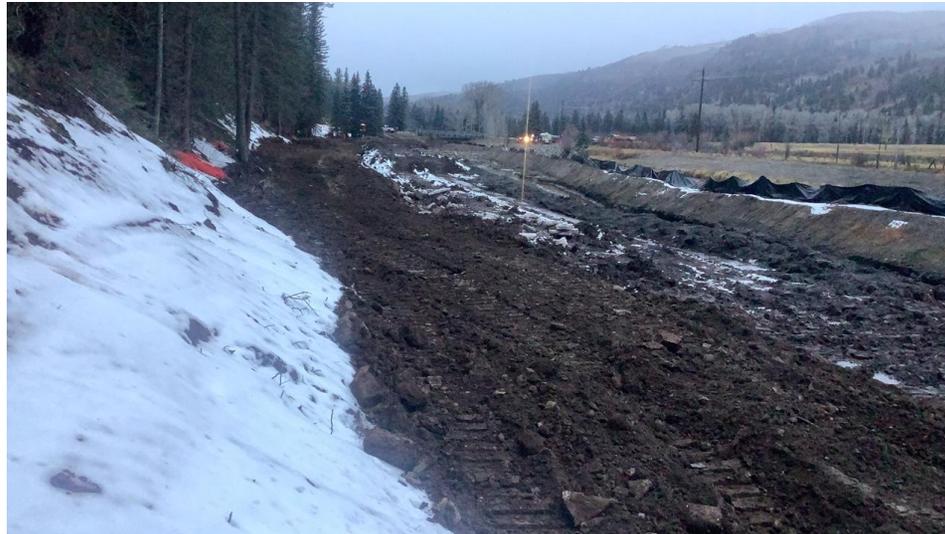
Mine tailings from ST1 South have been fully excavated. The area has also been completely backfilled with clean material.

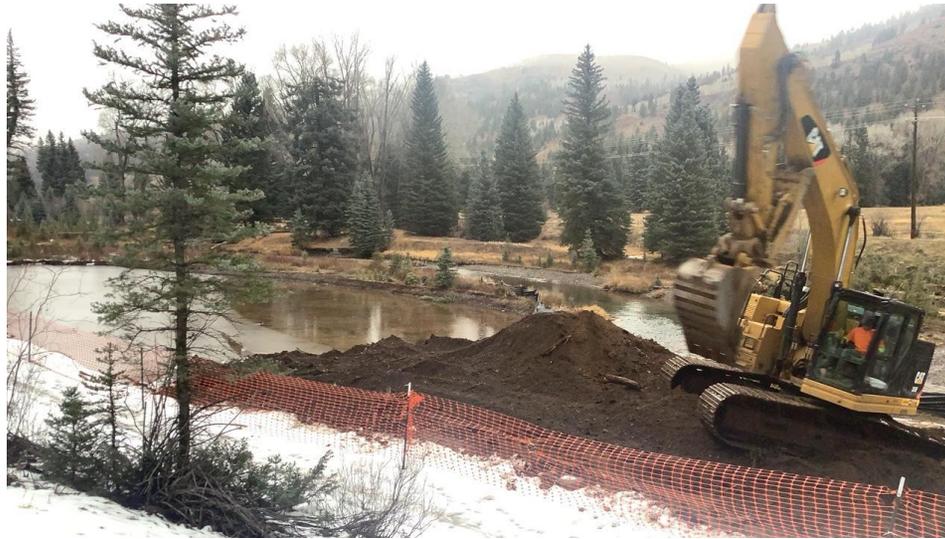
Excavation of ST3 is approximately 90% complete. The operator has piled up the excavated tailings in order to load dump trucks more efficiently.

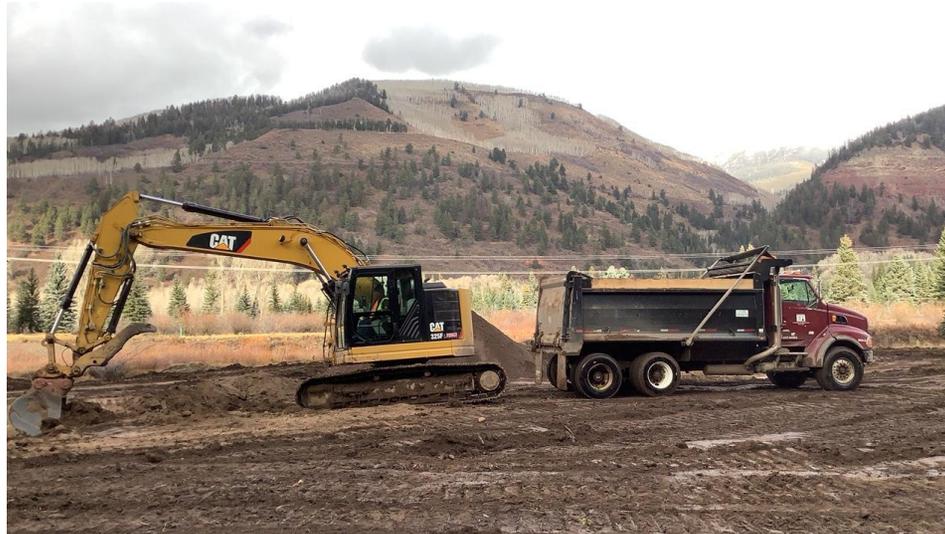
Excavator works in borrow source to load dump truck with clean backfill material.

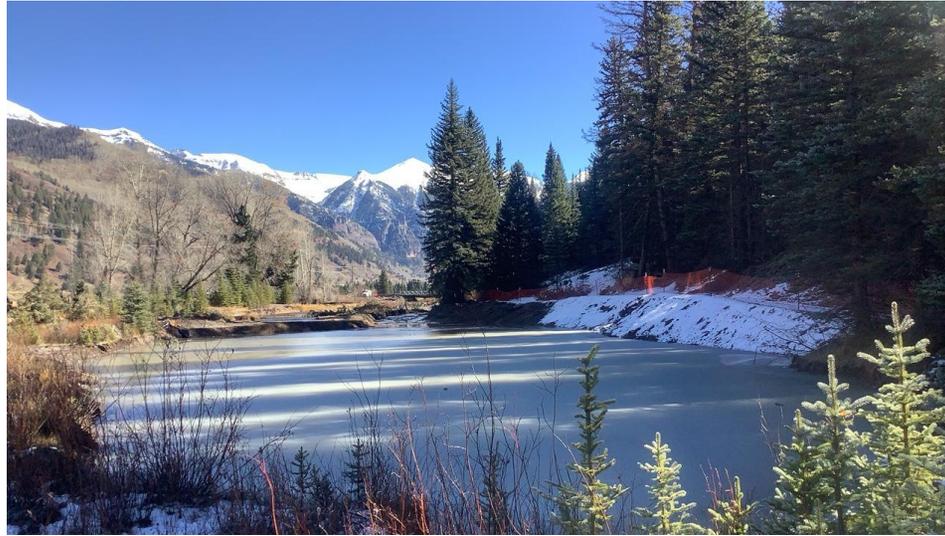
Excavation and hauling of mine tailings from ST3 has been fully completed.
