# Valley Drive Abandoned Slurry

## Photo Log

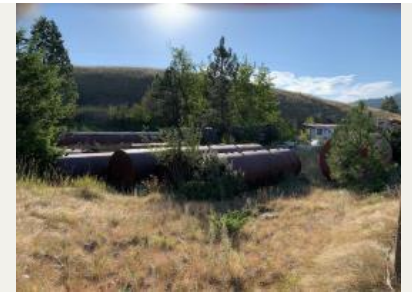
Description: View of site facing southeast

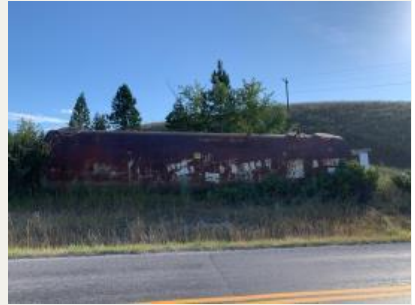
Description: View of the tank on site that has released or discharged hydrocarbon product into the right a way drainage pathway along West Valley Drive. Facing northeast

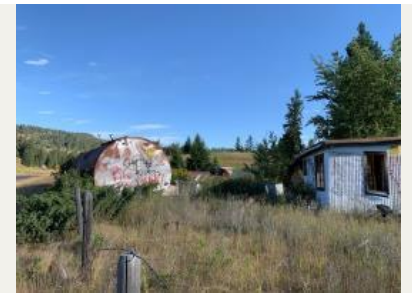
Description: View of site facing northwest.

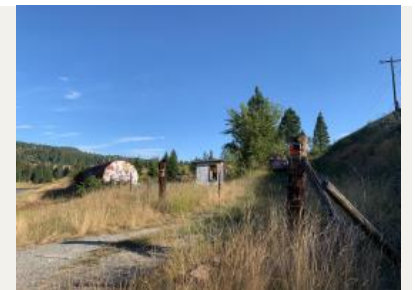
Description: View of site facing north

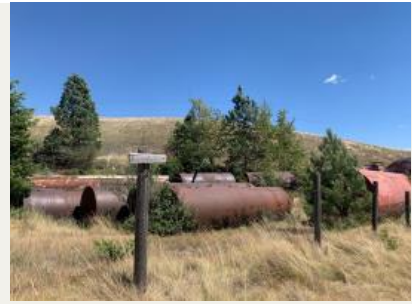
Description: View of tanks located on the northern portion of the site. Facing east

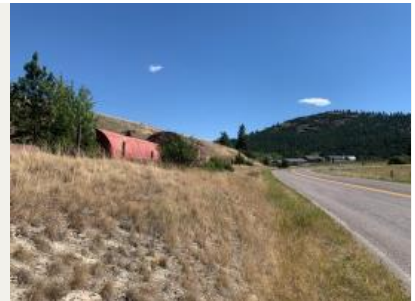
Description: View of the right a way drainage pathway along the southwest property line. Facing southeast

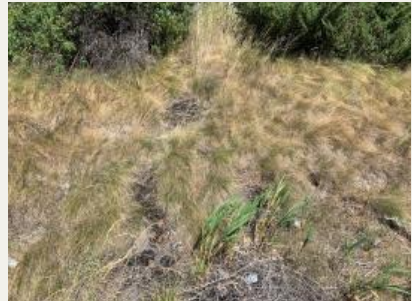
Description: View of the pathway that the hydrocarbon product that has been released or discharged from a tank into the right a way drainage pathway along West Valley Drive. Facing East

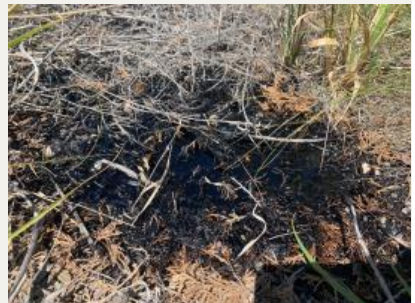
Description: Close up view of the hydrocarbon product that has been released or discharged from a tank into the right a way drainage pathway along West Valley Drive.

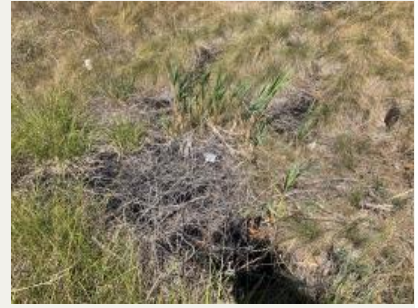
Description: View of the hydrocarbon product that has been released or discharged from a tank into the right a way drainage pathway along West Valley Drive.

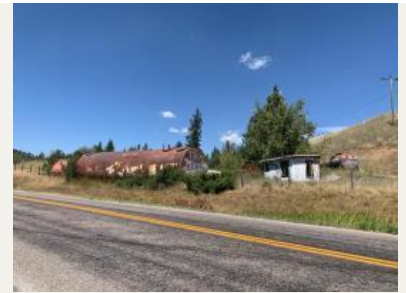
Description: View of the site facing northeast

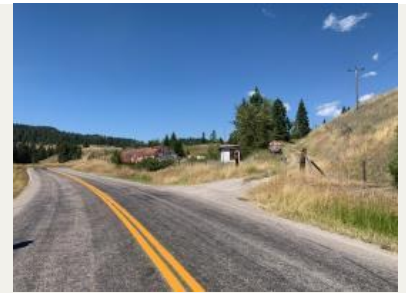
Description: View of the site facing North
