**Subject: Contract No. 68HERH19D0018; Task Order (TO) No. 68E0719F0190
Nevada Habilitation Site
East Edwards Street, Nevada, Vernon County, Missouri
Targeted Brownfields Assessment Hazardous Building Materials Survey**

**TARGETED BROWNFIELDS ASSESSMENT
HAZARDOUS BUILDING MATERIALS SURVEY**

**NEVADA HABILITATION SITE
EAST EDWARDS STREET
NEVADA, VERNON COUNTY, MISSOURI**

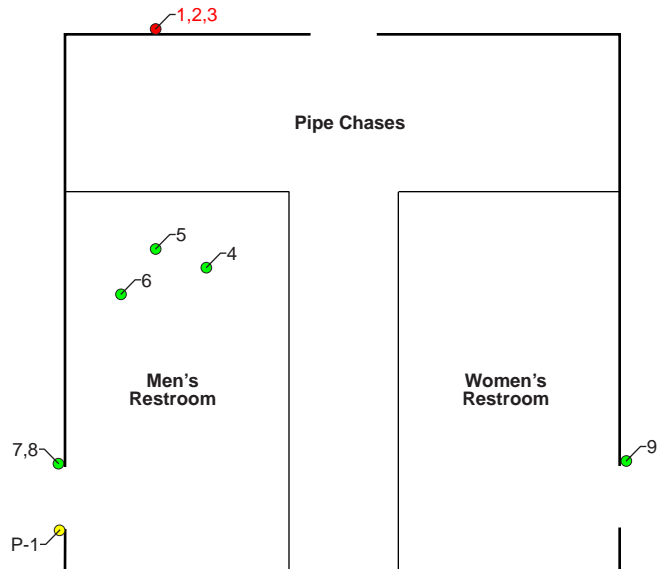
Figure 2 Sample Location Map

PLM results from samples of suspect ACM collected at the restroom building are in the laboratory report in Appendix D and summarized in Table 1 below. Bolded results in Table 1 indicate where asbestos was detected at concentration greater than 1 percent. Sample locations are shown on Figure 2 in Appendix A.

Regulated ACM was identified in roofing tar (approximately 150 square feet) on the roof of the restroom building. All regulated ACM should be removed by a licensed asbestos abatement contractor before demolition work disturbs the material. The removed waste must be transported to a disposal site approved to accept non-friable ACM. If the restroom building is to be renovated, the above ACM materials are not to be disturbed and may remain in place.

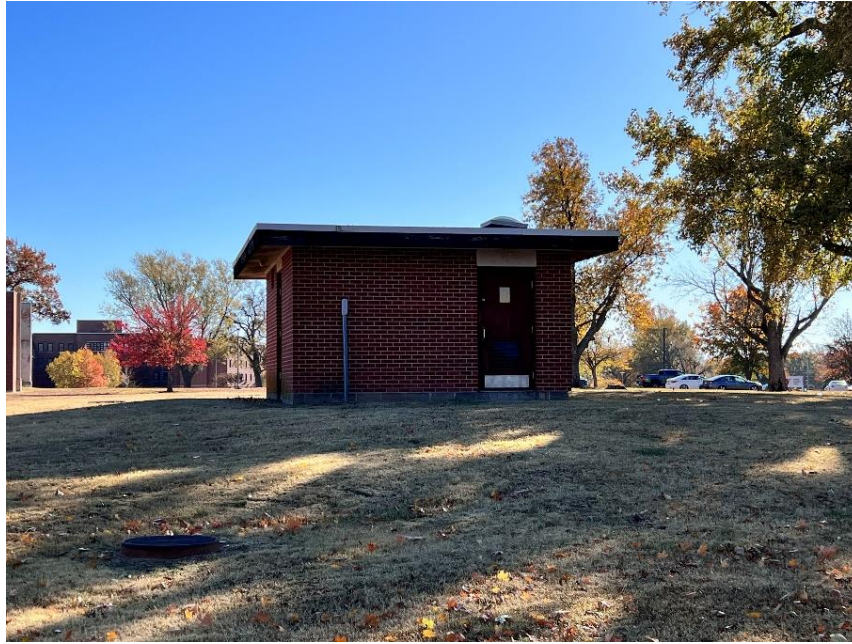
SUBTASK NO. 011.05	DESCRIPTION	This photograph shows the restroom building.	1
	CLIENT	U.S. Environmental Protection Agency (EPA)	Date: 10/26/22
Direction: East	PHOTOGRAPHER	Zach Usher

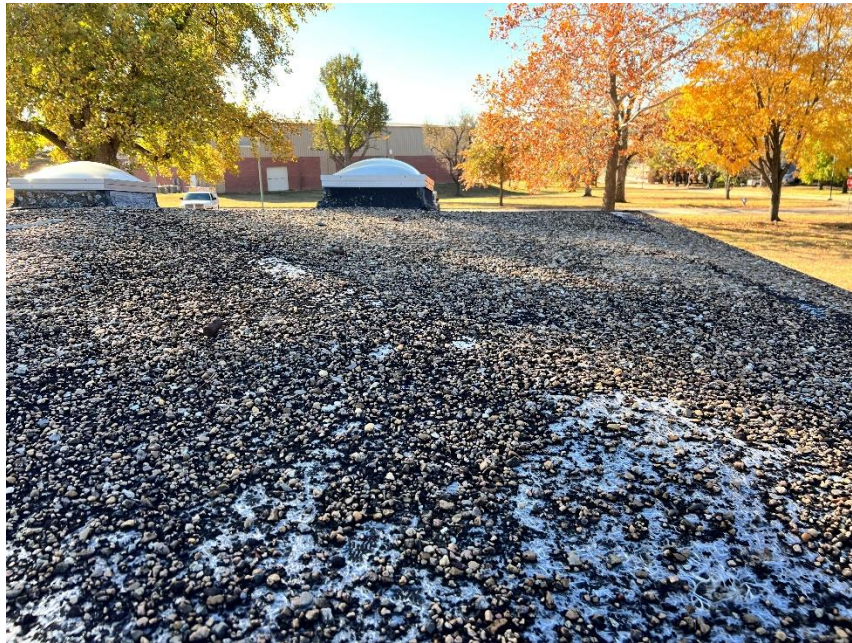
SUBTASK NO. 011.05	DESCRIPTION	This photograph shows the asbestos-containing roofing tar on the restroom building.	2
	CLIENT	EPA	Date: 10/26/22
Direction: South	PHOTOGRAPHER	Zach Usher

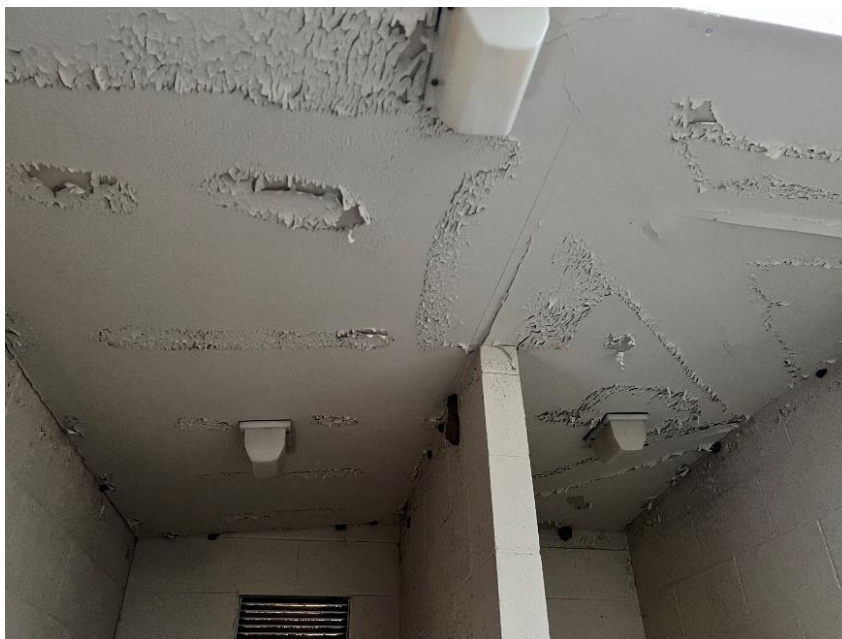
SUBTASK NO. 011.05	DESCRIPTION	This photograph shows the drywall ceiling inside the restroom building.	3
	CLIENT	EPA	
Direction: Not Applicable (N/A)	PHOTOGRAPHER	Zach Usher	Date: 10/26/22

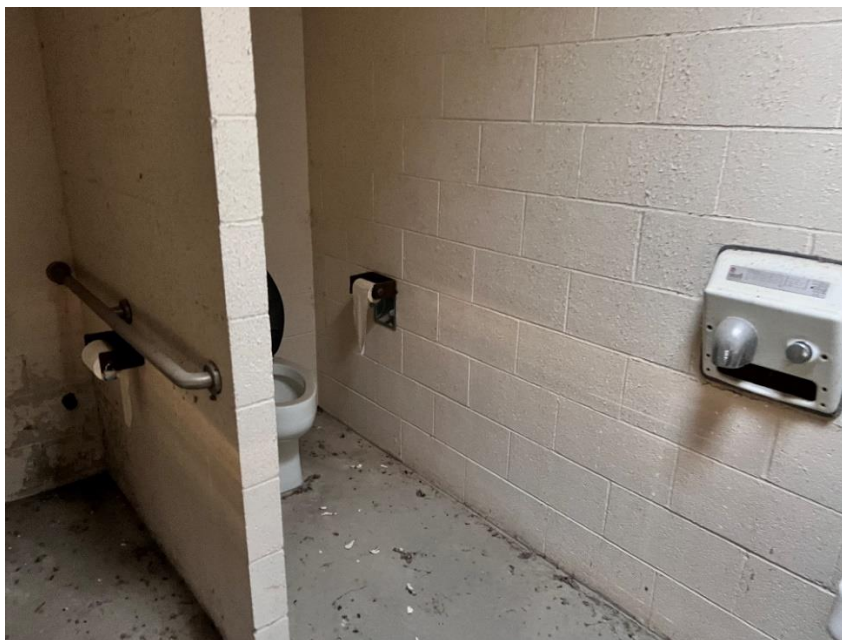
SUBTASK NO. 011.05	DESCRIPTION	This photograph shows concrete walls and floor inside the restroom building.	4
	CLIENT	EPA	
Direction: N/A	PHOTOGRAPHER	Zach Usher	Date: 10/26/22

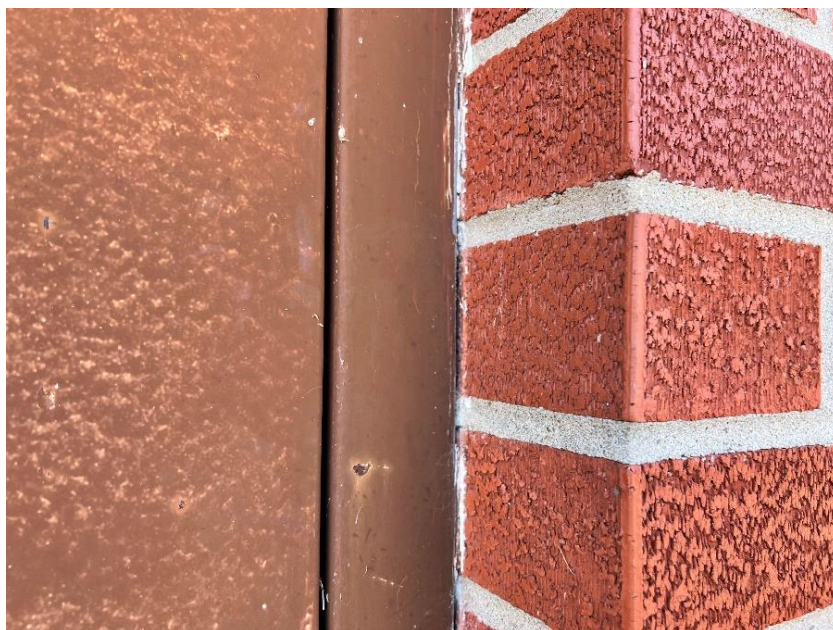
Laboratory results indicated no sampled building materials contained concentrations of PCBs exceeding 50 ppm; no PCBs were detected in the restroom building.

SUBTASK NO. 011.05	DESCRIPTION	This photograph shows white caulk on a metal doorframe on the exterior of the restroom building.	5
	CLIENT	EPA	Date: 10/26/22
Direction: N/A	PHOTOGRAPHER	Zach Usher

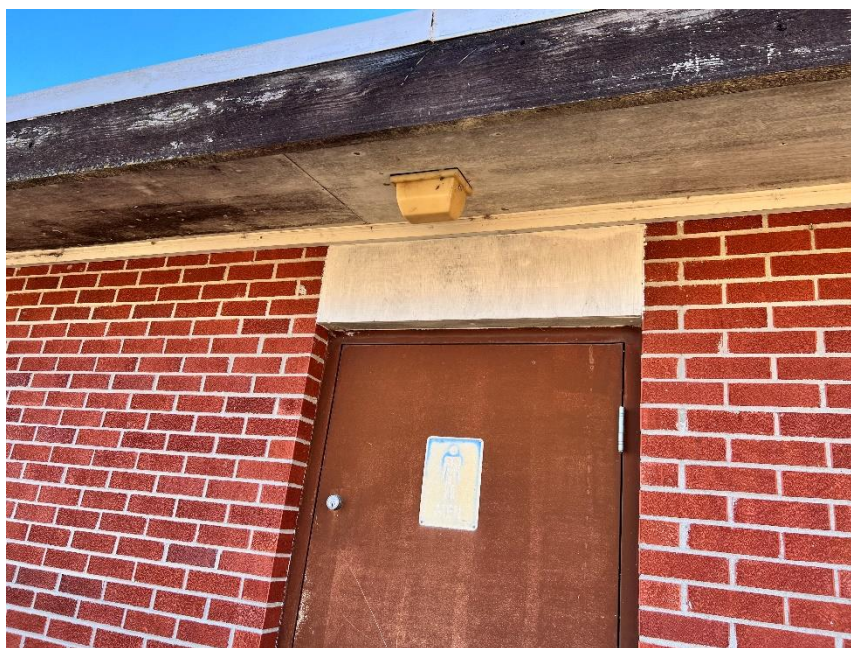
SUBTASK NO. 011.05	DESCRIPTION	This photograph shows wooden soffit on the exterior of the restroom building.	6
	CLIENT	EPA	Date: 10/26/22
Direction: East	PHOTOGRAPHER	Zach Usher
