MEMORANDUM

RE: Indoor Sampling Activities. Zonolite/W.R. Grace Facility, Easthampton, Massachusetts. TDD Number (No.) 01-08-11-0009; Task No. 0487; Document Control (DC) No. R-5851.

PHOTODOCUMENTATION LOG
Zonolite/W.R. Grace Facility • Easthampton, Massachusetts

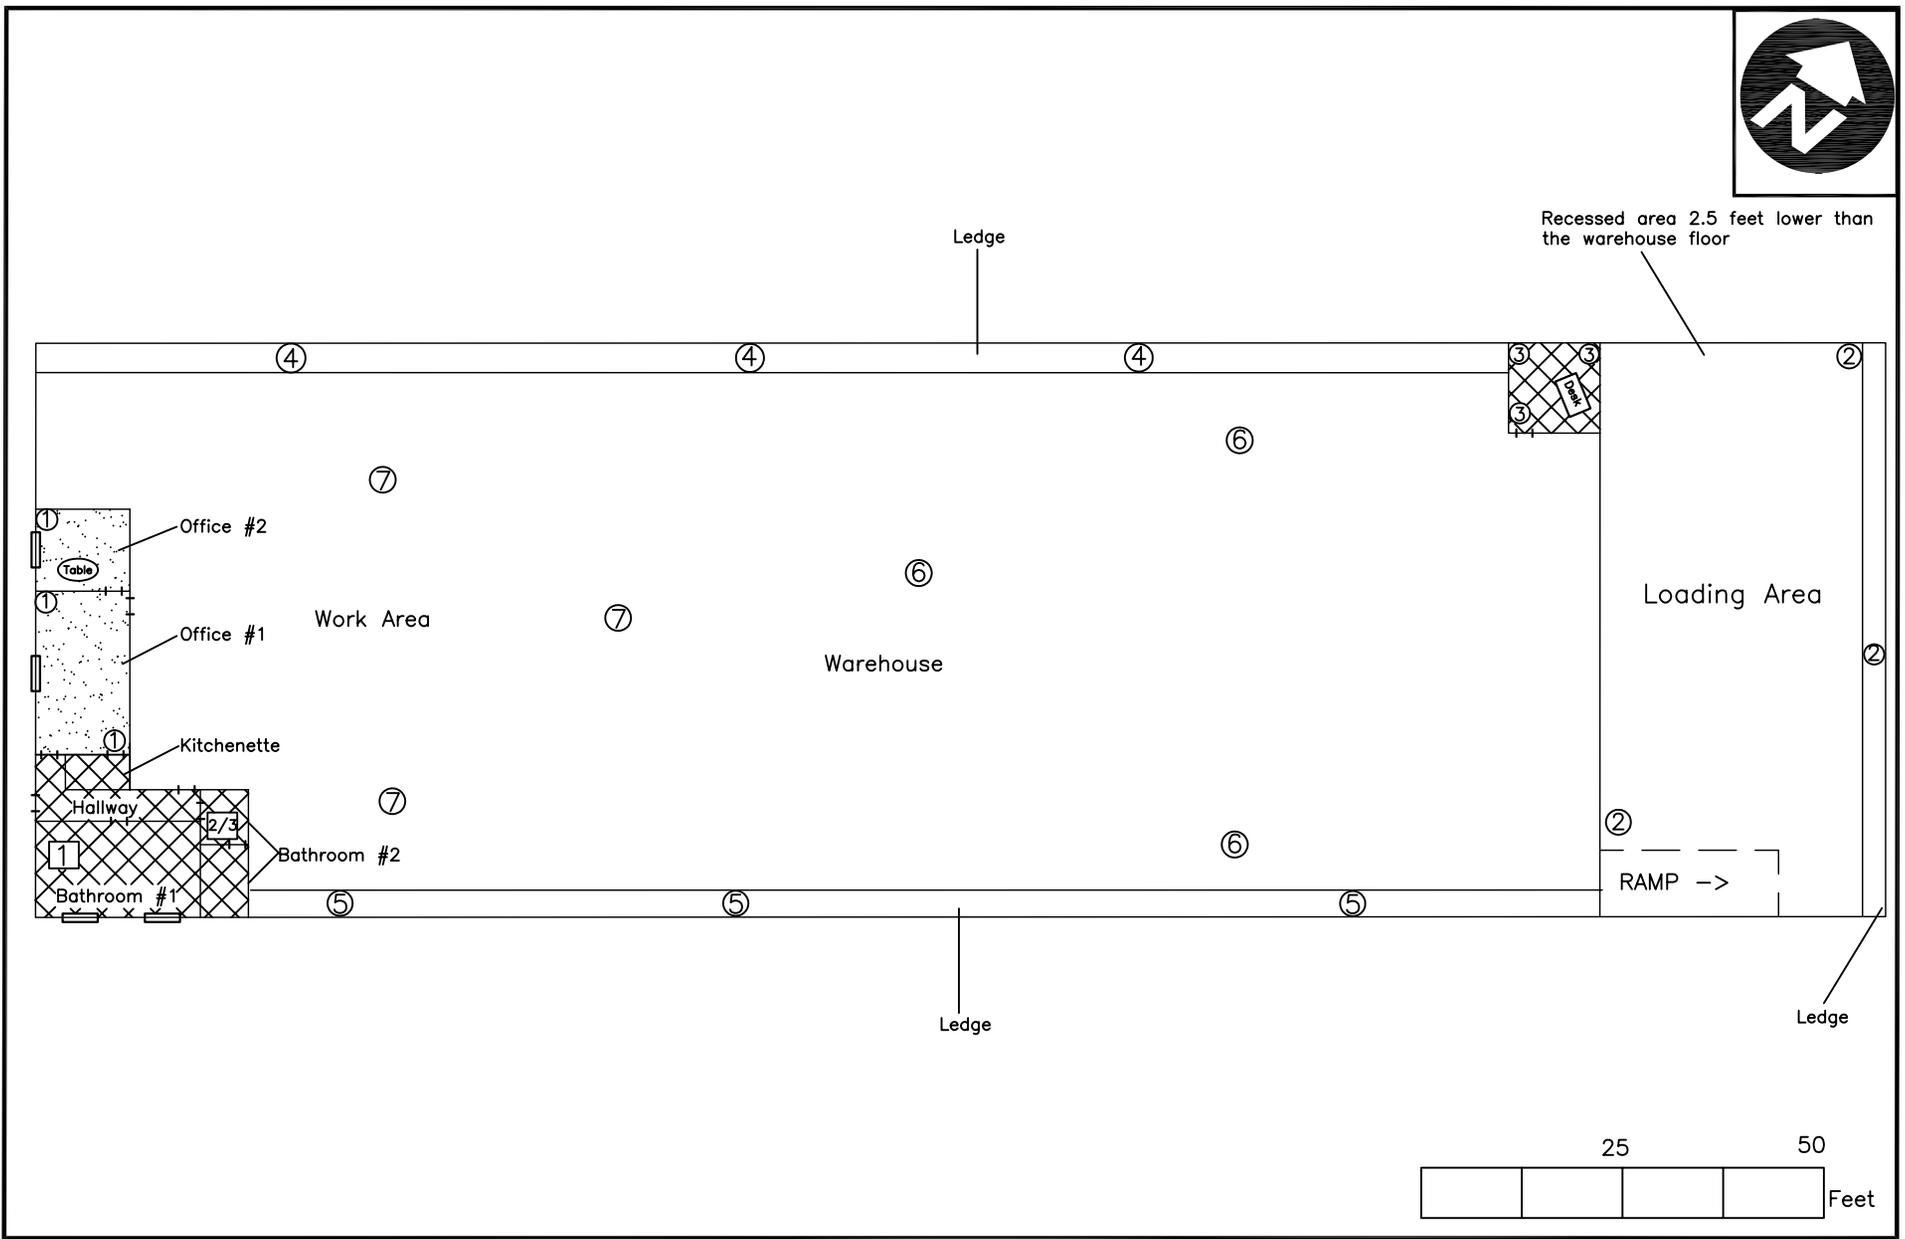
FIGURE 3

OSC McKeown selected seven locations for microvacuum dust samples. All microvacuum dust samples were collected using low-flow sampling pumps that were calibrated prior to and following sample collection. Microvacuum dust samples were composite samples consisting of three 100-square-centimeter (cm²) aliquots, each collected over a duration of 2 minutes. Microvacuum samples were collected from the following surfaces and locations: the floor of Office #1 (two aliquots) and Office #2 (one aliquot) (sample AS-01); the floor (two aliquots) and ledge (one aliquot) of the loading area (sample AS-02); the floor of the small office within the warehouse (sample AS-03); the ledge along the western wall of the warehouse (sample AS-04); the ledge along the eastern wall of the warehouse (sample AS-05); the floor in the northern portion of the warehouse (AS-06); and the floor in the southern portion of the warehouse, excluding the area partitioned off for concrete cutting operations (sample AS-07). In addition, START collected one field blank and one lot blank for quality control purposes. During sampling activities in the loading area, START observed apparent fragments of broken light bulbs on the floor. See Attachment A, Figure 3, Sample Location Diagram, for dust and bulk sample locations.

SAMPLE LOCATION DIAGRAM

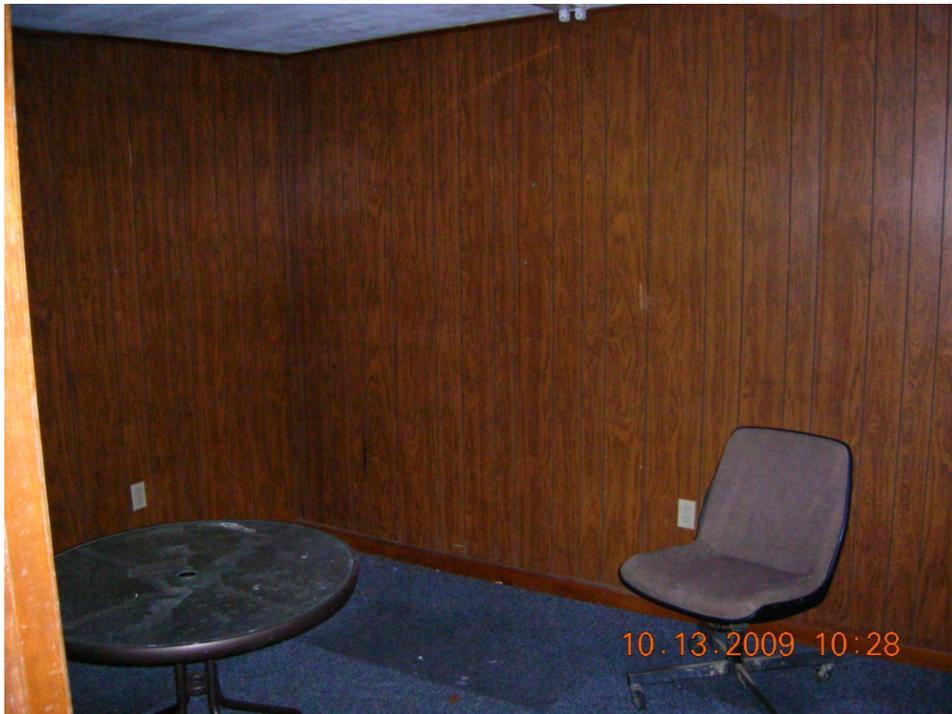
SCENE: View of Office Number (No.) 2, located in the western portion of the building. One aliquot of composite microvacuum sample AS-01 was collected in the corner of the room.

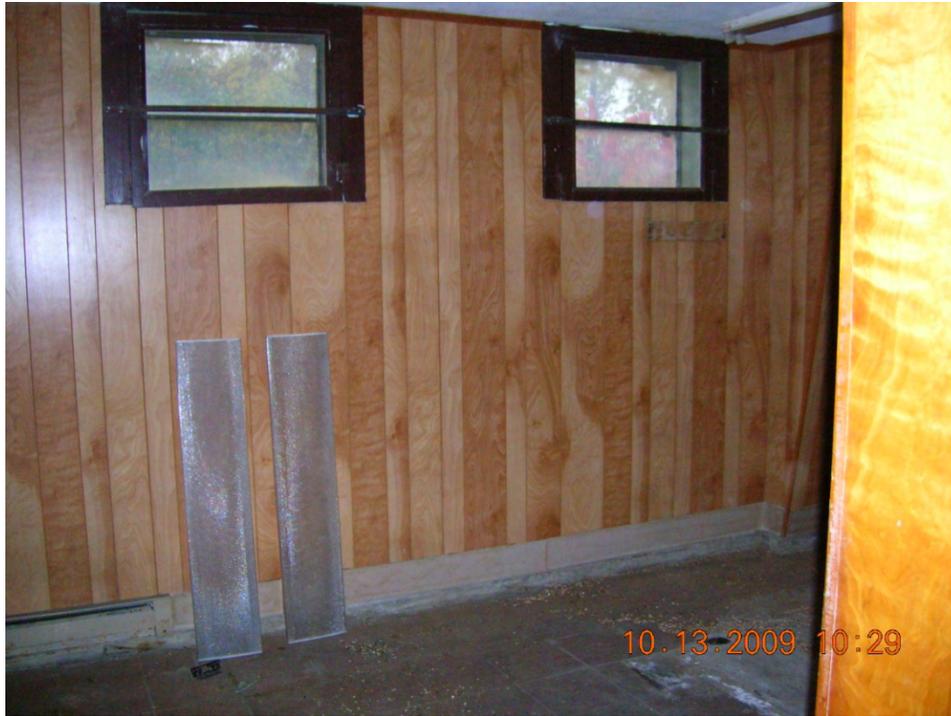
SCENE: View of Bathroom No. 1, a large bathroom located in the southeastern portion of the building, in which bulk sample BA-01 was collected.

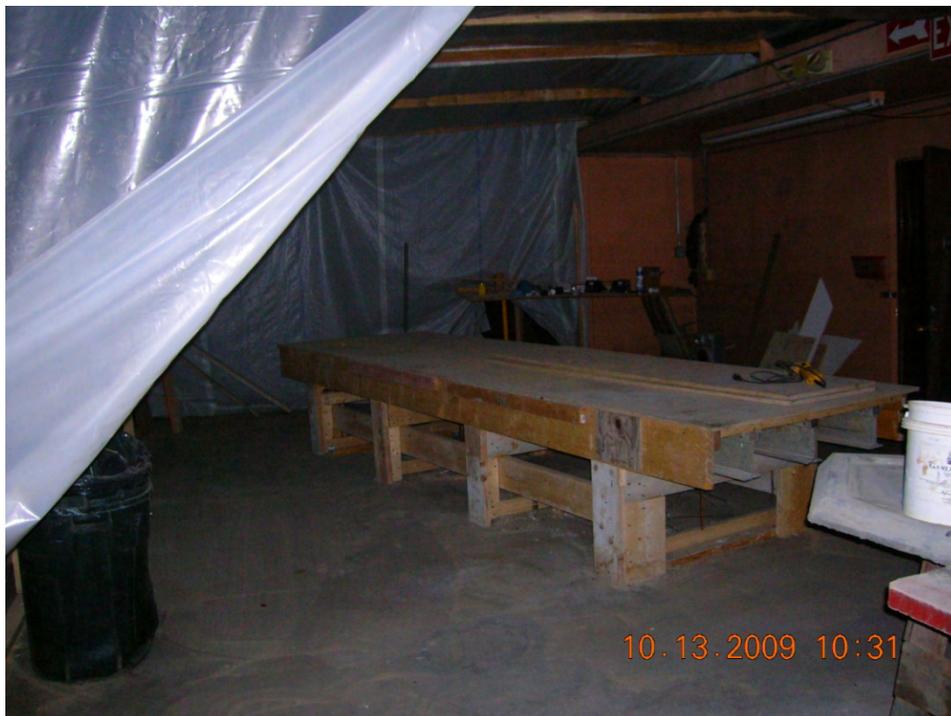
SCENE: View of a partitioned area in the warehouse area of the building, used for cutting countertops (the work area).

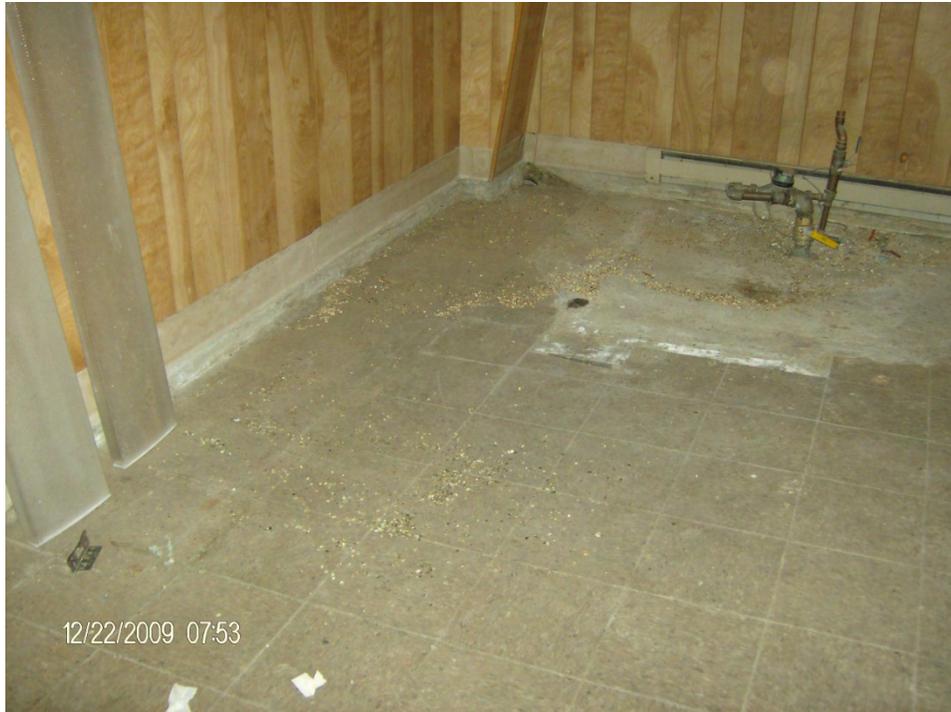
SCENE: View of suspected vermiculite material on the floor of Bathroom No. 1. Bulk sample BA-01 consisted of this material. Note that the time stamp on some photographs is incorrect.

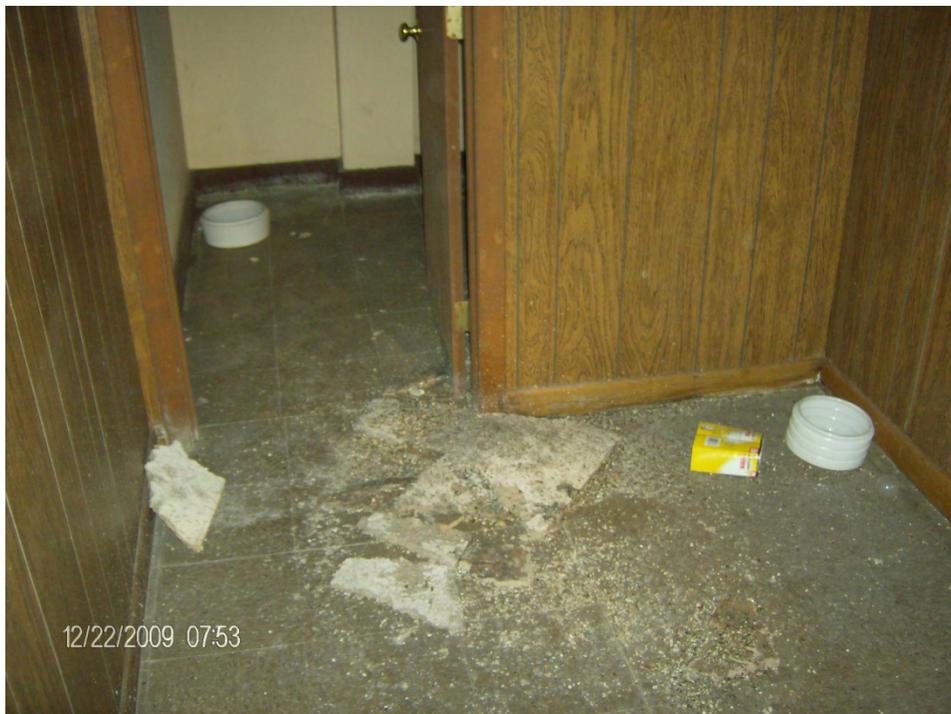
Analytical results of bulk samples revealed trace levels (less than the method detection limit of 0.25% by volume) of tremolite/actinolite asbestos in sample BA-02 and duplicate sample BA-03. According to the laboratory report, one small bundle of Libby amphibole tremolite/actinolite was observed in each of these two samples. No asbestos was detected in sample BA-01. See Attachment B, Table 2, for a summary of analytical results of bulk samples.

SCENE: View of suspected vermiculite material and fallen ceiling tiles on the floor of Bathroom No. 2, located adjacent to Bathroom No. 1. Bulk sample BA-02 and duplicate sample BA-03 consisted of this material.

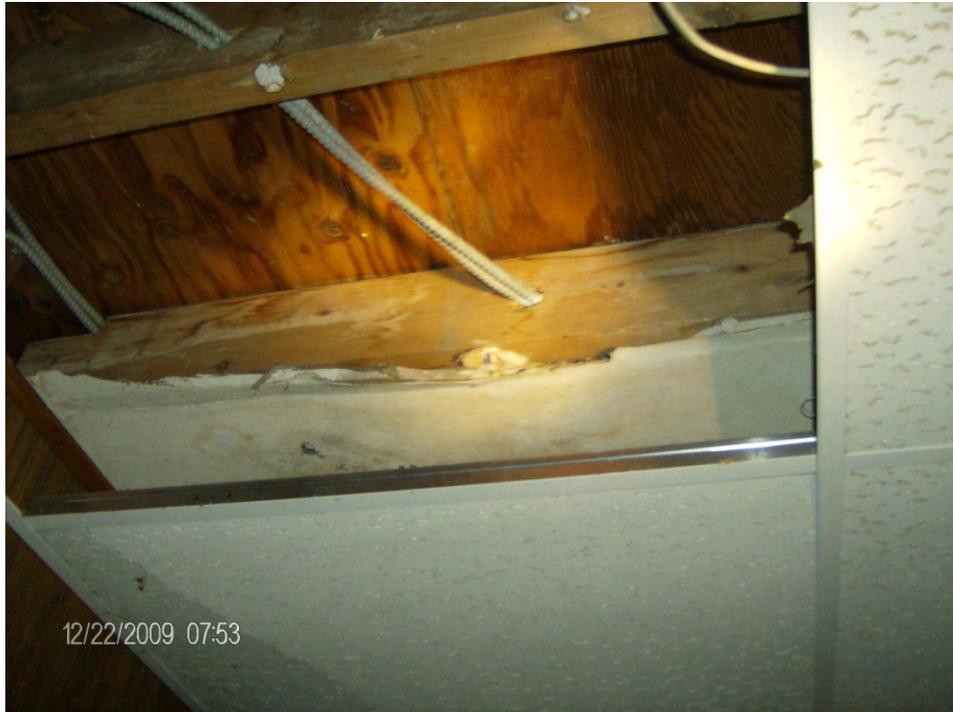
SCENE: View of suspected vermiculite material used as ceiling insulation in the ceiling of Bathroom No. 2.

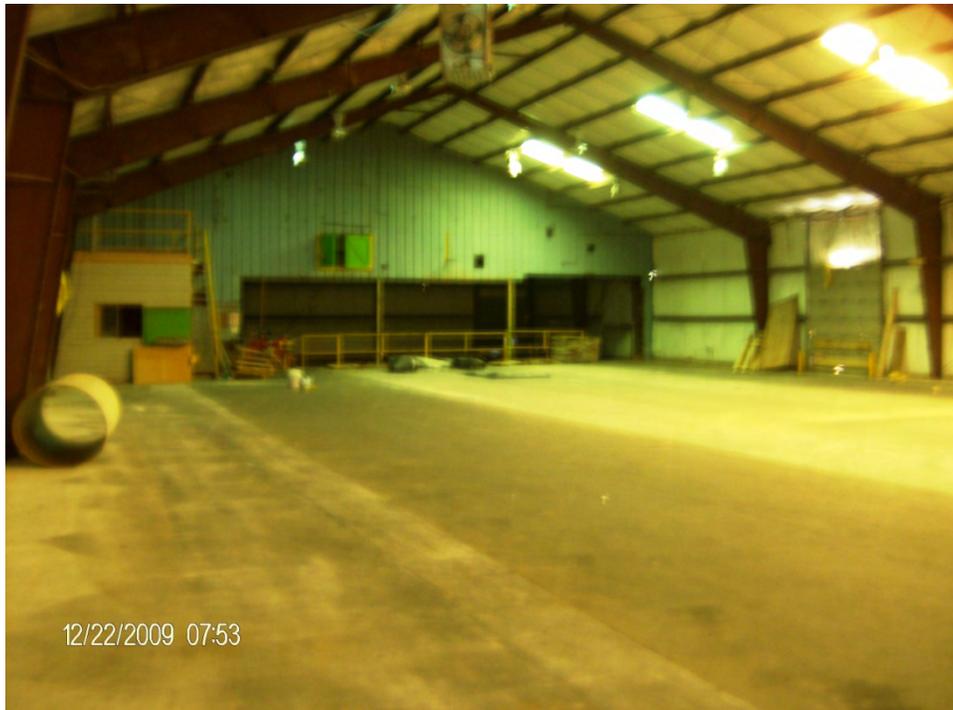
SCENE: View of the warehouse portion of the building. Microvacuum dust samples AS-06 and AS-07 were collected from the floor of the warehouse.

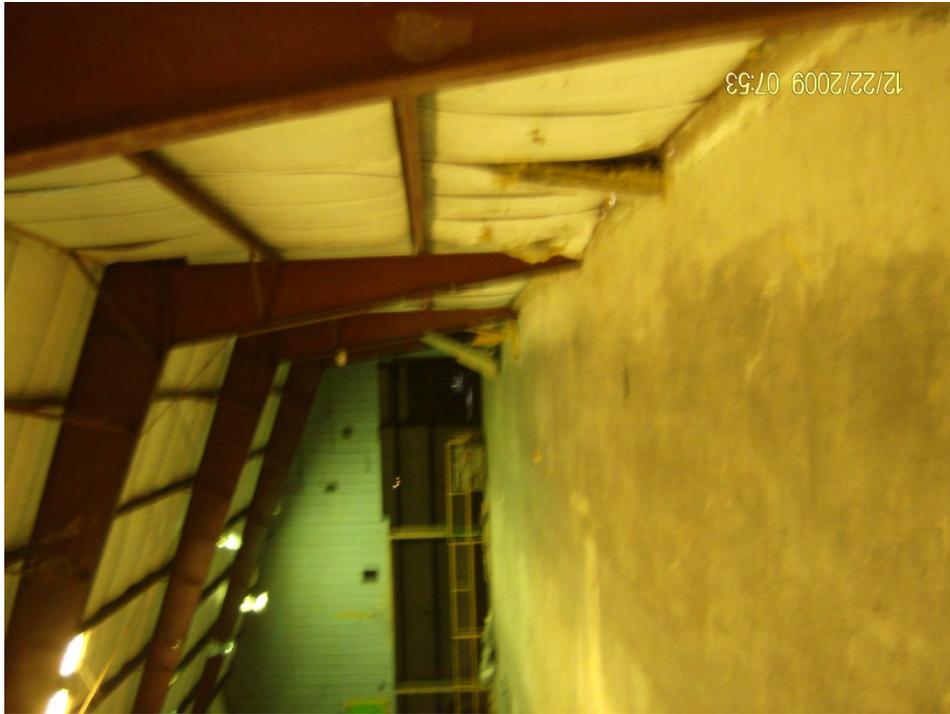
SCENE: View of the eastern wall of the warehouse. Microvacuum dust sample AS-05 was collected from the ledge along the wall.

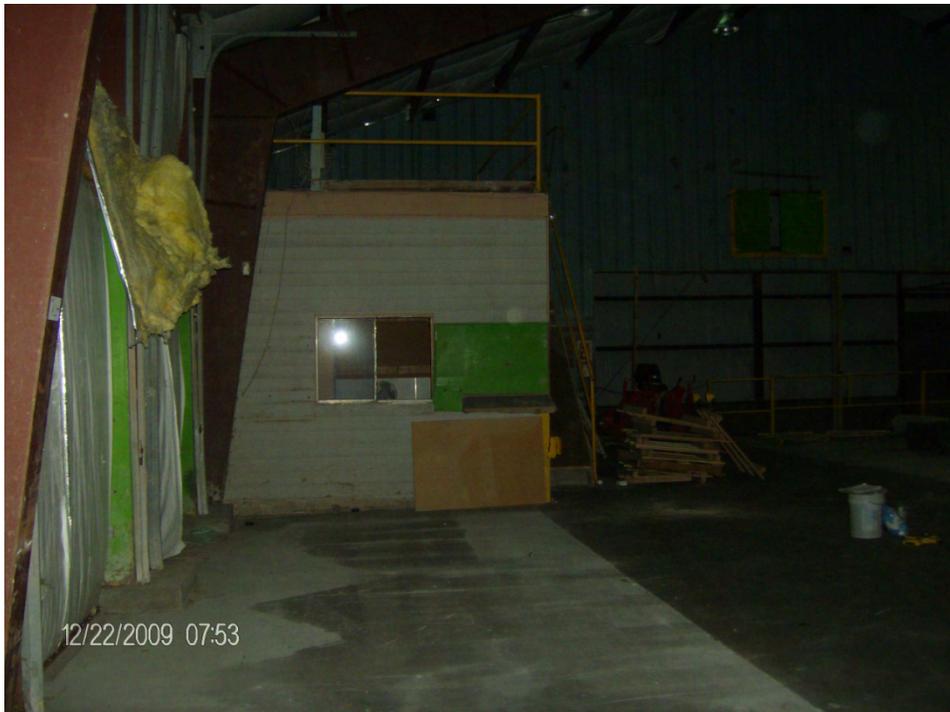
SCENE: View of the exterior of a small office located adjacent to the loading area, in the warehouse portion of the building. Microvacuum dust sample AS-03 was collected from the floor of this office.

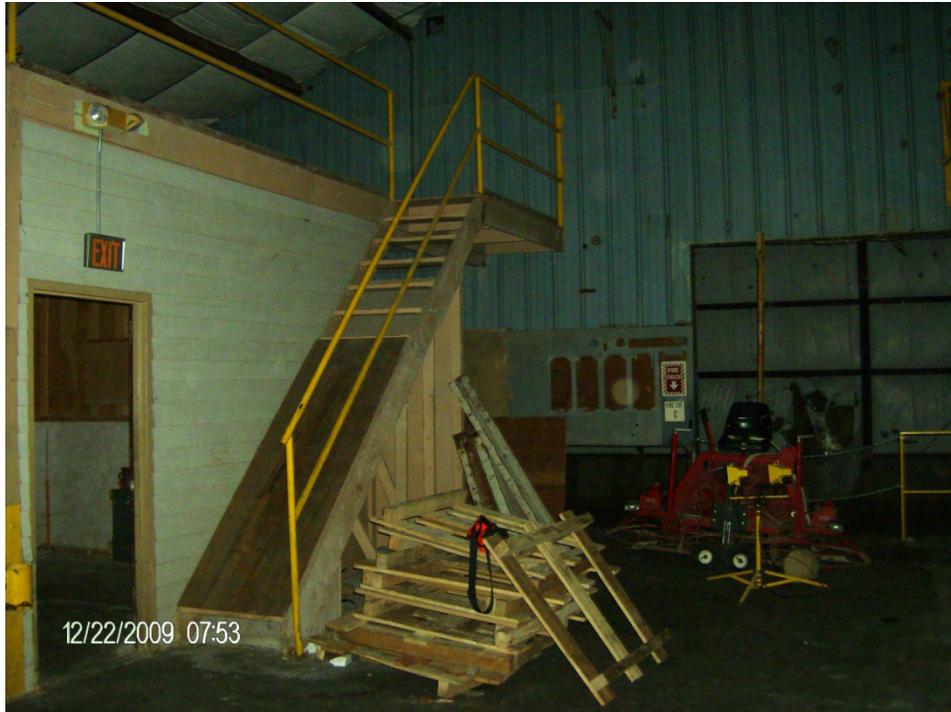
SCENE: View of the entrance to the small office located adjacent to the loading area, in the warehouse portion of the building. Note that the second story area above the office was inaccessible.

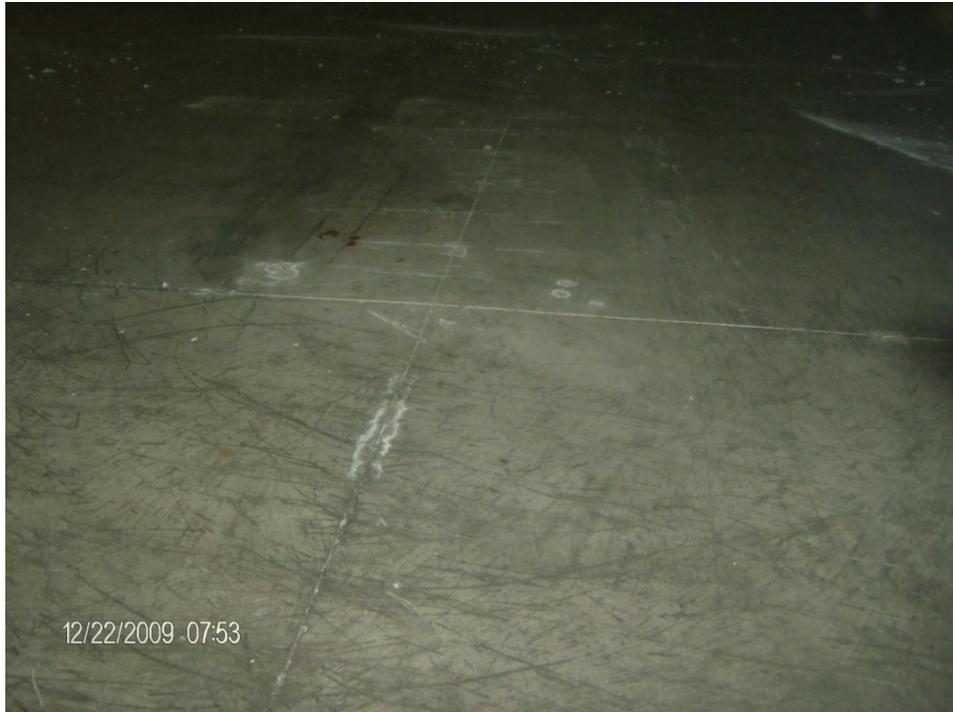
SCENE: View of the floor of the warehouse. Microvacuum samples AS-06 and AS-07 were collected from the floor of the warehouse.
