**Burns Asbestos Removal Action  
Removal Action Report  
Former Burns Air Force Radar Range  
Harney County, Oregon  
TDD: 04-06-0001**

**BURNS ASBESTOS REMOVAL ACTION  
REMOVAL ACTION REPORT  
TDD: 04-06-0001**

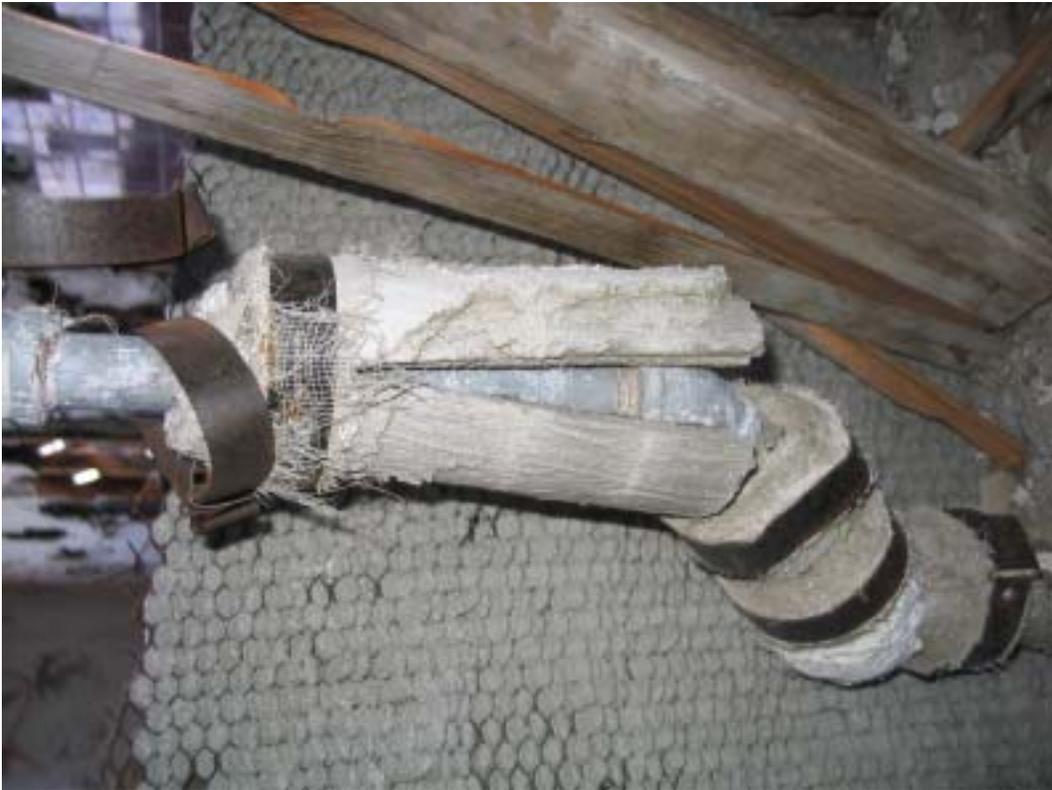
Photograph 6. Significantly damaged, friable ACM (pipe insulation).

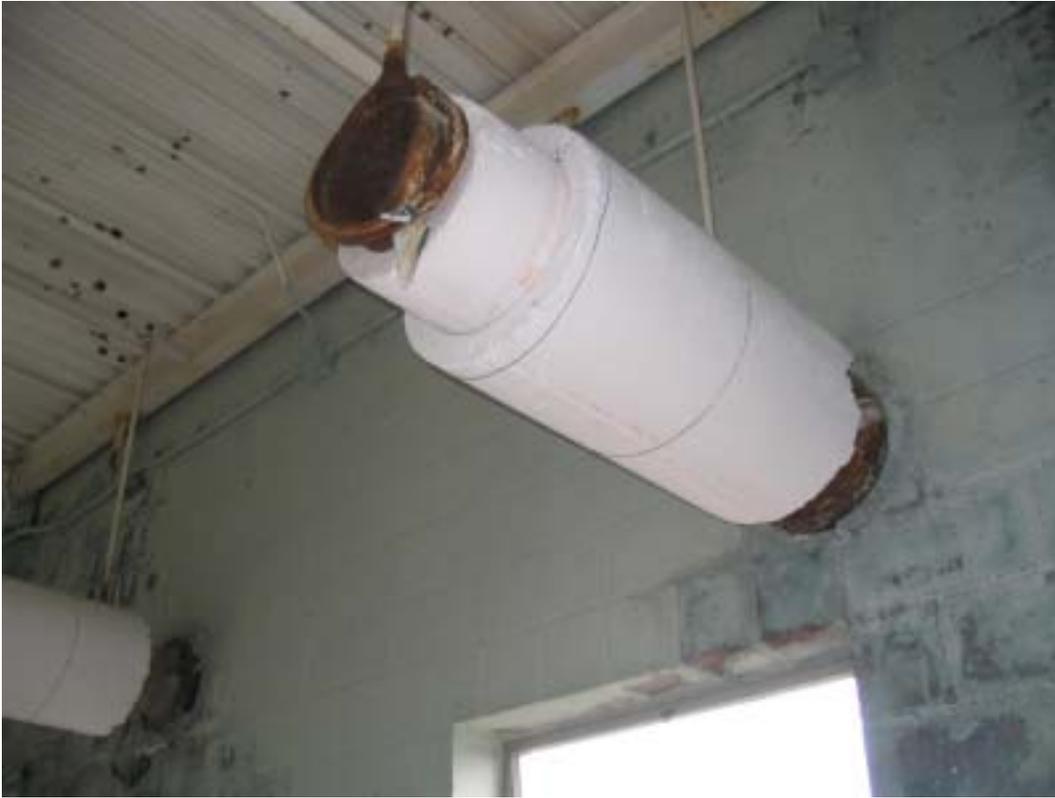
Photograph 7. Friable ACM (pipe insulation).

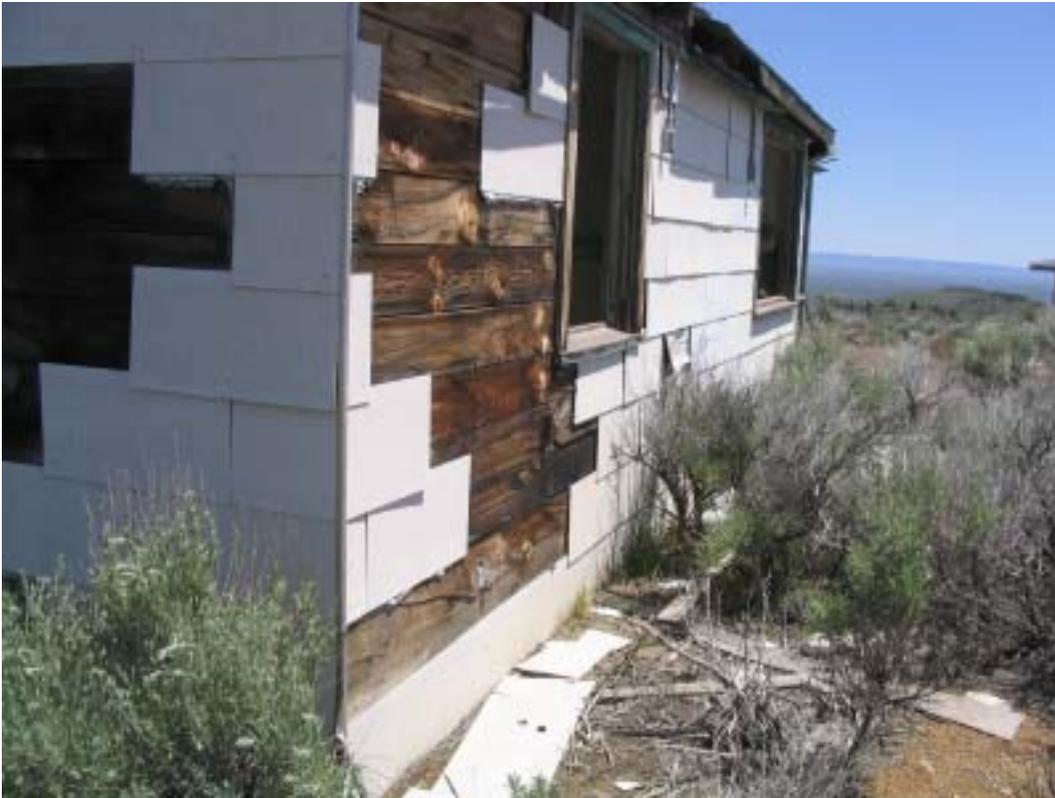
Photograph 8. Cement-asbestos board (CAB) siding.

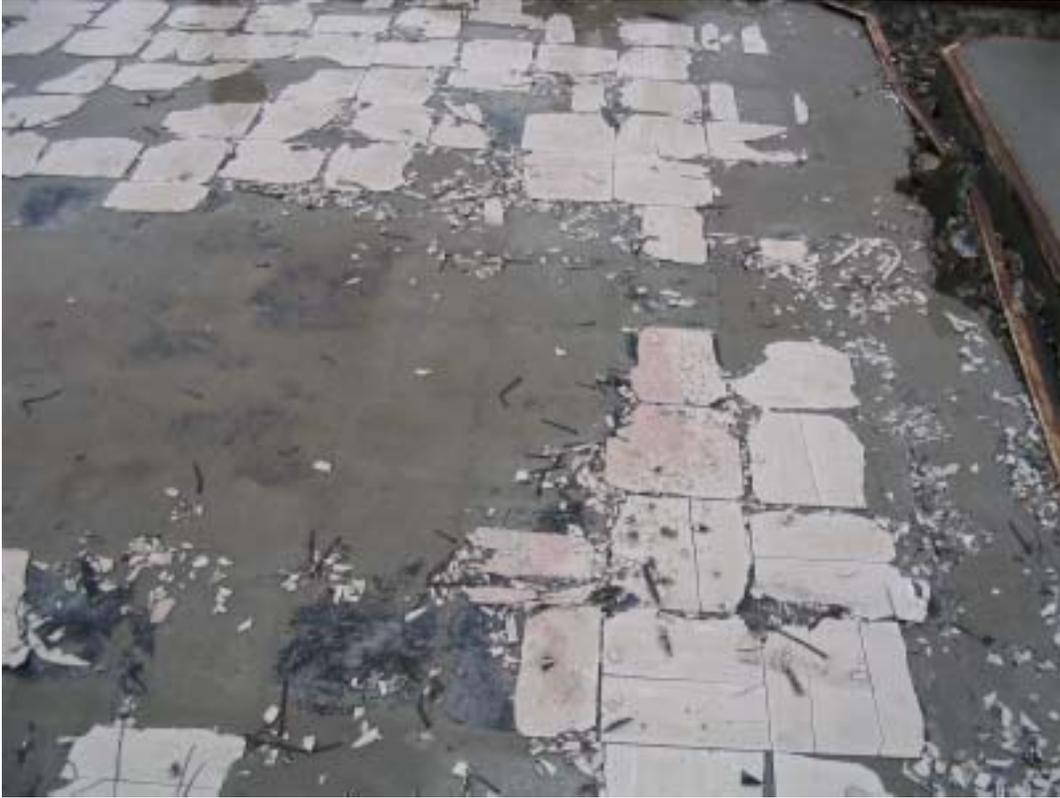
Photograph 9. Significantly damaged ACM floor tile.

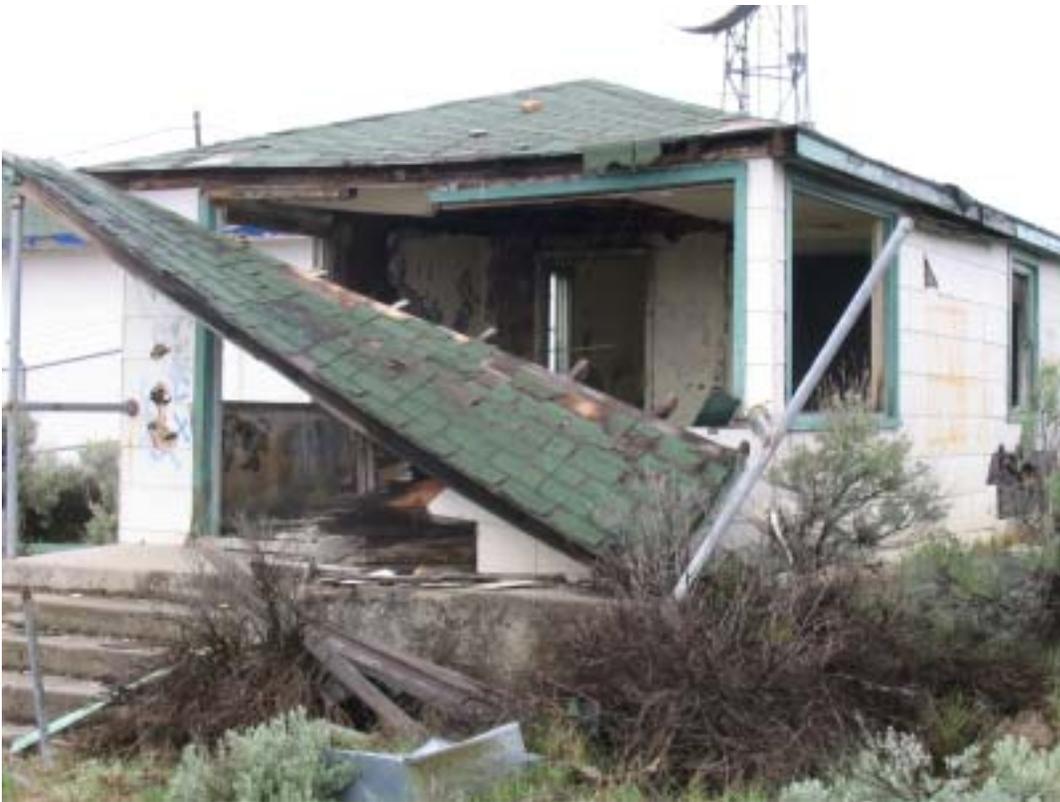
Photograph 10. Building 100, with collapsing roof.

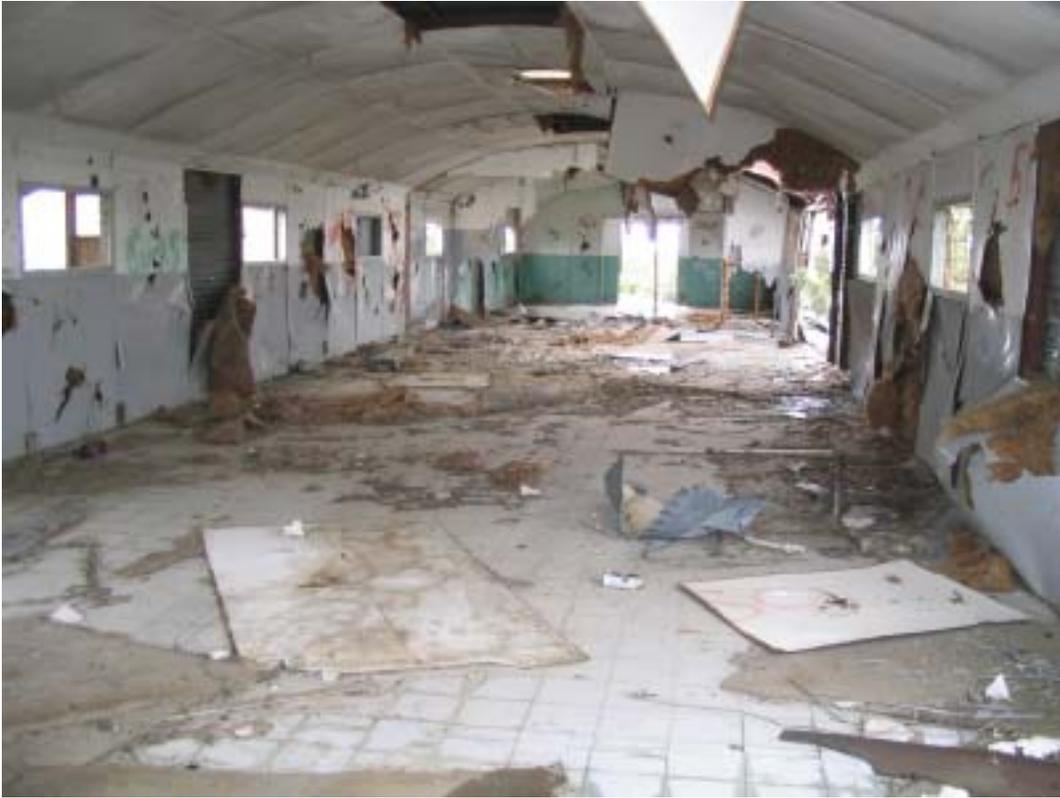
Photograph 11. Interior of Building 158, with damaged walls and ceiling.

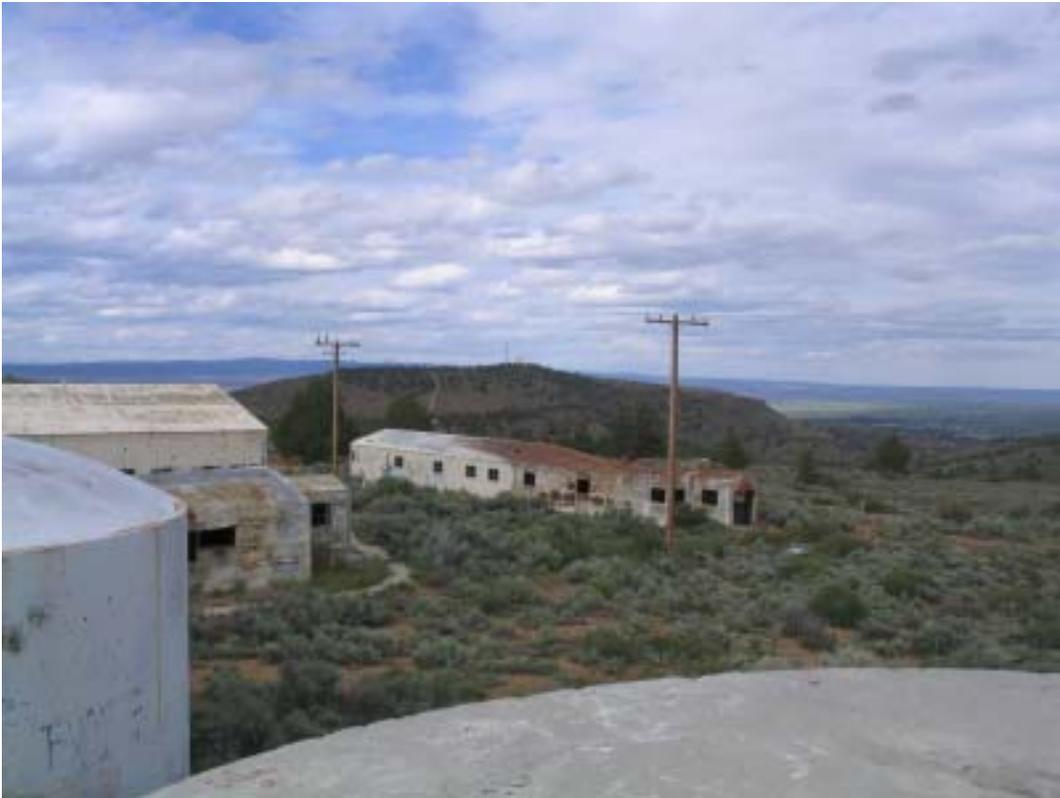
Photograph 12. Building 149 with visible fire damage and collapsing roof.

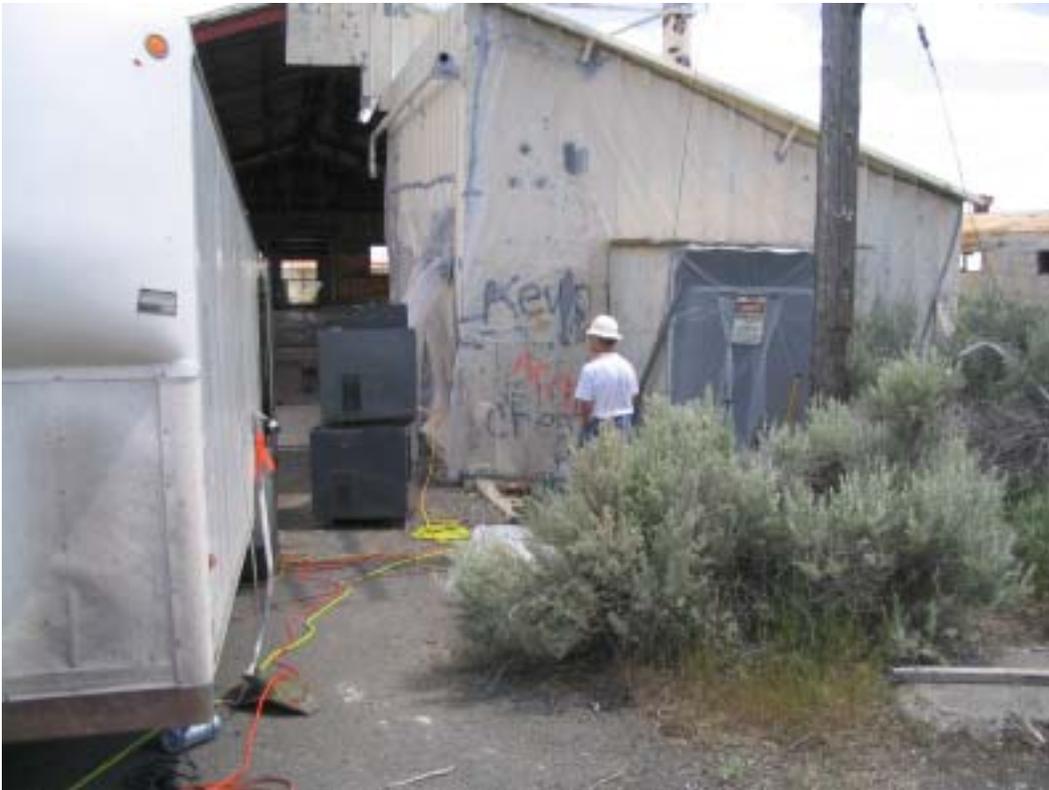
Photograph 18. Negative air enclosure for asbestos abatement at Building 155.

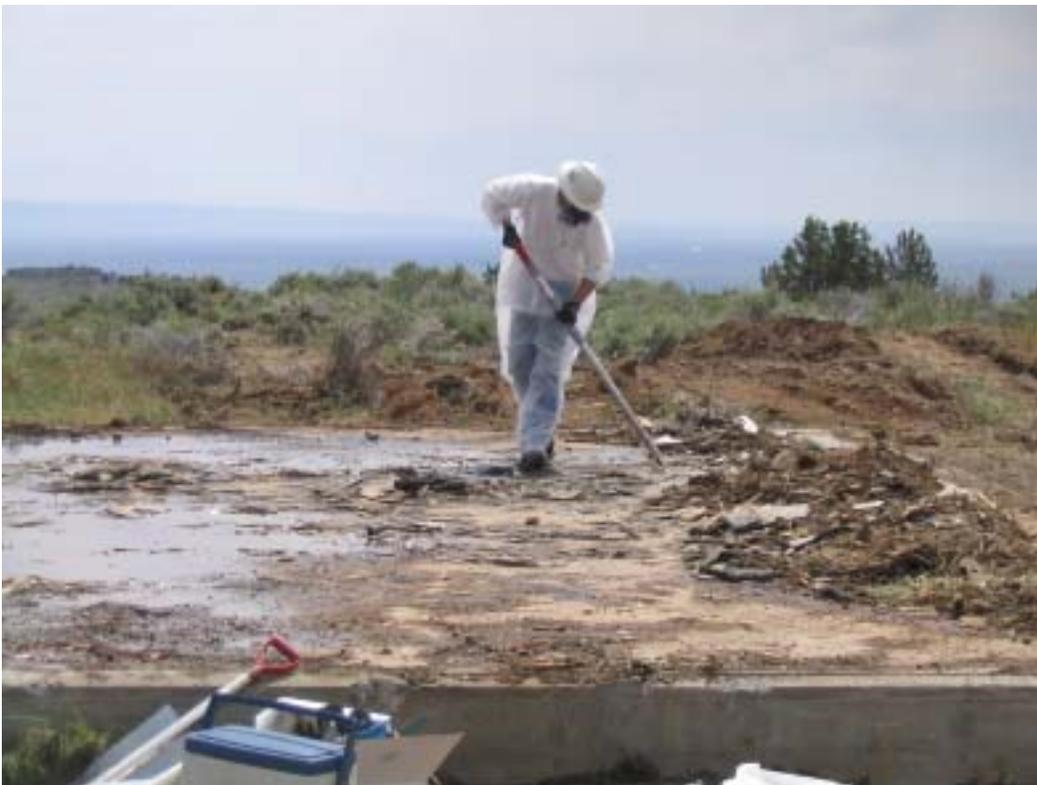
Photograph 20. Abatement worker removes ACM floor tile from concrete slab.

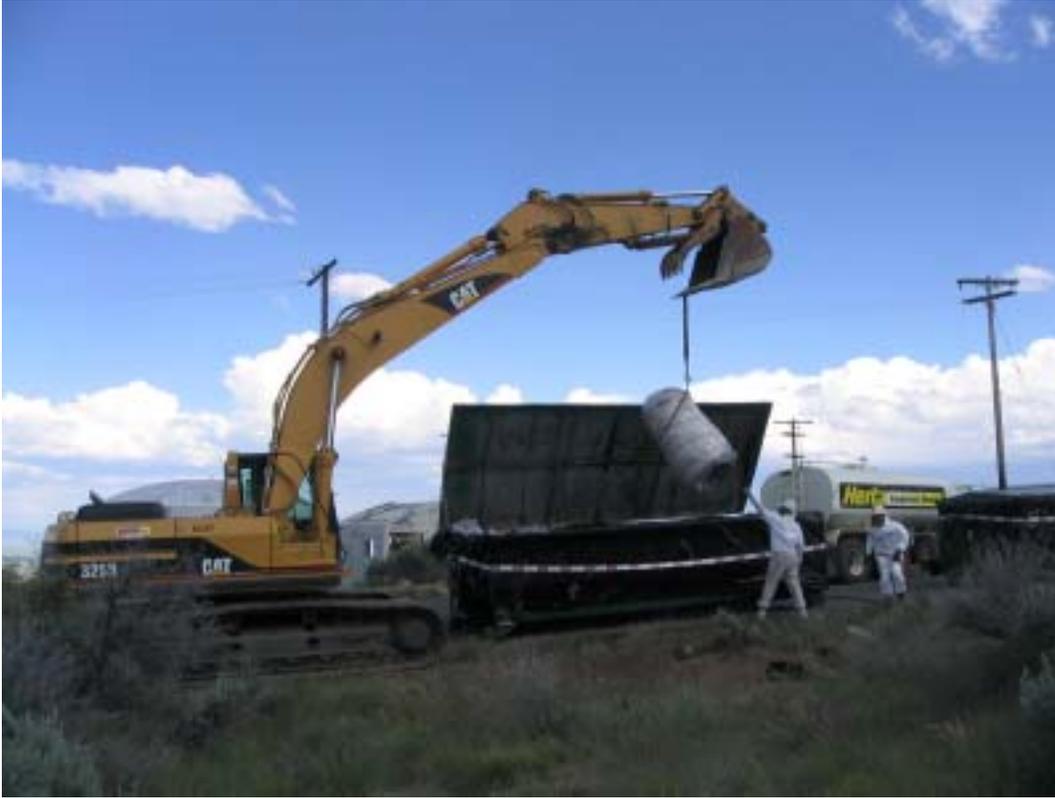
Photograph 21. ERRS loads a tank covered with friable ACM into waste container.

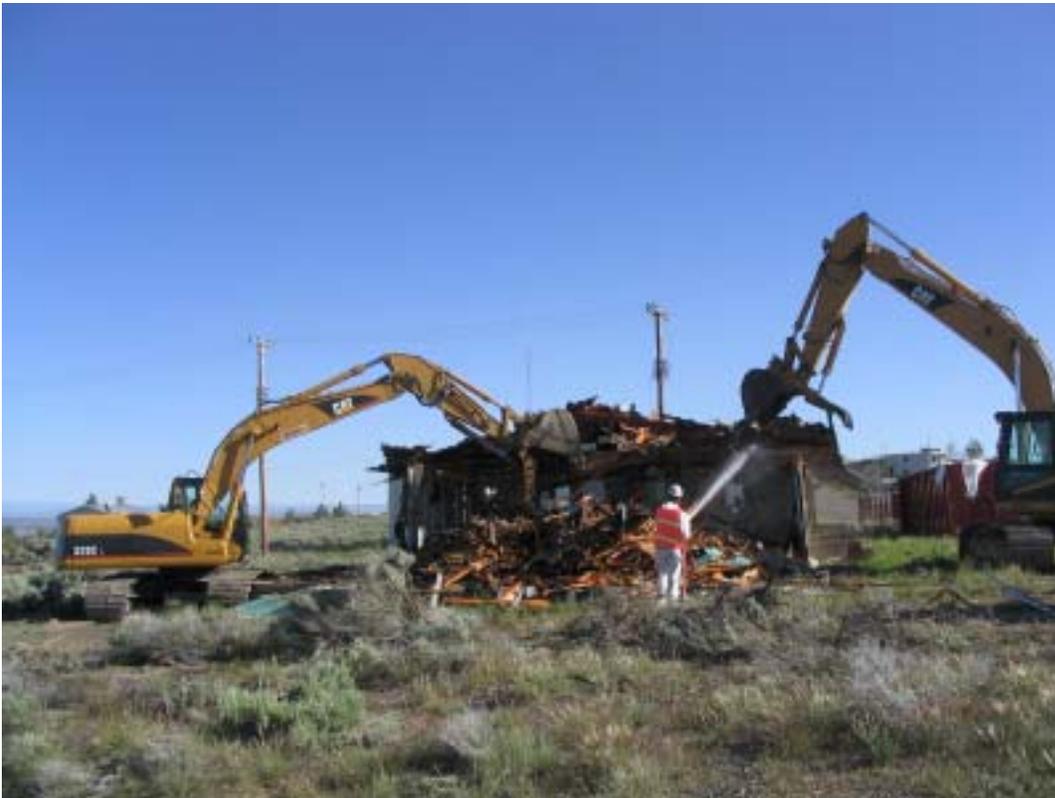
Photograph 22. ERRS demolishes Building 105.

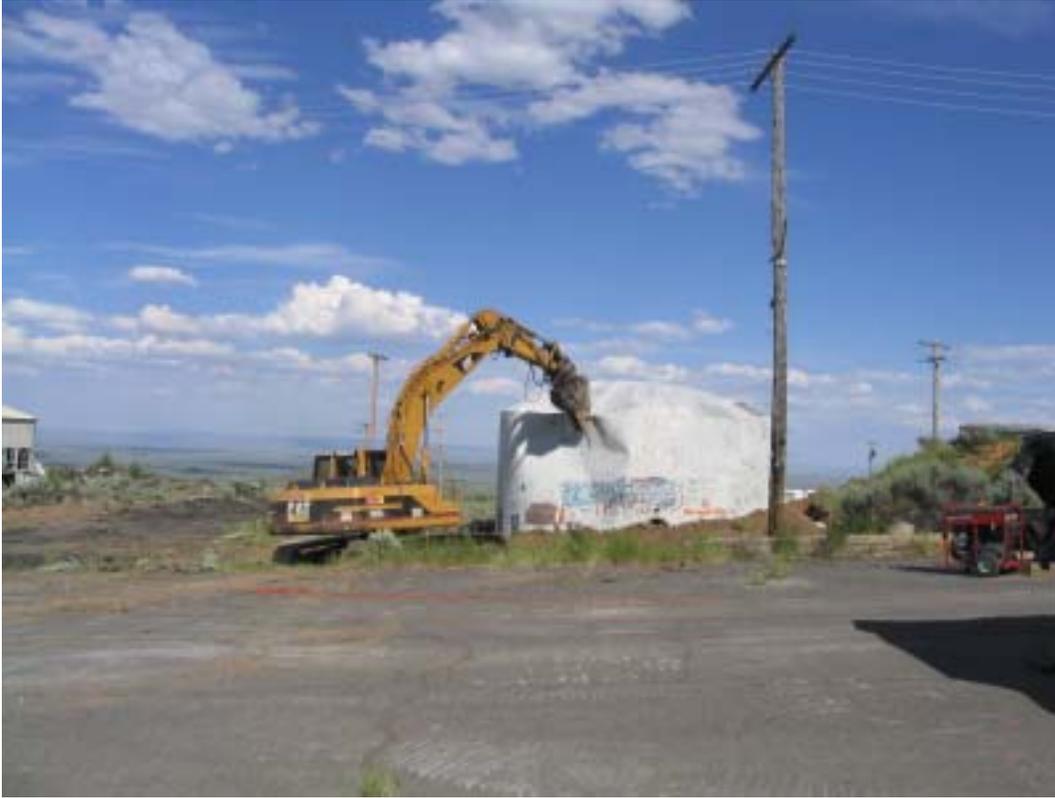
Photograph 23. Excavator with shears attachment demolishes Tank 804.

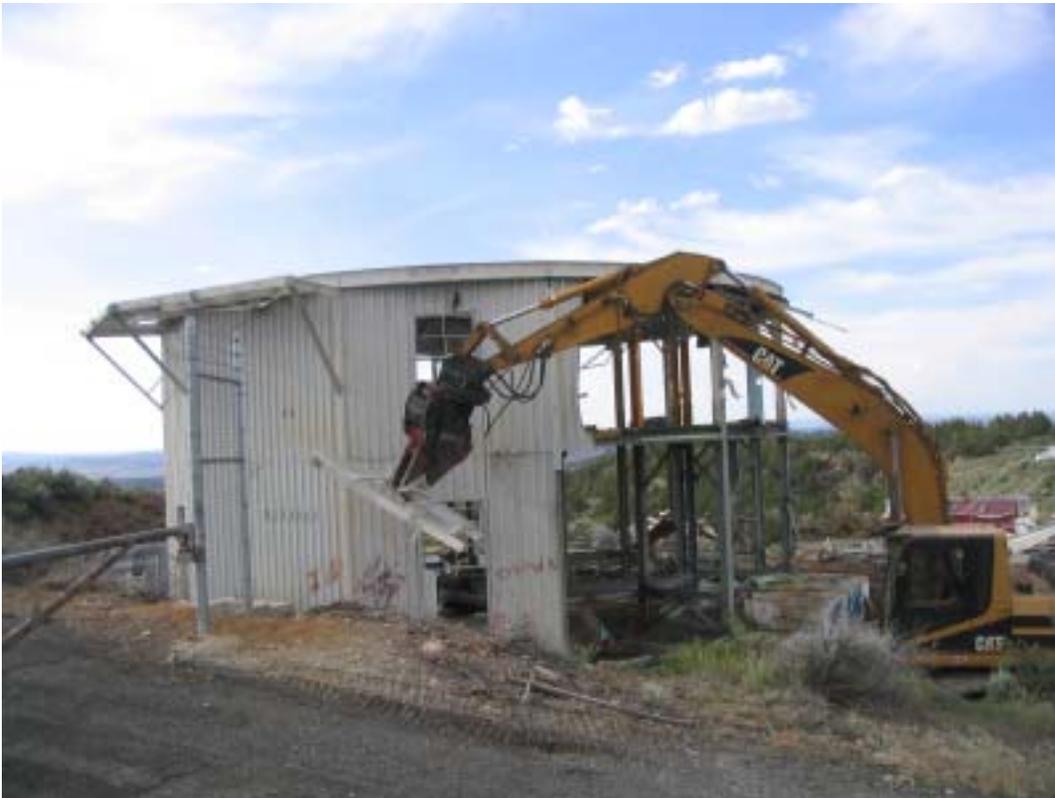
Photograph 24. Excavator with shears attachment demolishes Building 200 (radome).

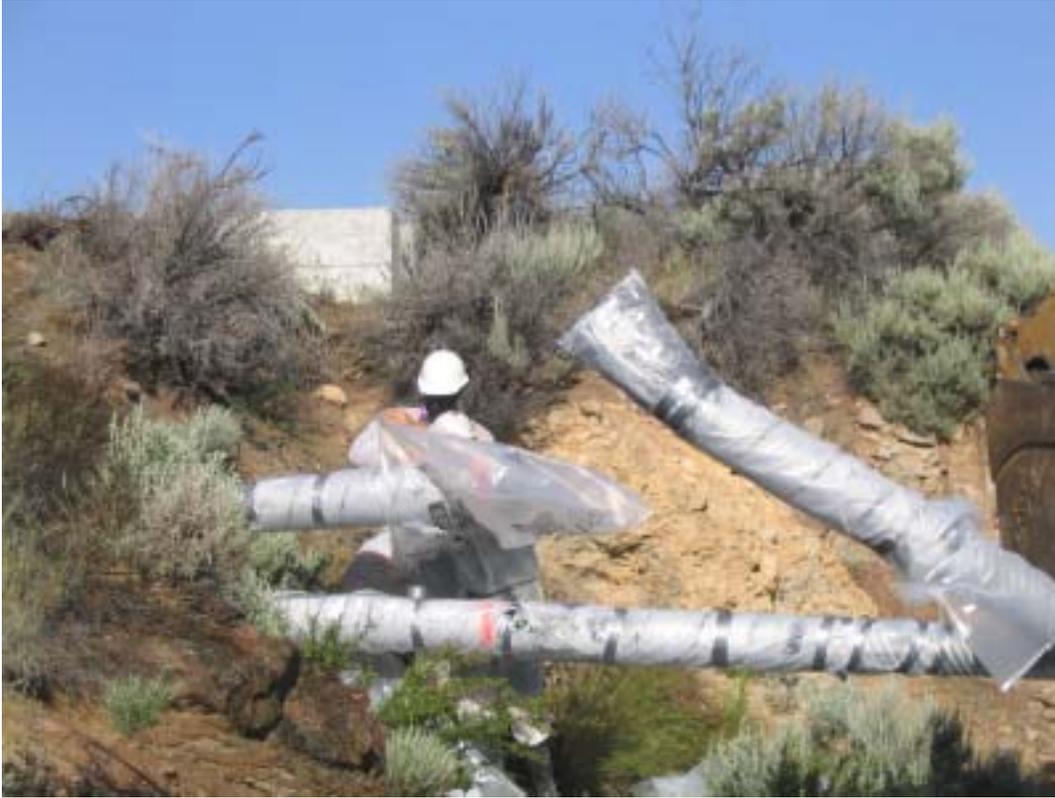
Photograph 27. Asbestos workers wrap the cut end of ACM steam line.

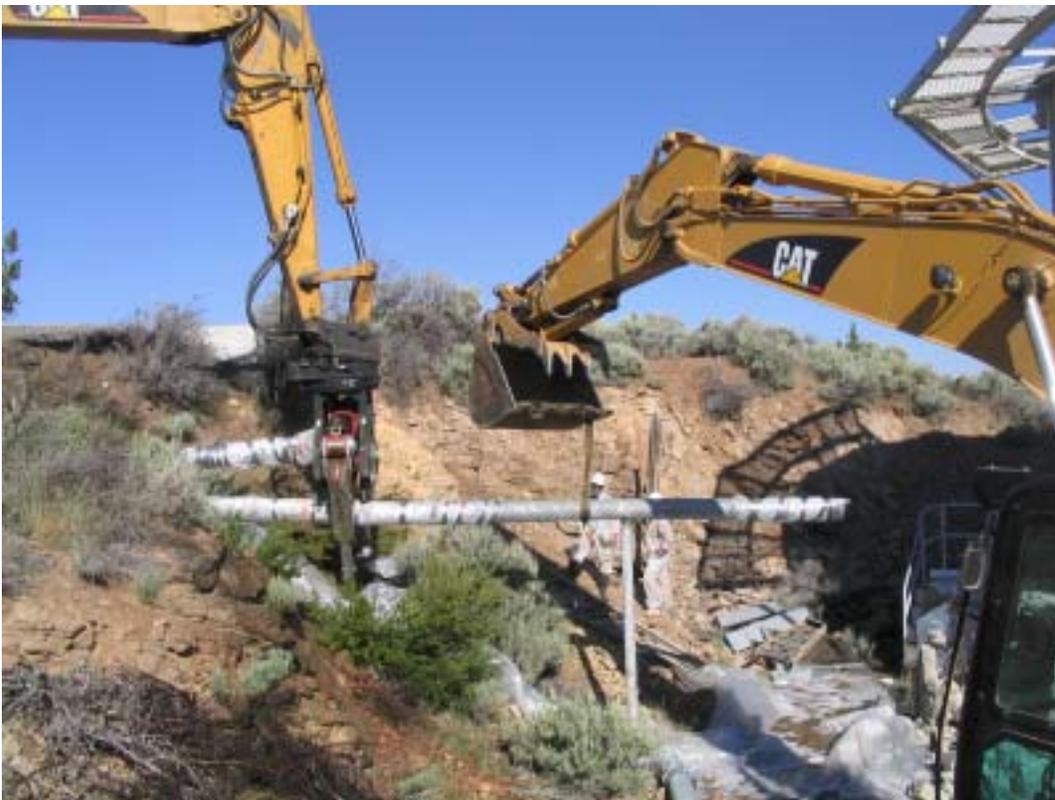
Photograph 28. Excavator with shears attachment prepares to cut ACM steam line.

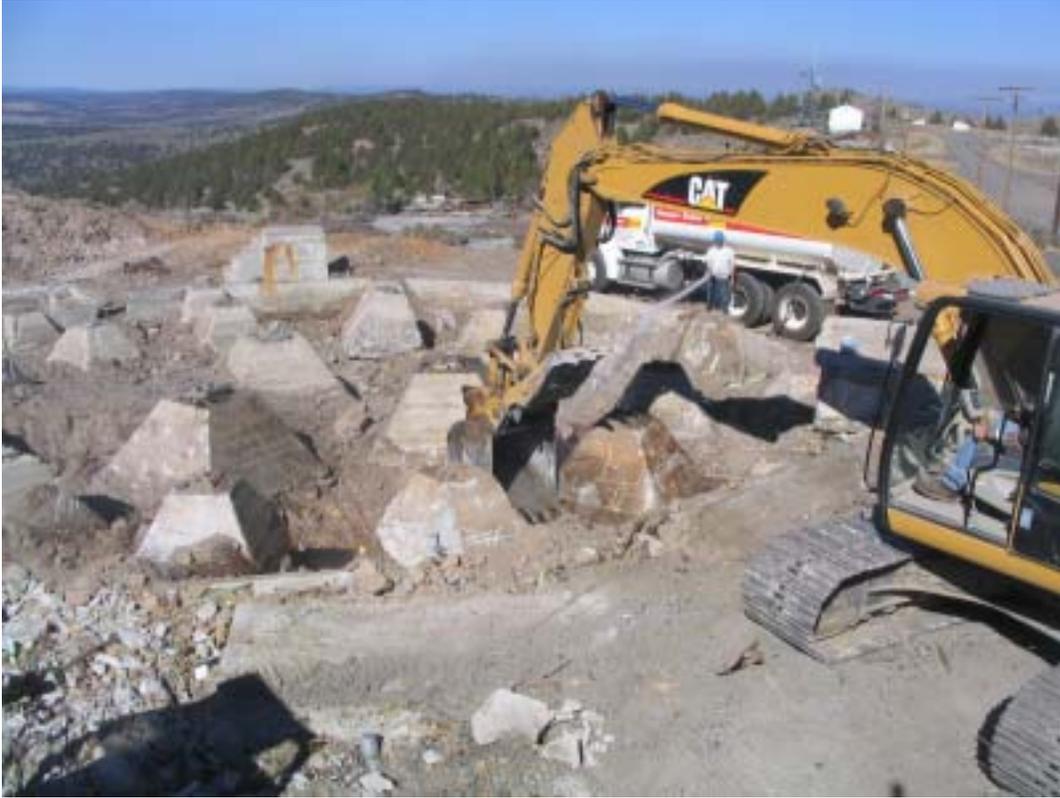
Photograph 33. ERRS excavates PCB-contaminated soil in foundation of Building 200.

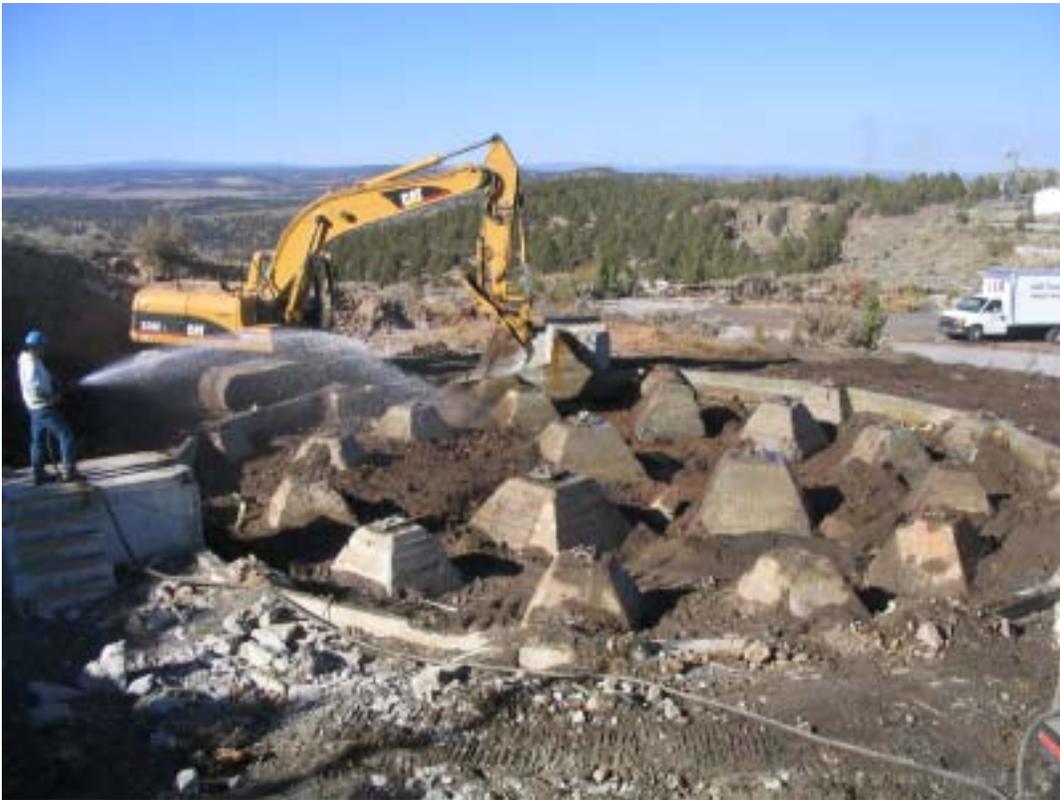
Photograph 34. ERRS backfills the foundation of Building 200.

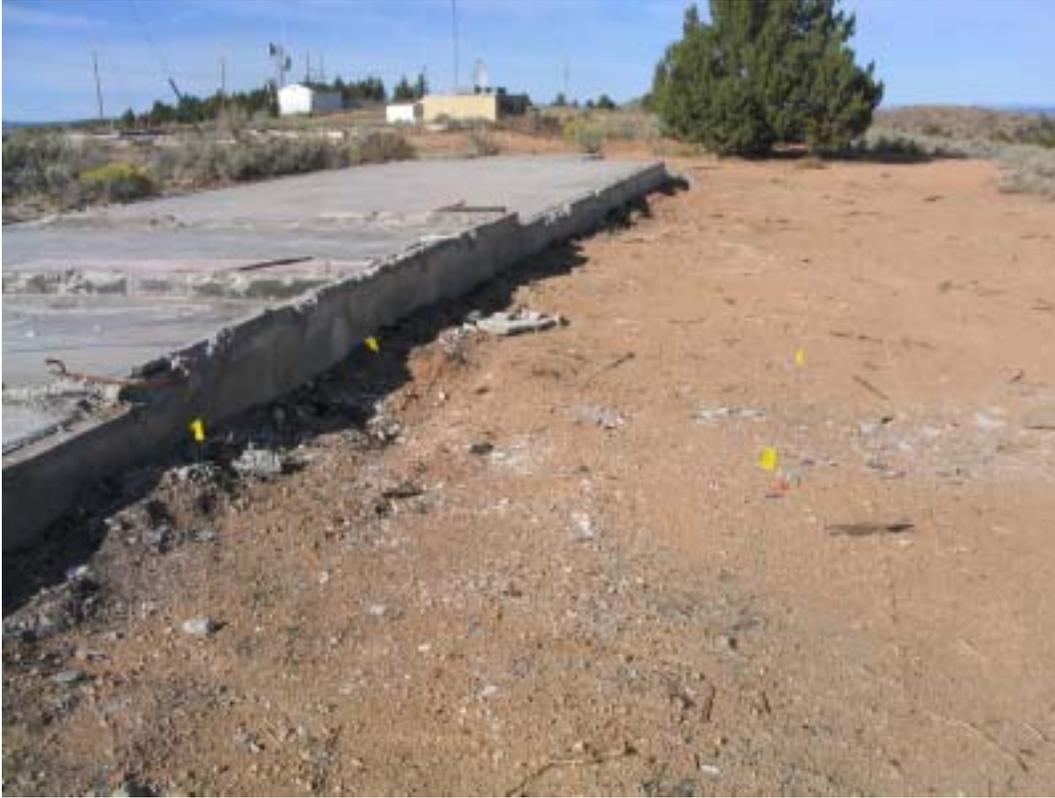
Photograph 39. Test plot area for small pieces of ACM debris, near Building 149.

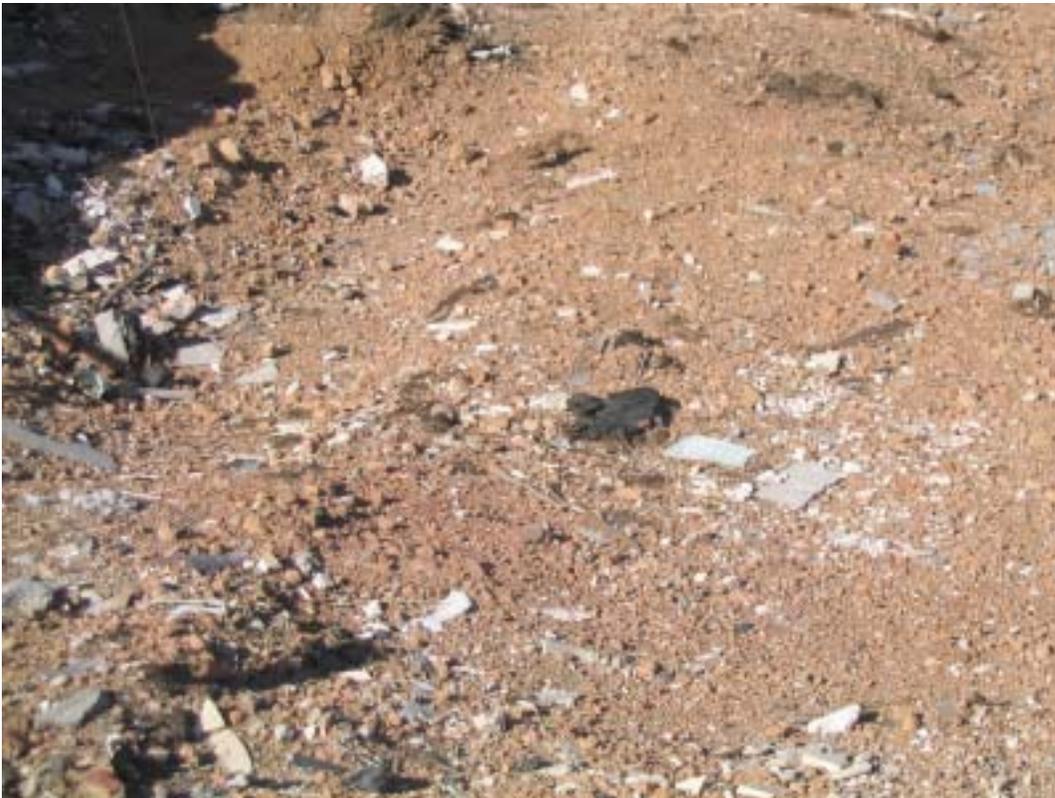
Photograph 40. Close-up of Building 149 test plot, with small pieces of ACM debris.
