**ACTION MEMORANDUM**

**SUBJECT:** Approval and Funding for a Removal Action at the Red and Bonita Mine Site in San Juan County, Approximately Seven Miles North of Silverton, Colorado.

Site ID# 08UP

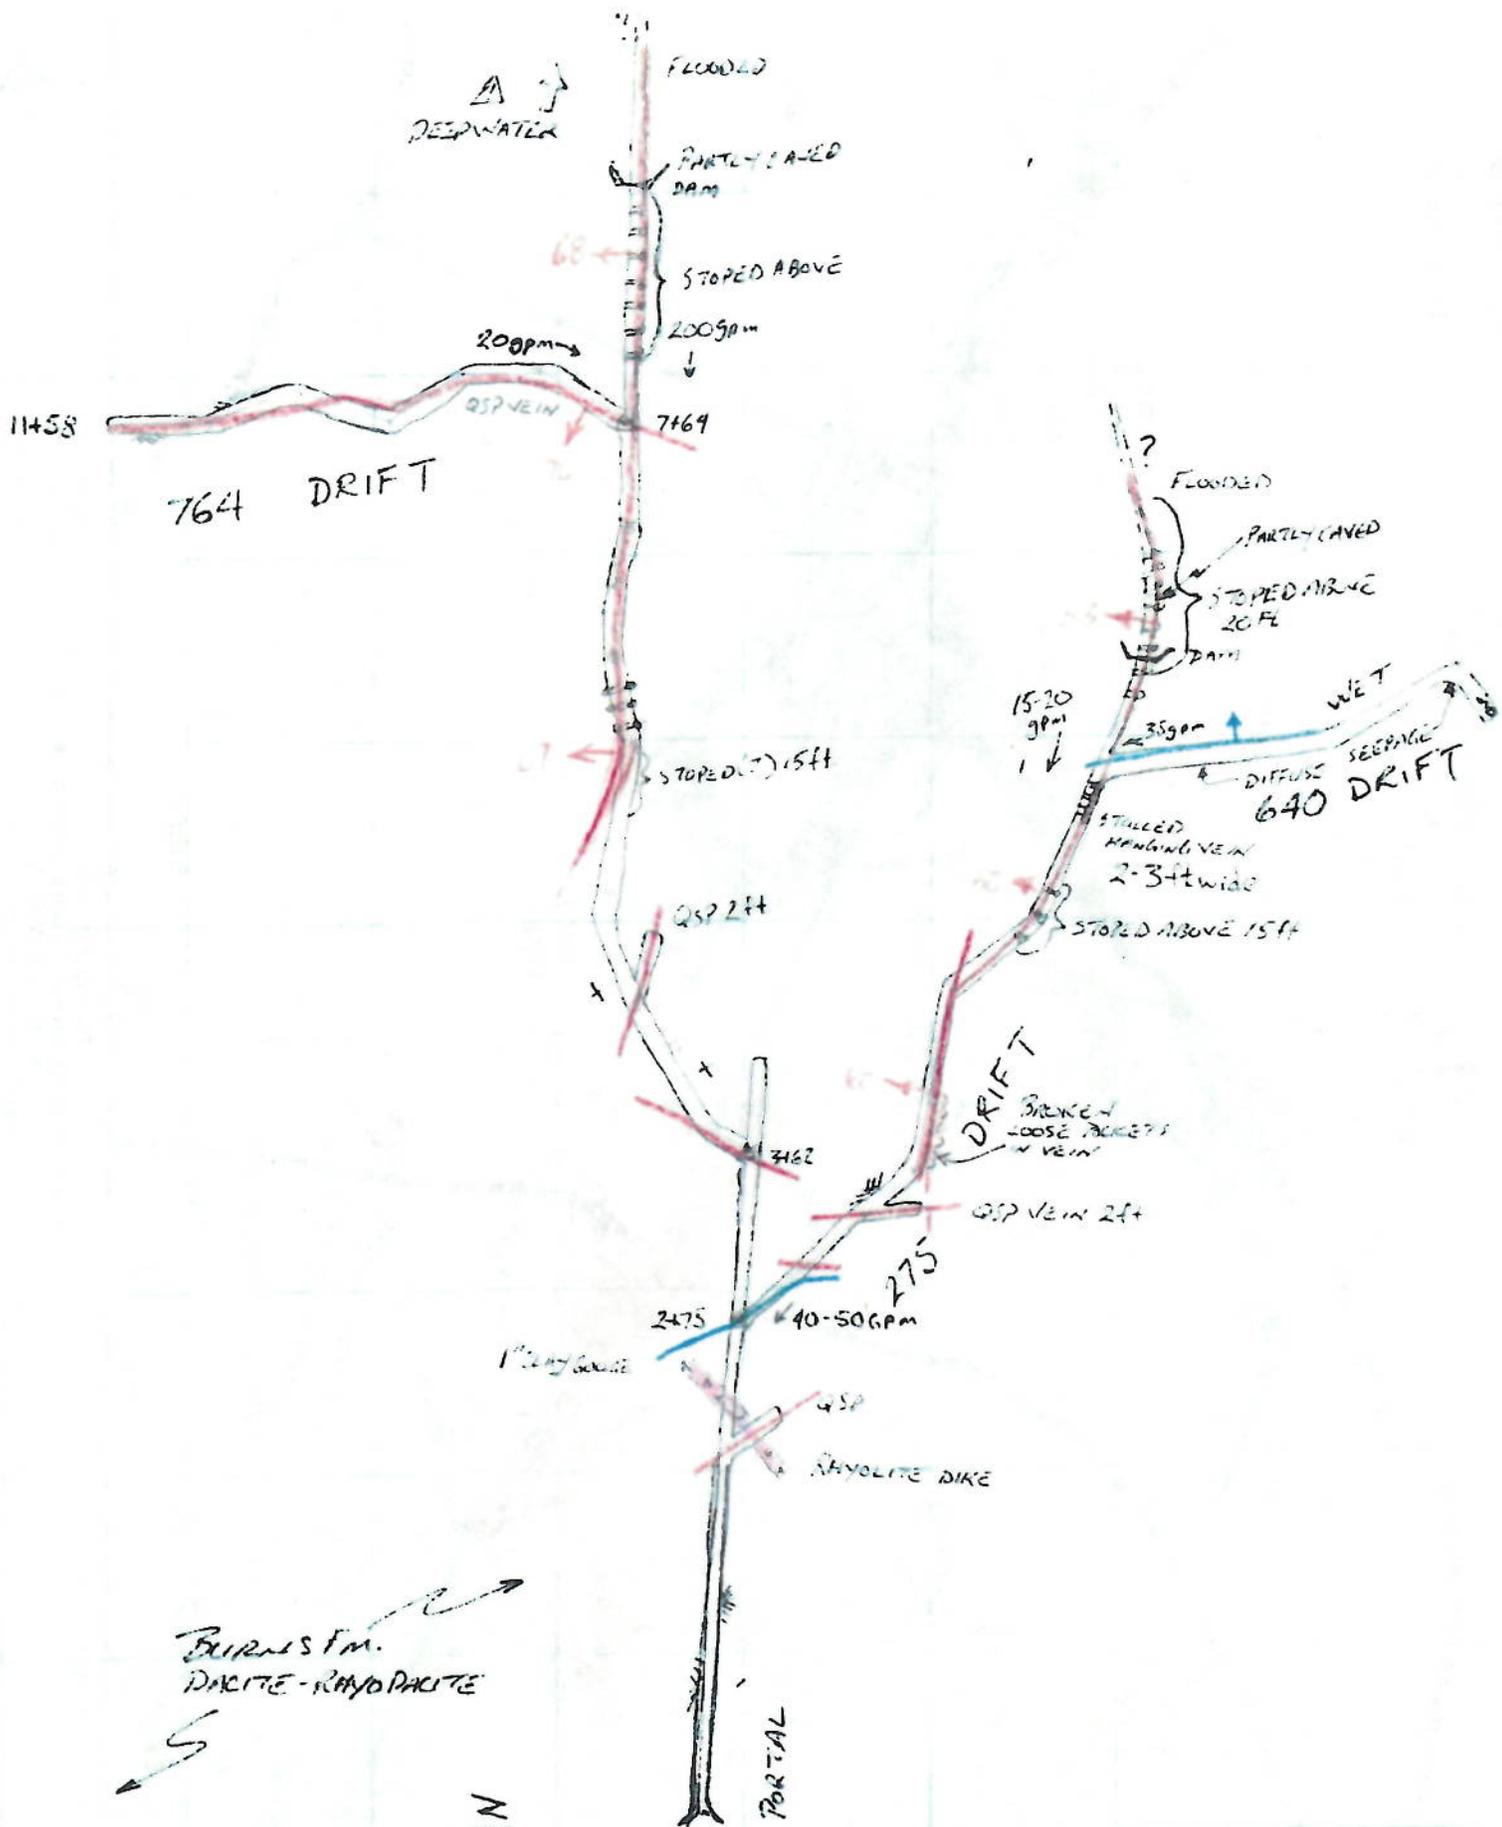
MINE GEOLOGY BY RED & BONITA BKS LOCATION SAN JUAN Co. CO DATE 13/AUG/2013 SCALE 1"=100ft  
 MILL LVL

In September/October 2011, the EPA removed blockage in the Red and Bonita Mine opening and constructed a temporary portal for accessing the mine. The mine adit is approximately five feet wide by seven feet high and extends underground for several hundred feet in multiple directions (Attachment 1-Figure 2). Investigations of the mine allowed access to approximately 2,000 feet of workings. Collapsed ground within the tunnels prevented further investigation. However, based on historic

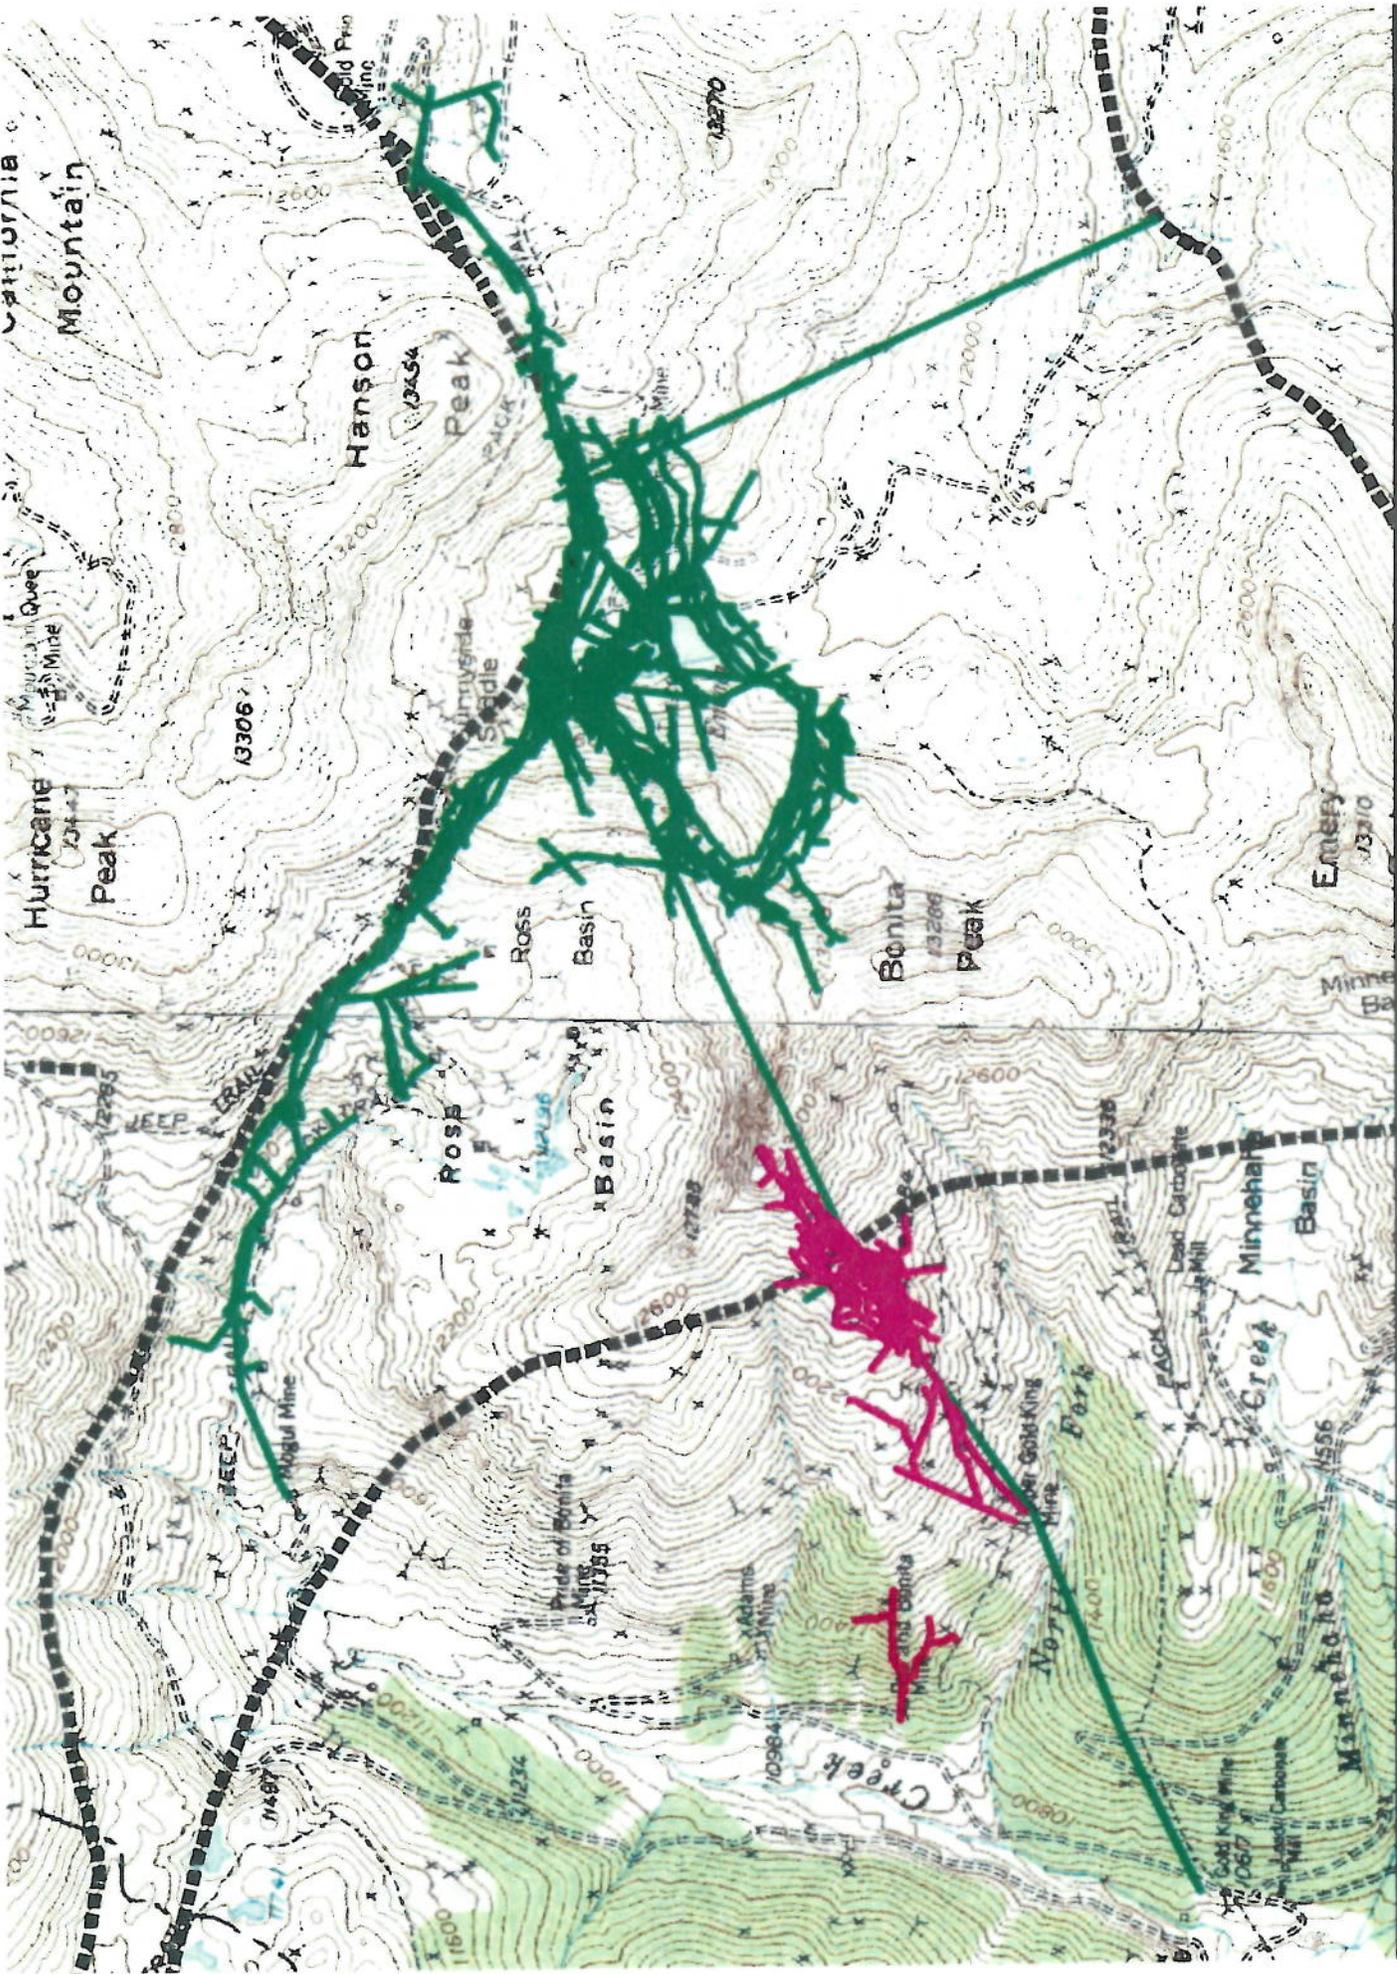
**RED AND BONITA MAP**

information and the estimated waste dump volumes, it is estimated that there are only approximately 3,500 feet of underground workings and that the adit does not connect to other mines (Figure 3). In addition, there is no mapped surface opening to the mine and none were found during Site investigations in September 2014 or previously.

Mine Workings past cave-ins are only projected to line of sight

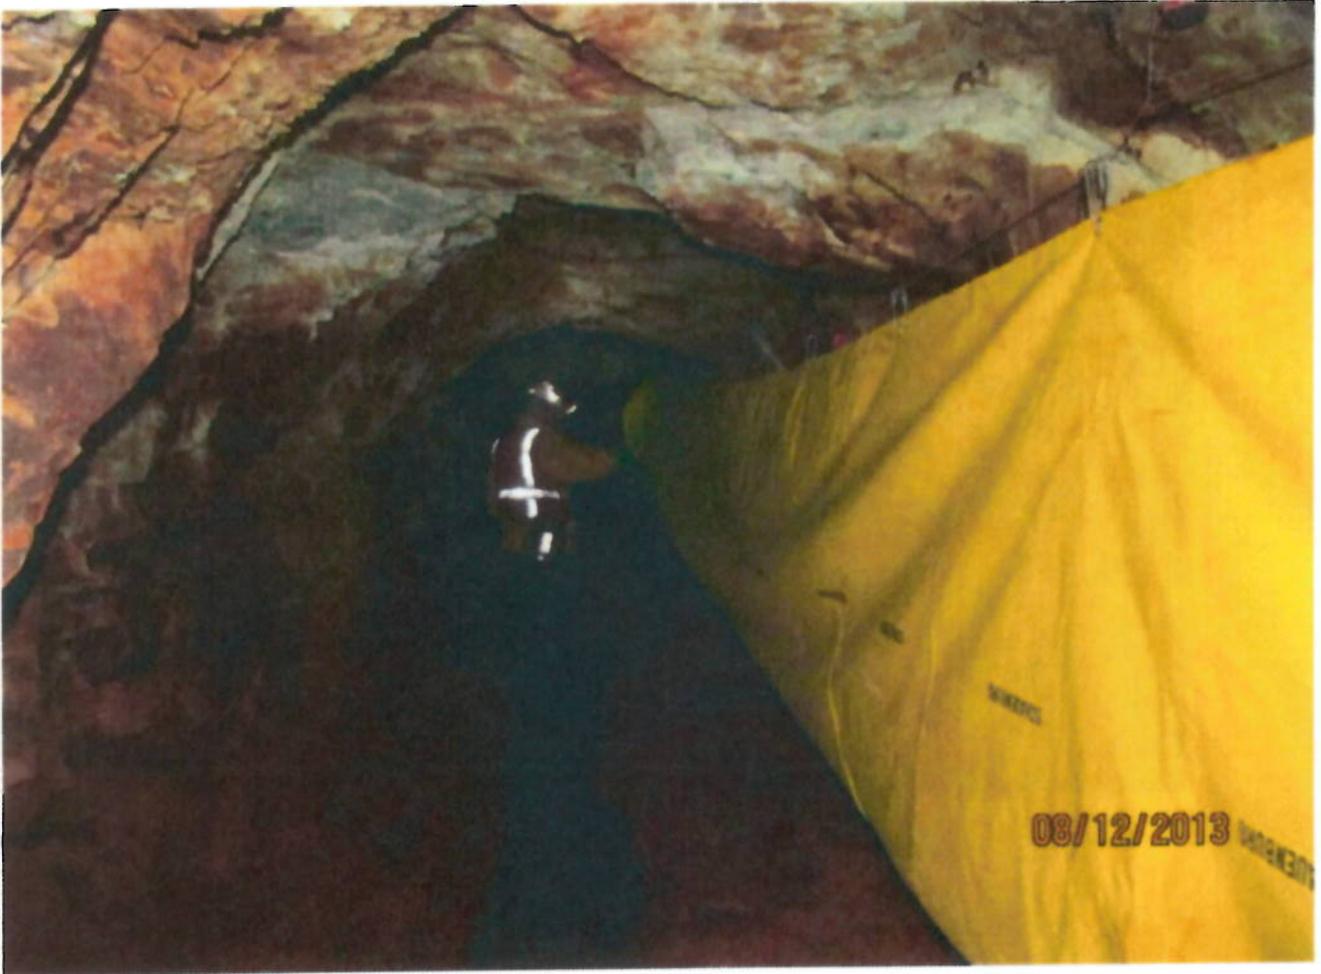
Red and Bonita Mine adit

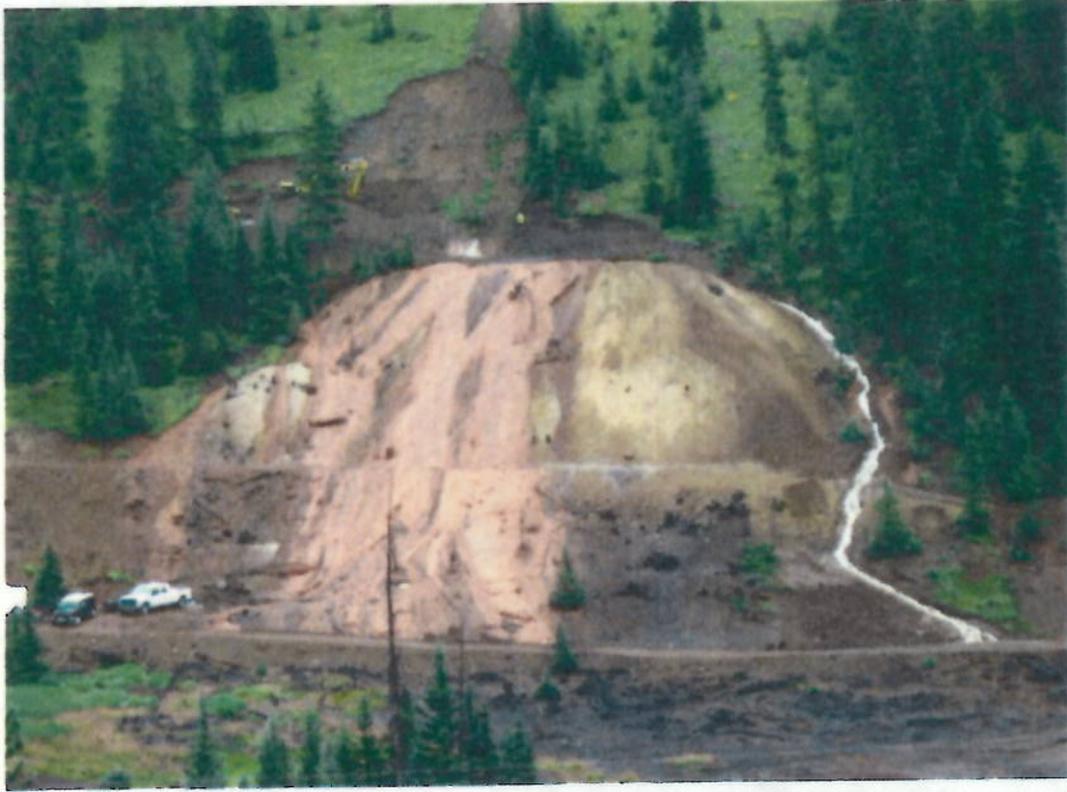
Red and Bonita Mine tailings dump view

EPA installed a new portal structure in October 2011 after removing 30 feet of blockage at the adit entrance. Adit discharge flows overland across, and approximately 200 feet down, a mine dump face before being channelized at the toe of the dump. The channel directs flow into an iron bog en route to Cement Creek approximately 500 feet down gradient of the toe of the dump.

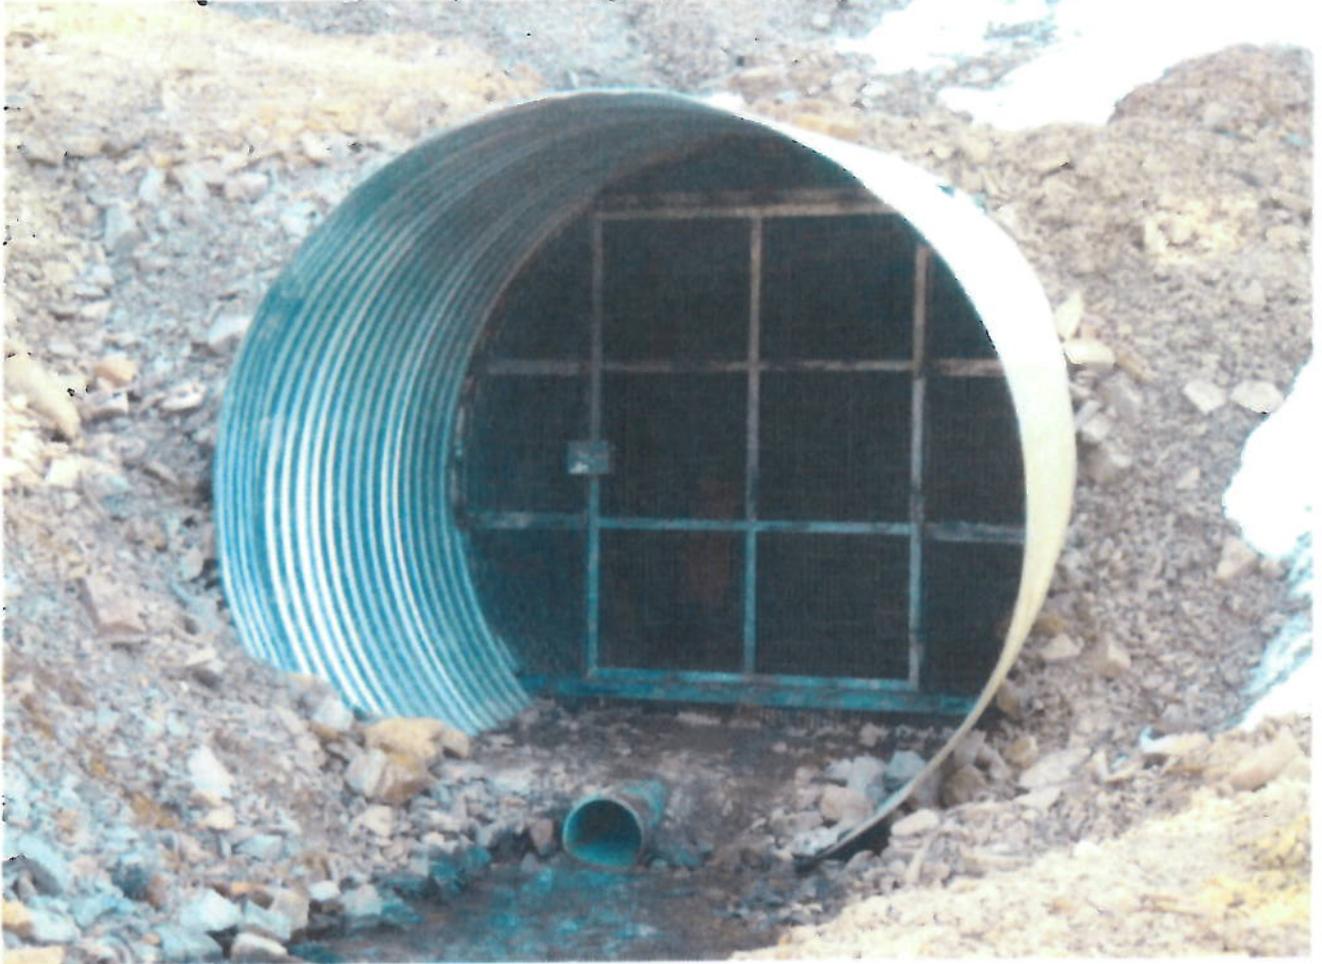
Red and Bonita Mine portal
