REMOVAL ASSESSMENT REPORT
ABANDONED URANIUM MINE SITES
HAYSTACK NO.1, SECTION 24, AND BIBO TRESPASS

Navajo Nation, Baca/Haystack Chapter, McKinley County, New Mexico

EPA Contract No.: EP-S5-13-02
TDD No.: 0002/1302-T2-R9-14-07-0001
Document Control No.: 0009-08-AAFI

June 2015

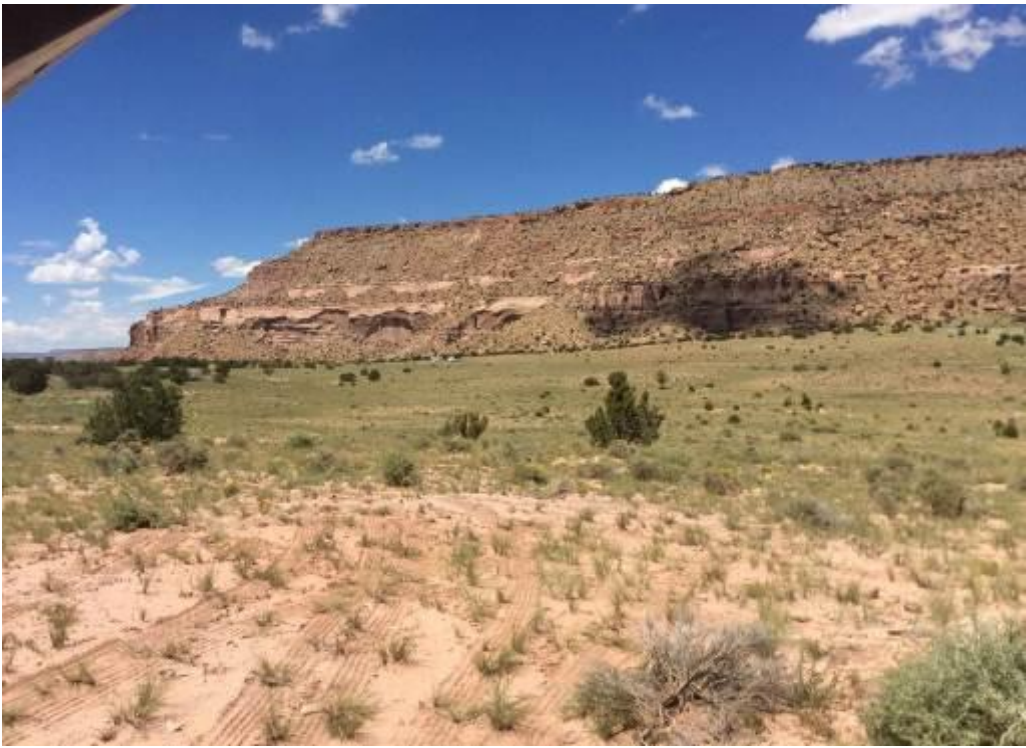
Project Name: Haystack No. 1 Removal Assessment		Site Location: Baca/Haystack Chapter, Navajo Nation	TDD No. 0002/1302-T2-R9-14-07-0001
Photo No. 1	Date: 8/16/2014

Direction Photo Taken: West			
Description: Haystack No. 1 Abandoned Uranium Mine (AUM), site overview

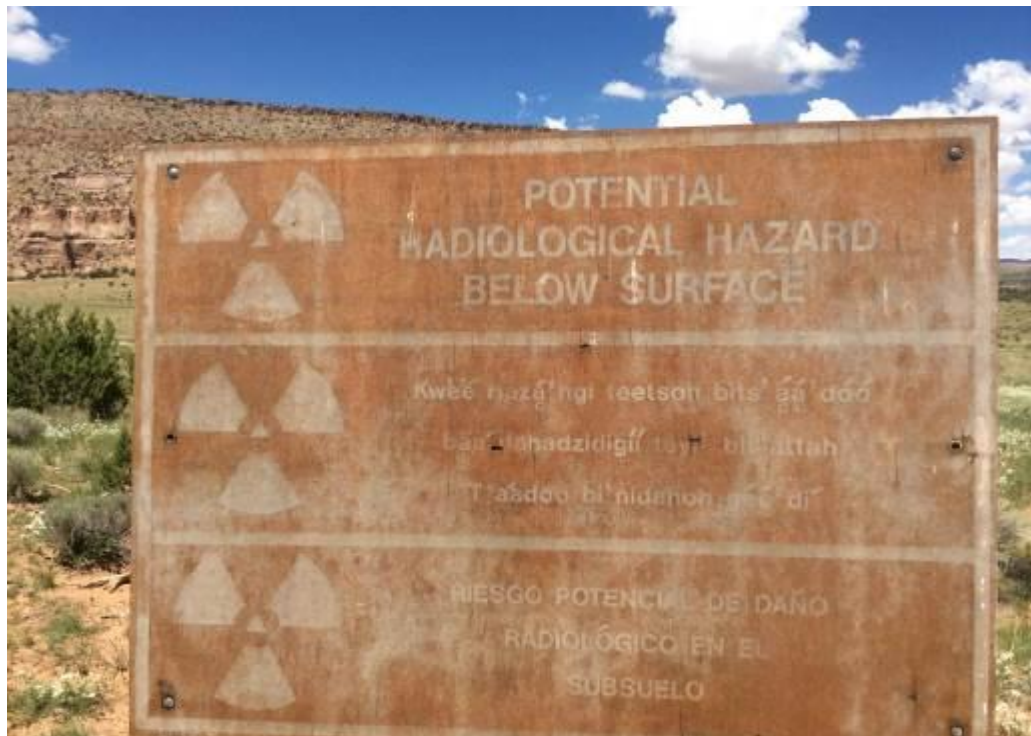
Photo No. 38	Date: 8/16/2014
Direction Photo Taken: Northwest	
Description: Worn sign reads, "POTENTIAL RADIOLOGICAL HAZARD BELOW SURFACE" in English, Navajo, and Spanish
