ACTION MEMORANDUM

SUBJECT: Approval and Funding for a Removal Action at the State Painting Site in West Valley City, Salt Lake County, Utah pursuant to the On-Scene Coordinator's delegated authority under CERCLA Section 104.

Site ID# A8V5

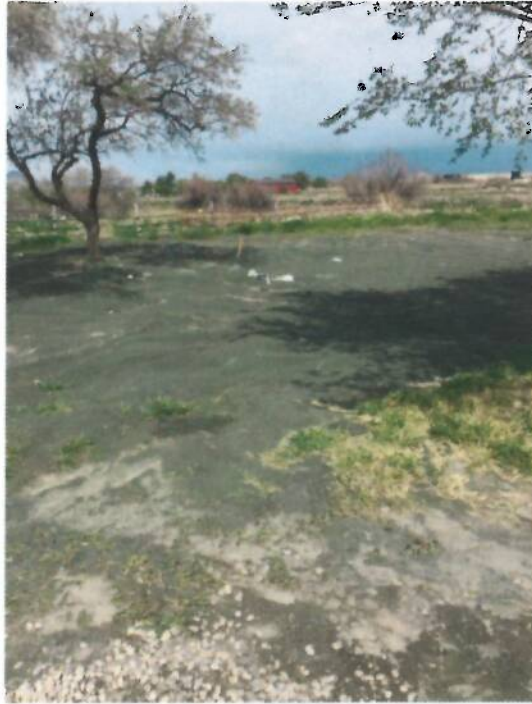
Photo 1: View of contaminated soil on the property. The spent sand blasting material can be seen as the green discoloration.

The spent blast material will be excavated and transported to an appropriate facility for disposal. The abandoned drums and containers will be characterized, segregated, overpacked into drums and transported to an appropriate off-site facility for disposal.

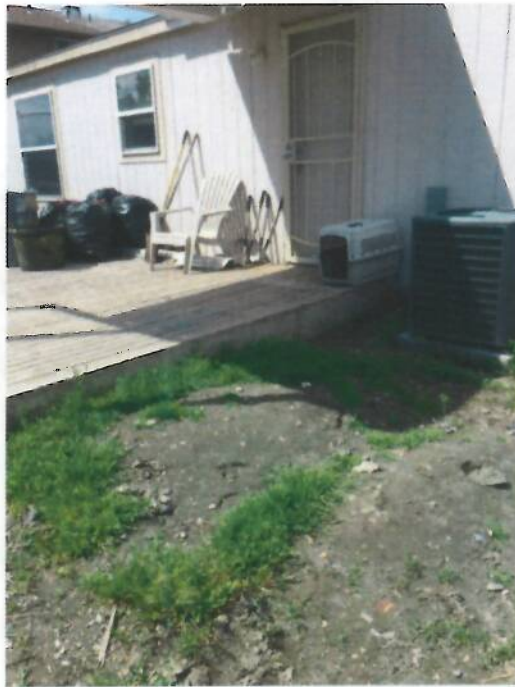
Photo 2: View of the back patio at the rental residence on the property. The spent sand blasting material can be seen as the green discoloration.

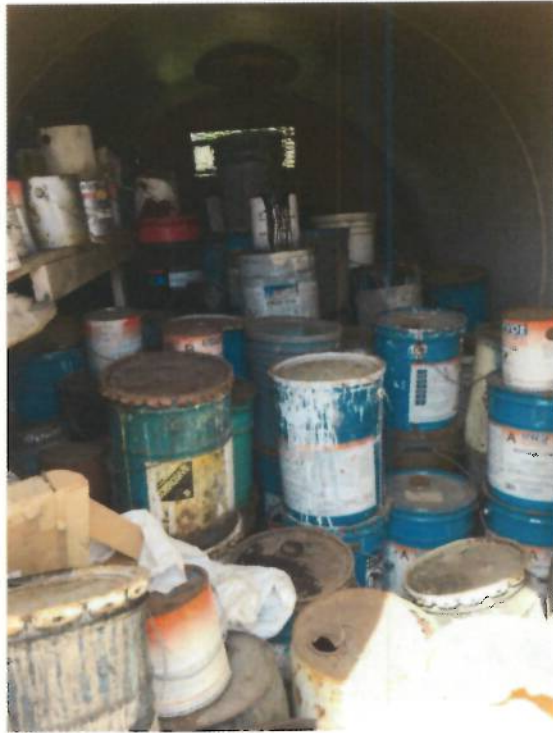
Photo 3: Containers of hazardous substances located on Site.

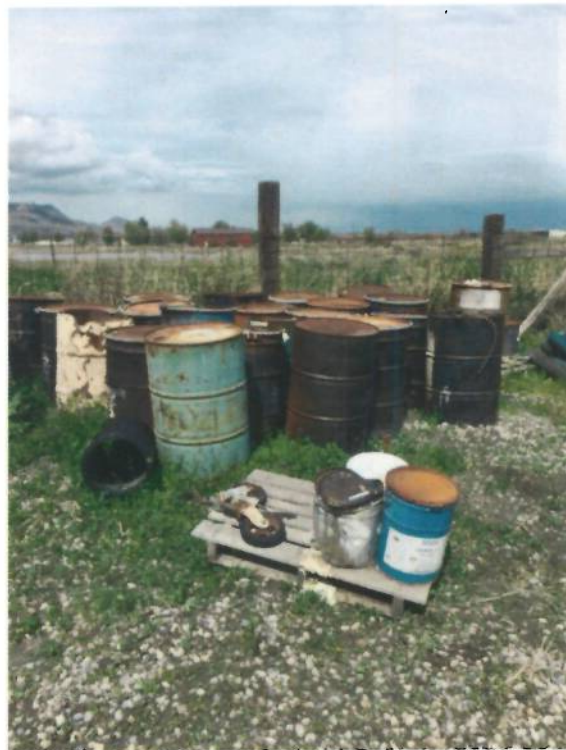
Photo 4: Drums and containers of hazardous substances located on Site.
