**Factory Street Lead Site
Assessment Report**

Honolulu, Hawaii

TAT No: 099505-T-001
TDD No: T09-9410-011
PAN No: EHI-0073-SBA

September 30, 1995

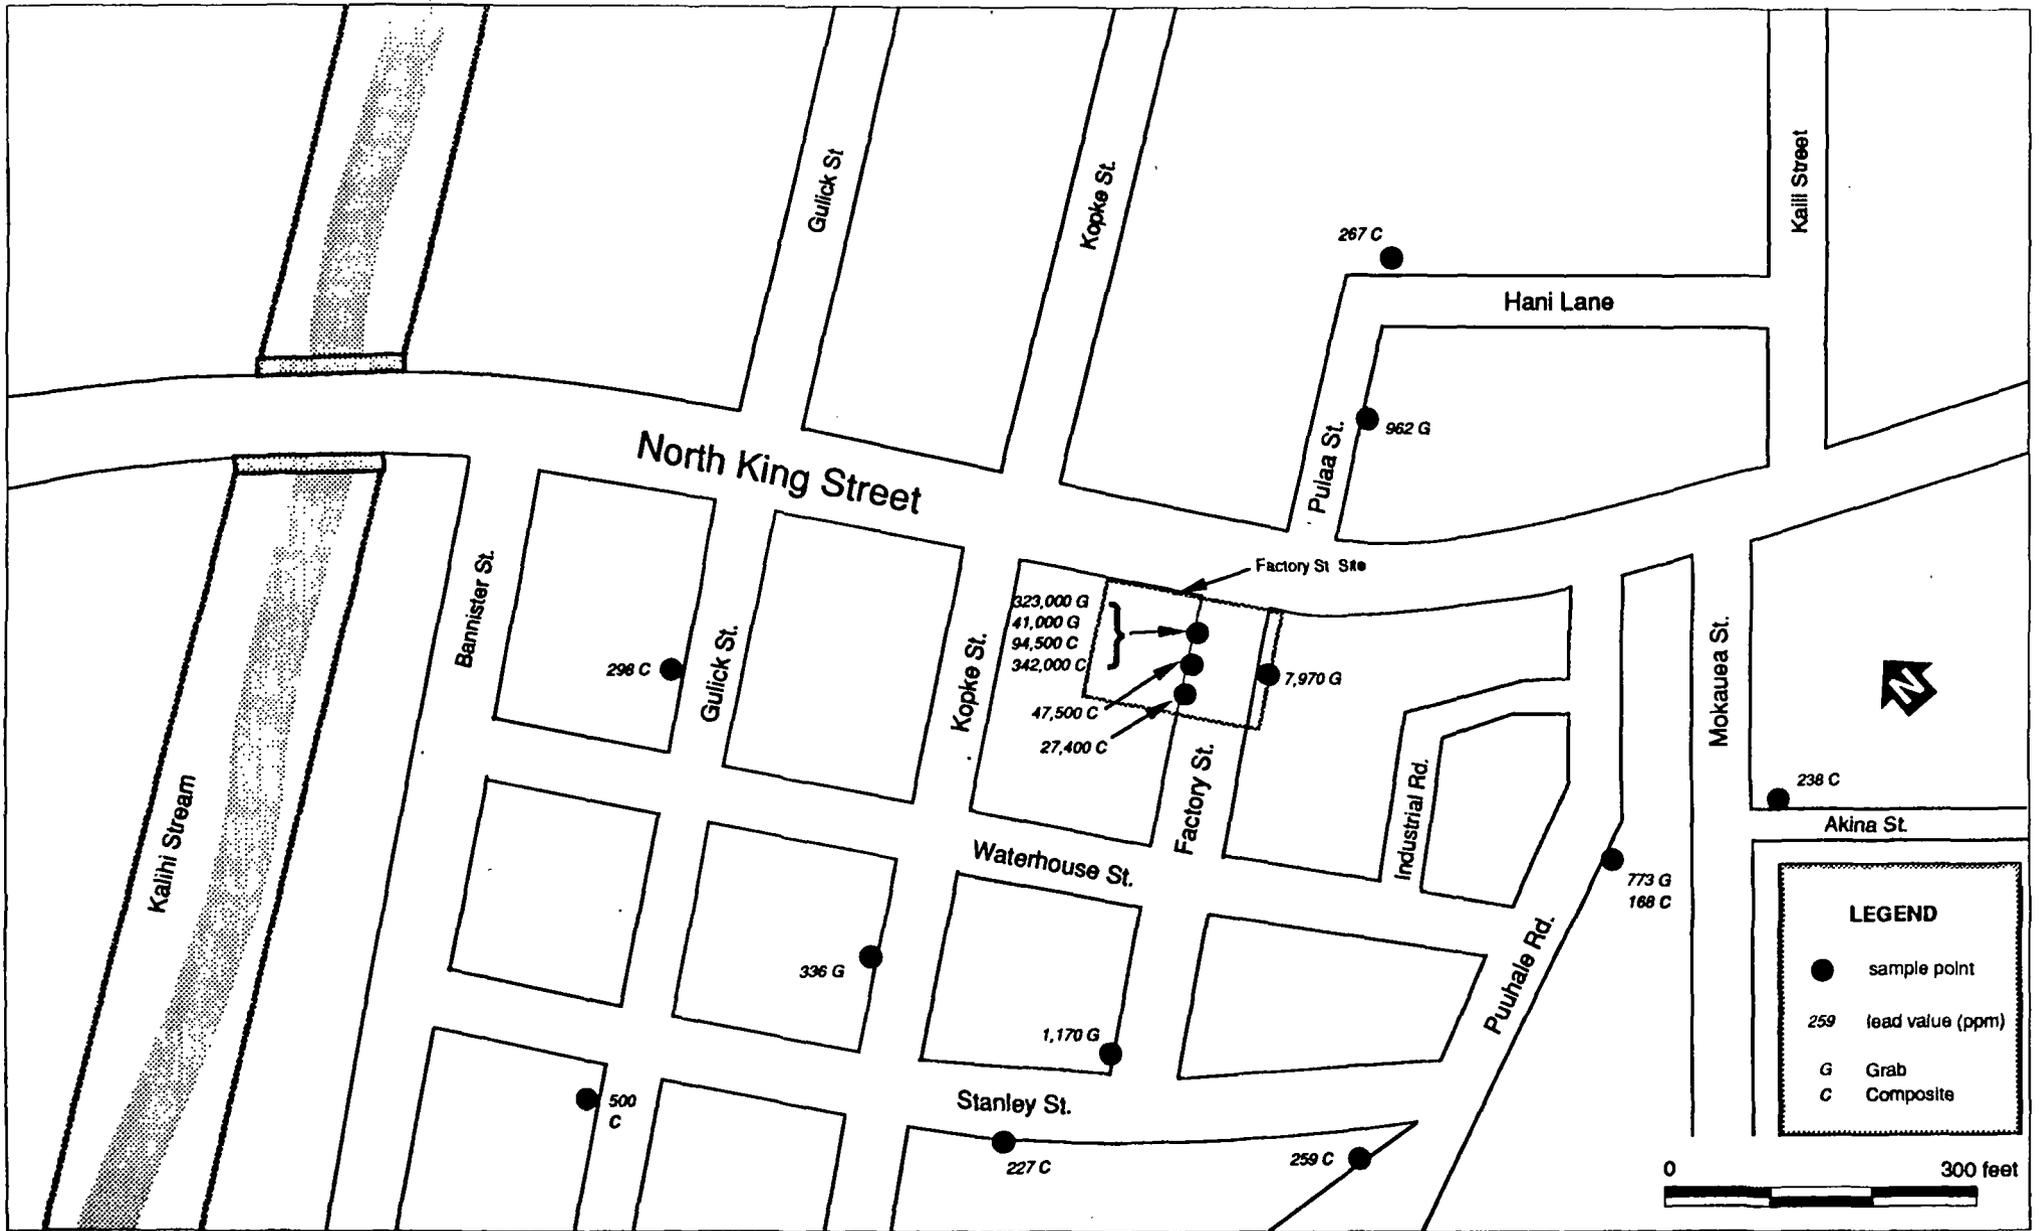
The HEER collected six soil samples in a two block radius around the site on June 6, 1993 (Figure 3). Analytical results revealed lead levels that ranged from 168 mg/kg to 1,170 mg/kg. Based on these findings, the HEER suspected that lead contamination from the Factory Street site had migrated off site potentially impacting the surrounding residential neighborhood and surface water in the Kalihi Stream located approximately 2000 feet to the south of the site. The Kalihi Stream lies approximately 1.5 miles to the west of the site and flows southwest into Keehi Lagoon. Storm water runoff from the Factory Street neighborhood flows on the surface to collection drains which empty directly into the stream. Residents utilize Keehi Lagoon for fishing and recreational activities.

Figure 3
HEER SAMPLE LOCATION MAP
Factory Street Lead Site
Honolulu, Hawaii

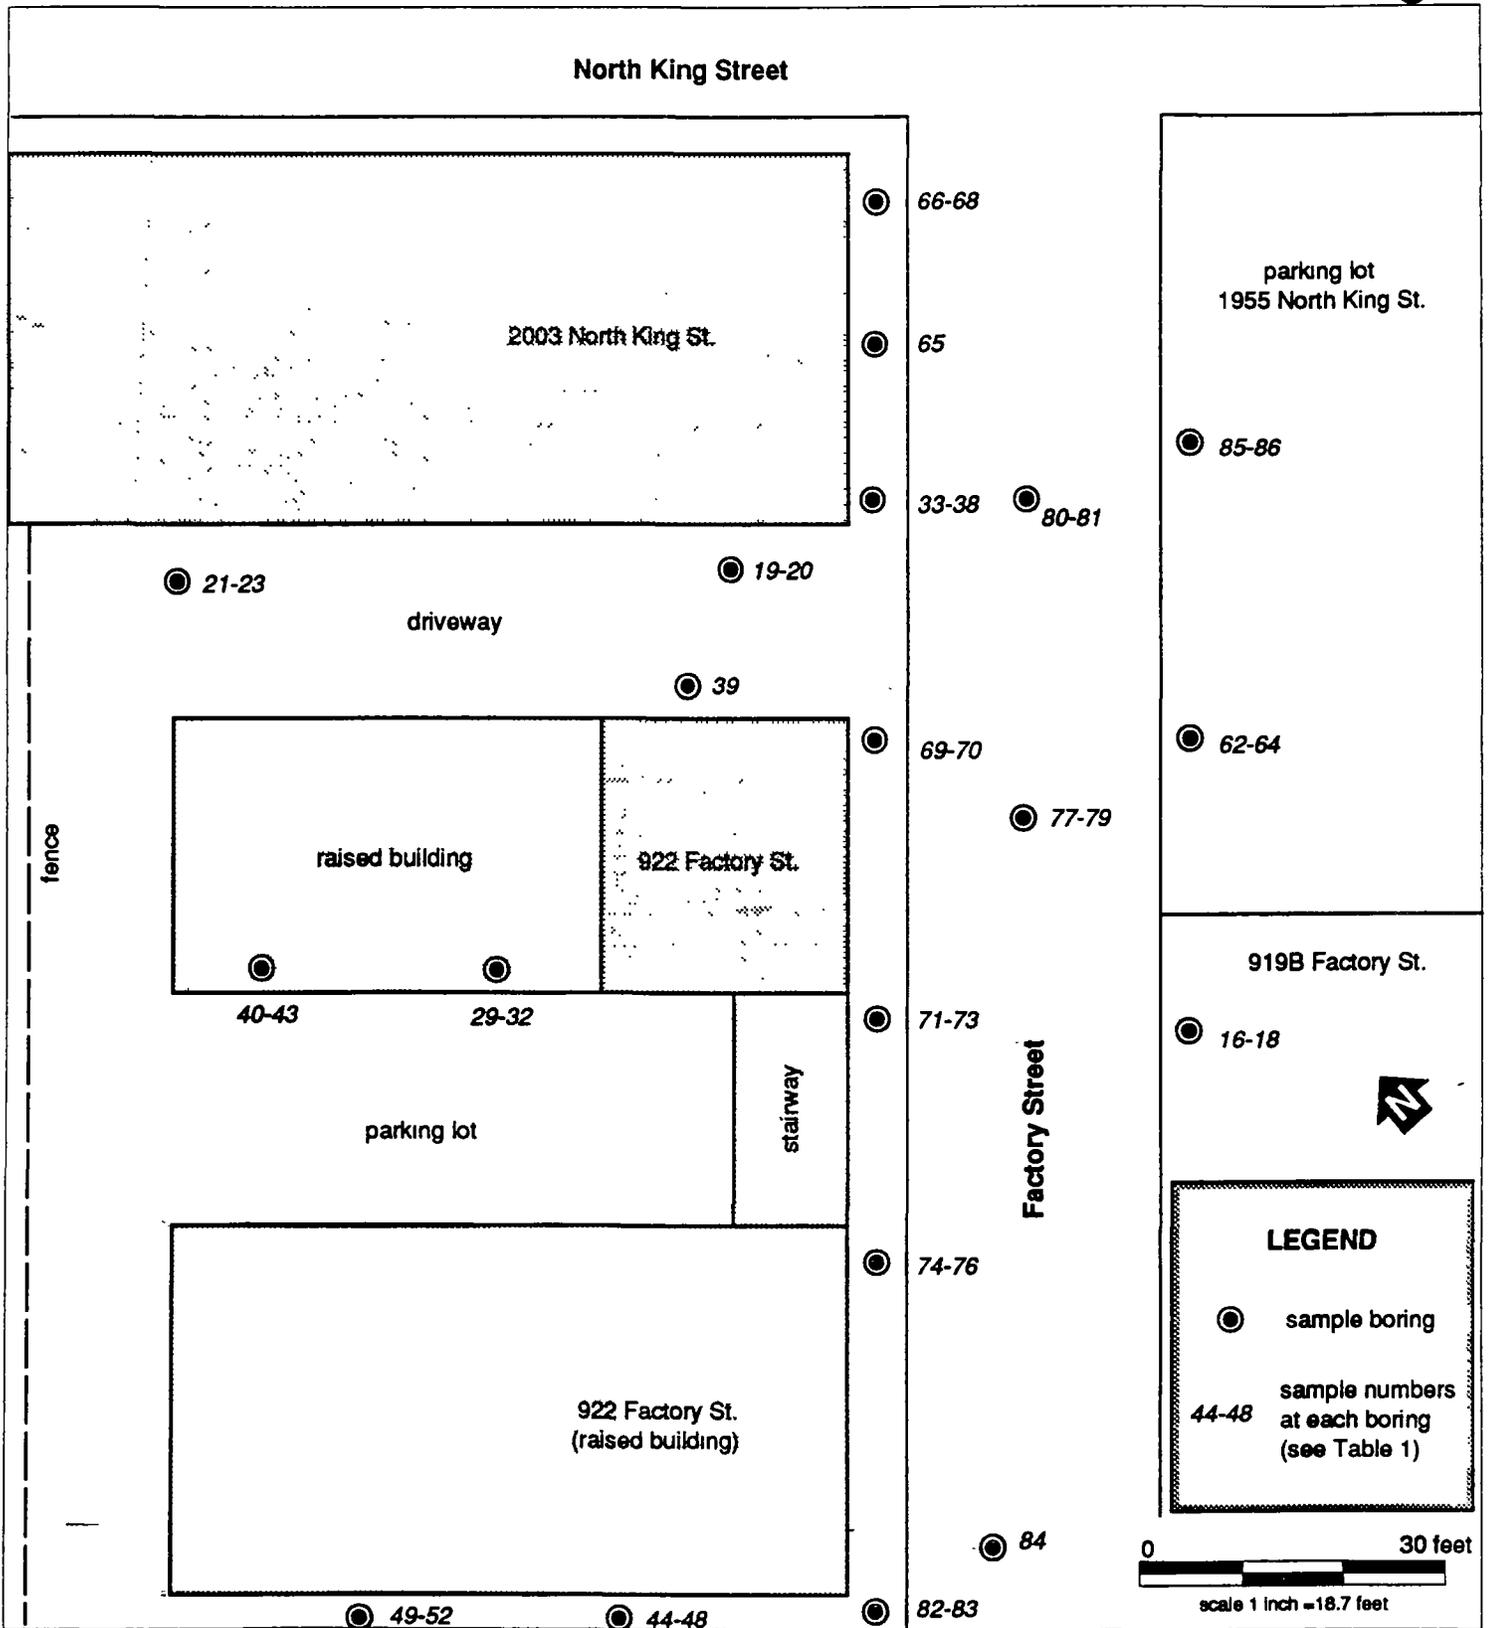
Street and surrounding the apartment complex at 915 Factory Street as well as curb side areas along both sides of Factory Street adjacent to the above addresses (Figure 4). Samples were also collected in the center of Factory Street beneath the asphalt. Most borings were completed to a depth of two to three feet using hand augers and power augers. All soil borings were advanced to refusal in an effort to reach groundwater. The deepest sample was collected at five feet. Soil augers encountered an extremely hard layer at two to five feet. Refusal at these depths was probably due to the presence of bedrock. The TAT observed a construction excavation approximately three blocks to the northwest on North King Street which revealed shallow, coarsely fractured basaltic bedrock.

Figure 4
**TAT ON-SITE SOIL BORING LOCATIONS AND
 SAMPLE NUMBERS**
 Factory Street Lead Site
 Honolulu, Hawaii

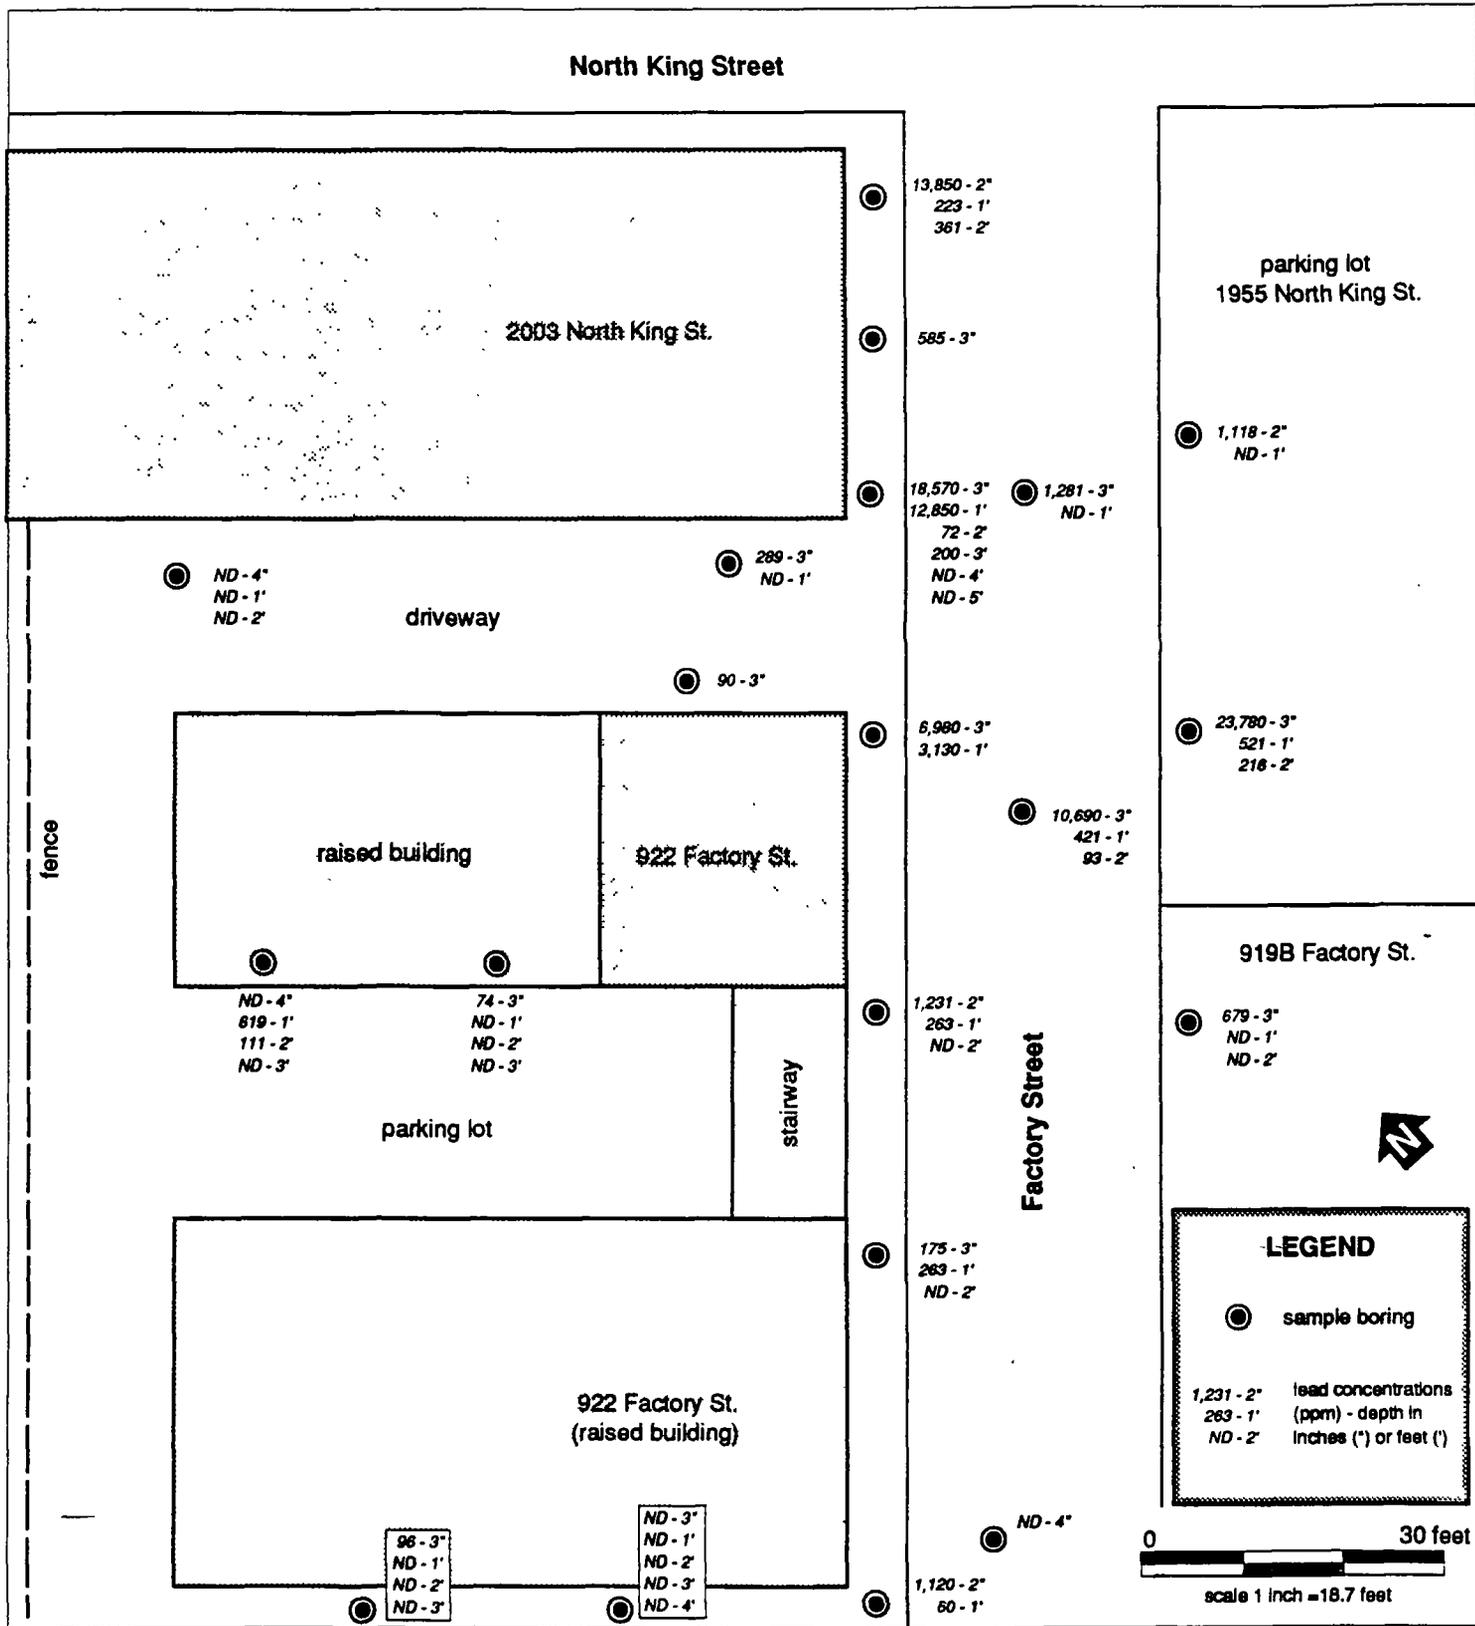
Areas which had the highest near-surface contamination were located adjacent to Factory Street on the shoulder or in narrow areas between buildings and the street (Figure 5). The highest lead levels were found in the narrow strip between the building at 2003 North King Street and Factory Street, and across the street at the edge of the parking lot at 1955 North King Street (Figure 5). These are both locations where Mr. Lau reportedly had soil removed. Three soil samples contained lead at greater than 10,000 mg/kg and one sample contained greater than 20,000 mg/kg lead. All were within one foot of the surface. One sample just beneath the asphalt in the center of Factory Street also contained greater than 10,000 mg/kg lead.

Figure 5
TAT ON-SITE SOIL SAMPLE LEAD CONCENTRATIONS
Factory Street Lead Site
 Honolulu, Hawaii

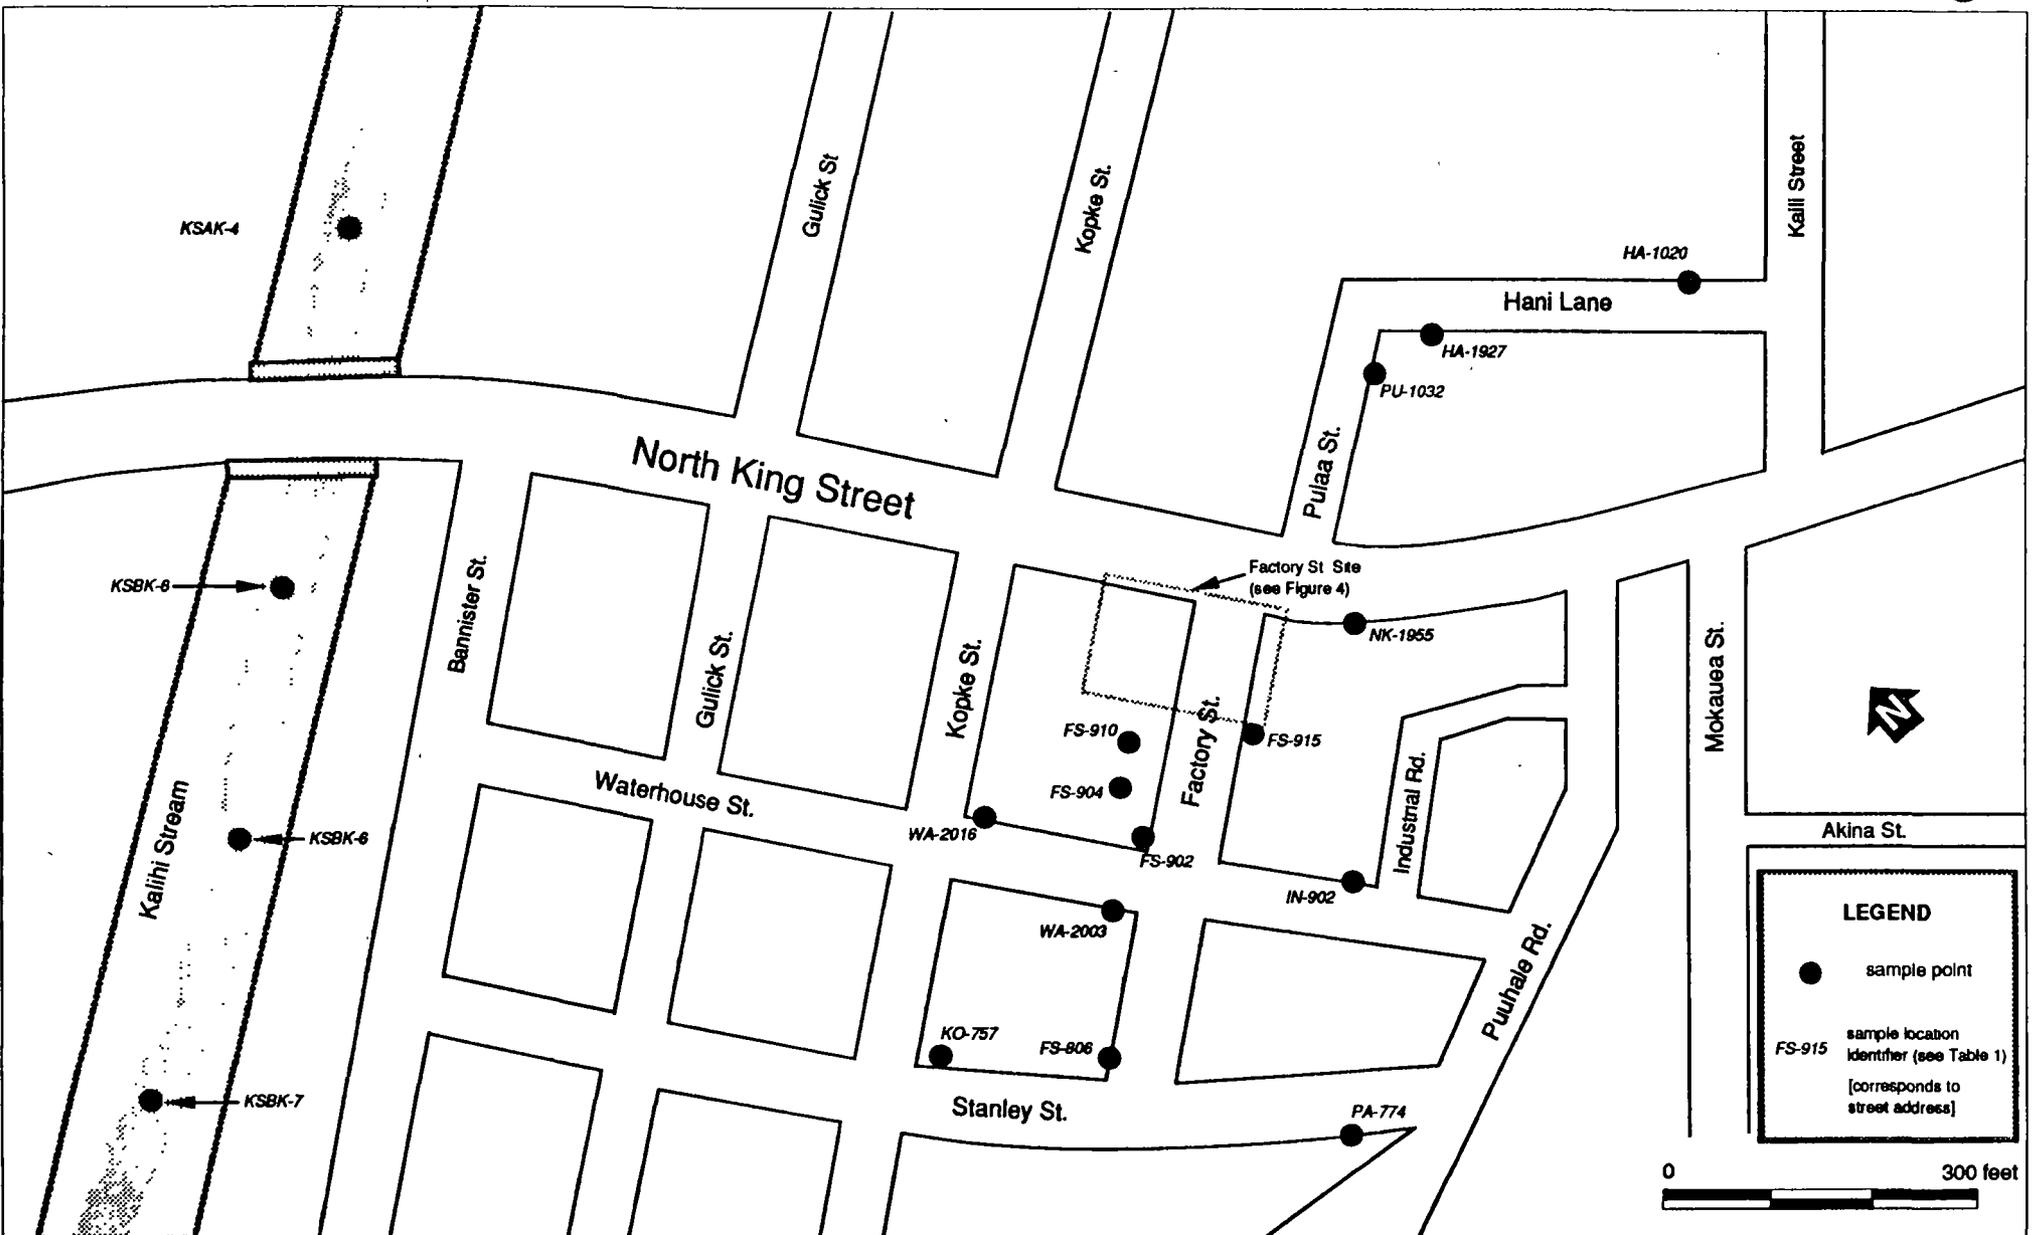
The TAT collected nine surface composite soil samples and drilled six soil borings within a three block radius of the site (Figure 6). The TAT concentrated sampling efforts in areas to the southwest of the site, which is the downslope or downgradient direction for surface water-borne contamination migration. Background samples were collected to the northeast on Pulaa Street and Hani Lane. Most off-site samples were collected from roadside areas of exposed soil or gravel. Two borings were drilled in garden plots on parcels adjacent to the site (904 and 910 Factory Street). There were three objectives of off-site sample collection:

Figure 6
TAT OFF-SITE SAMPLE LOCATION MAP
 Factory Street Lead Site
 Honolulu, Hawaii

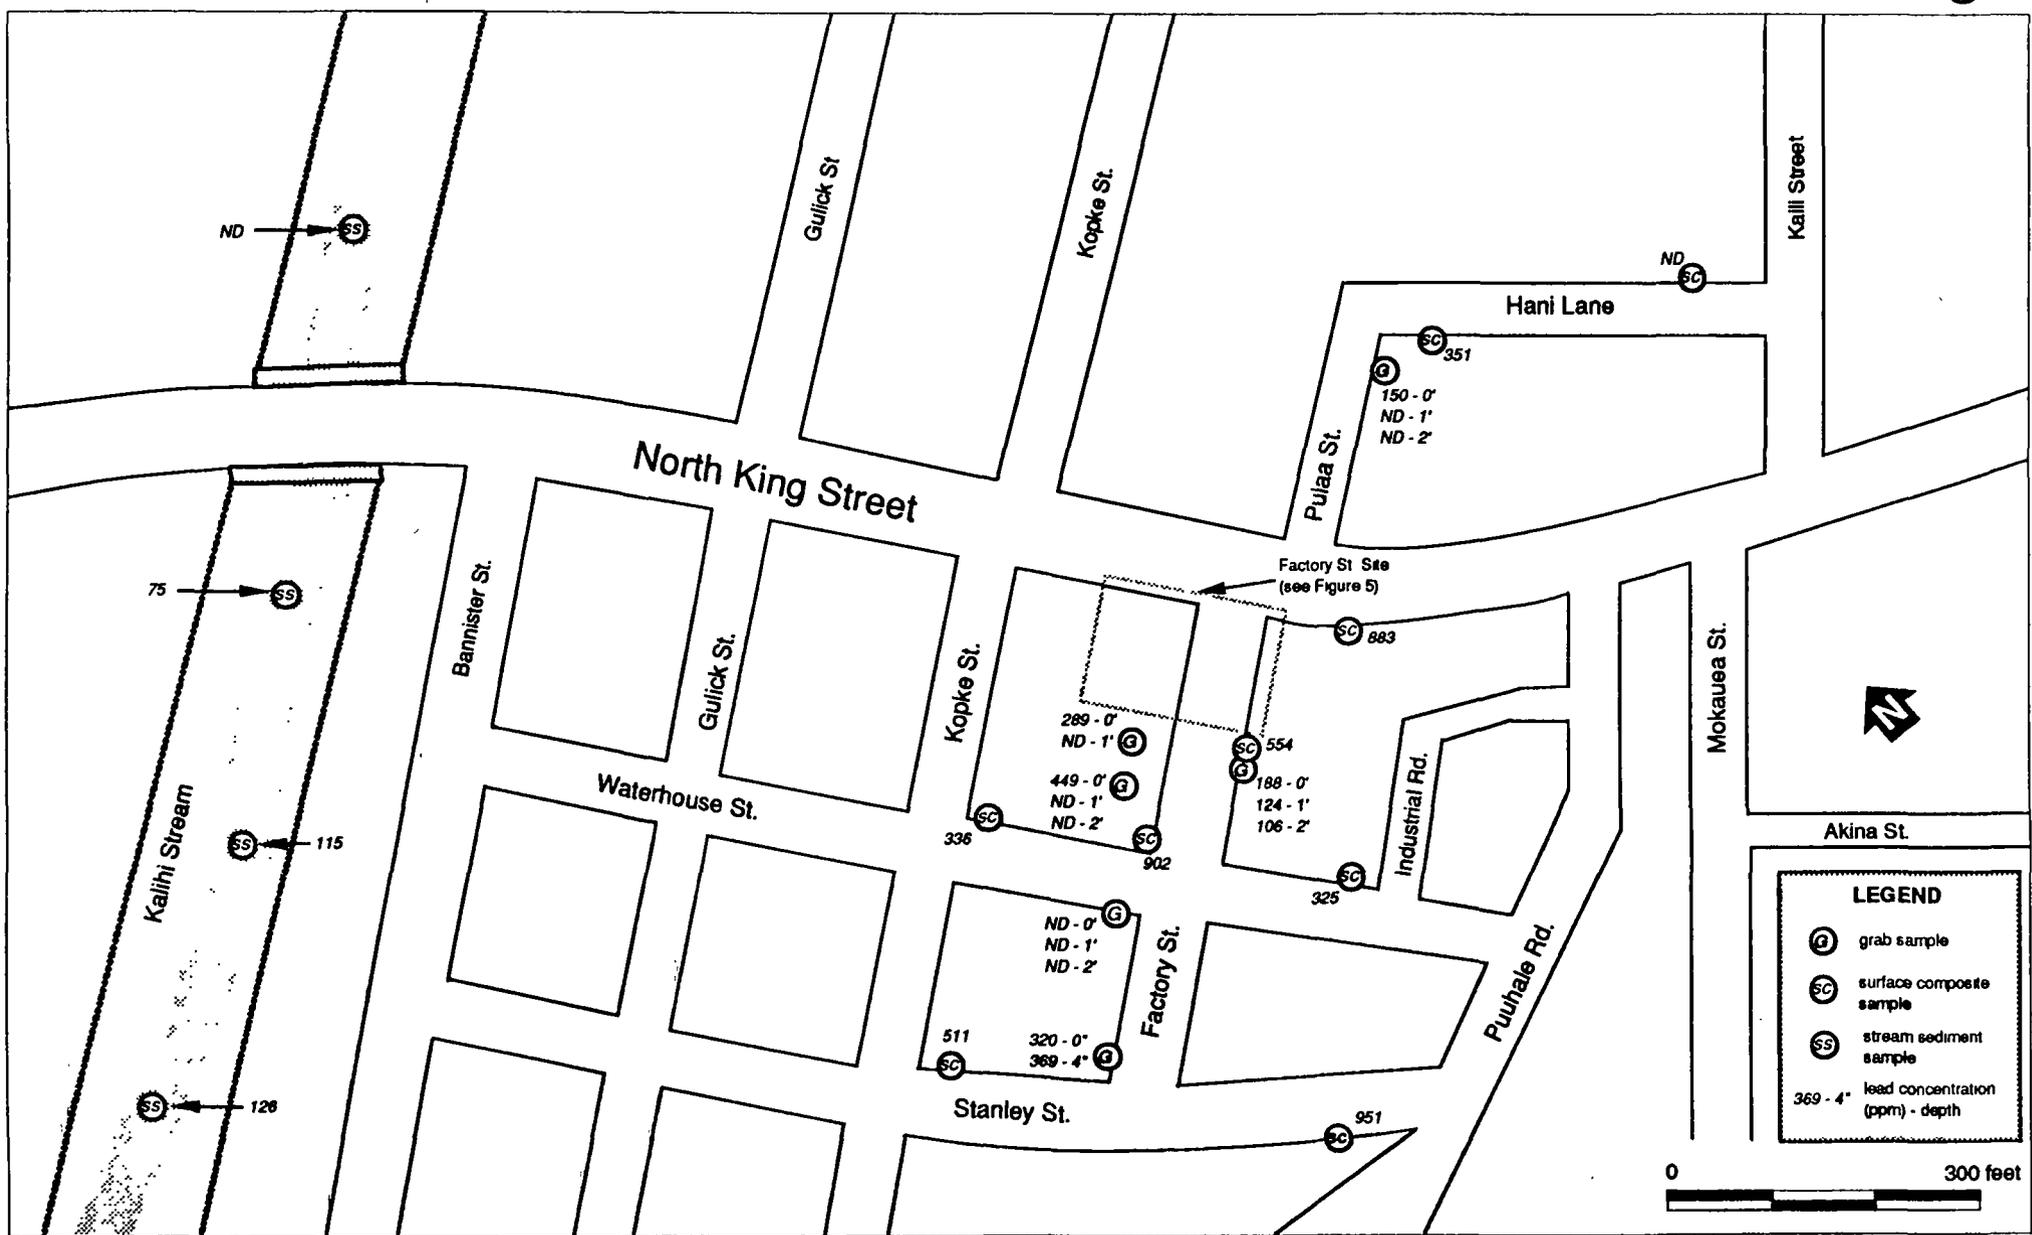
Figure 7
TAT OFF-SITE SOIL SAMPLE XRF LEAD CONCENTRATIONS
 Factory Street Lead Site

XRF sample results indicate shallow lead contamination ranging from non-detect (ND) to 951 mg/kg (Figure 7). While some of the higher values were located adjacent to the site, there did not appear to be any consistent distribution pattern such as might be expected in a downgradient surface migration plume. The off-site sample with the highest value was collected at 774 Puuhale Street. That sample contained 951 mg/kg lead. The TAT noted a pile of three discarded automobile batteries located on the 774 Puuhale Street property within 20 feet of the sample location (Appendix A, Photo 5). Eight more discarded automobile batteries were noted approximately 100 feet to the northwest at 2003 Stanley Street. Other discarded batteries were noted scattered throughout the neighborhood.

The HEER collected one sample upstream from North King Street and three samples downstream. — Results do indicate higher levels downstream (Figure 7); however, the values are lower than local background levels as determined in this sampling event. Lead contamination in Kalihi Stream could easily come from sources other than the site, such as runoff from North King Street related to historical use of leaded gasoline, lead paint, or from street corner automotive battery disposal.

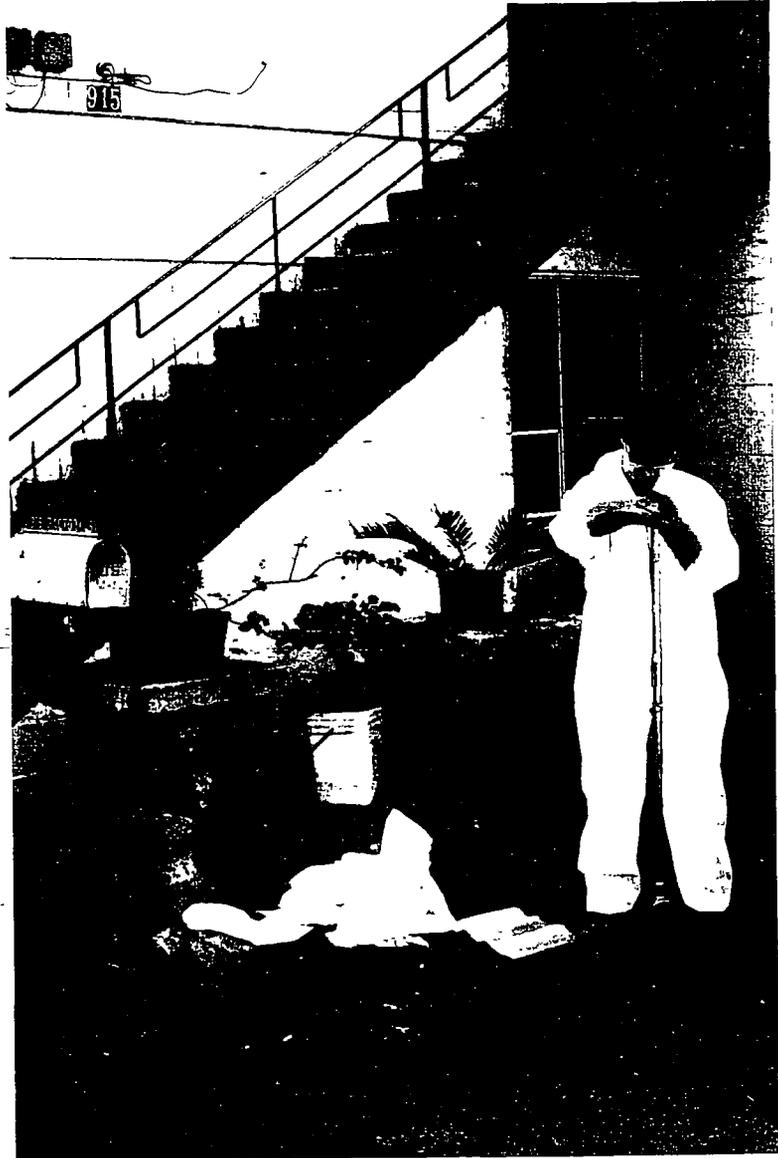
Photo 1: TAT collecting
soil sample with hand auger at
915 Factory Street

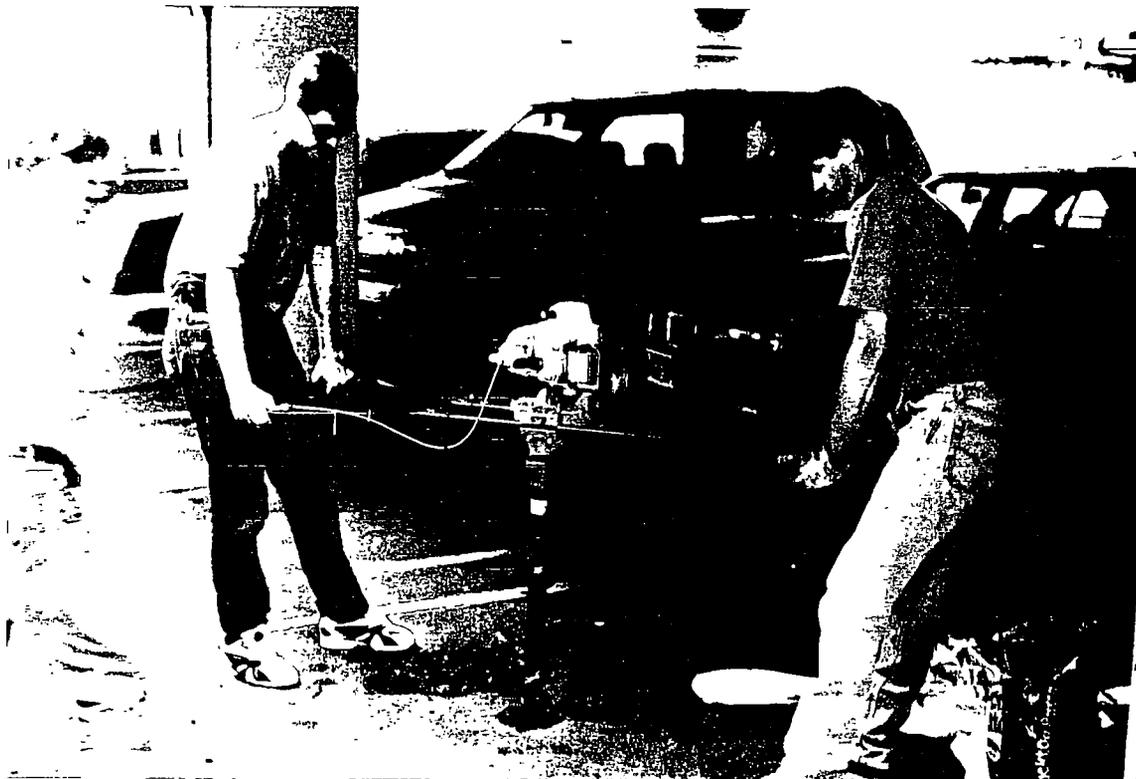
Photo 2: TAT and HEER drilling to sampling depth with power auger
in parking lot at 922 Factory Street

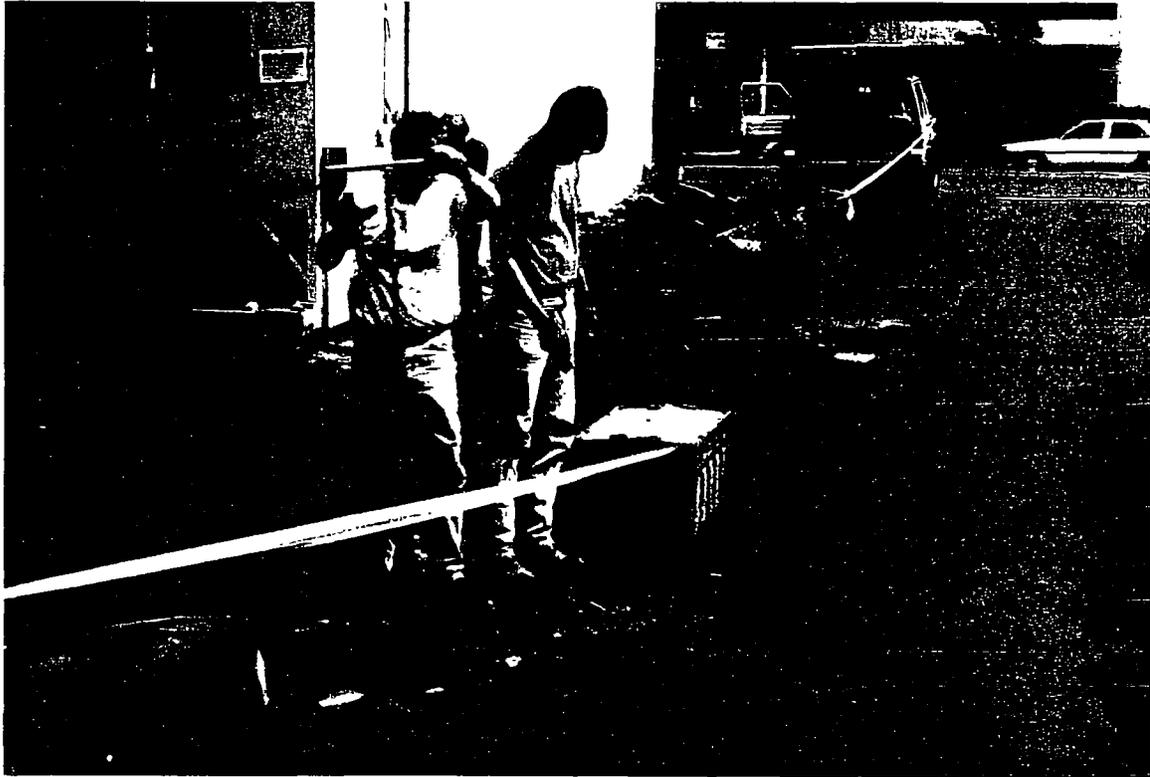
Photo 4: The TAT collecting soil samples beneath the asphalt
in the center of Factory Street

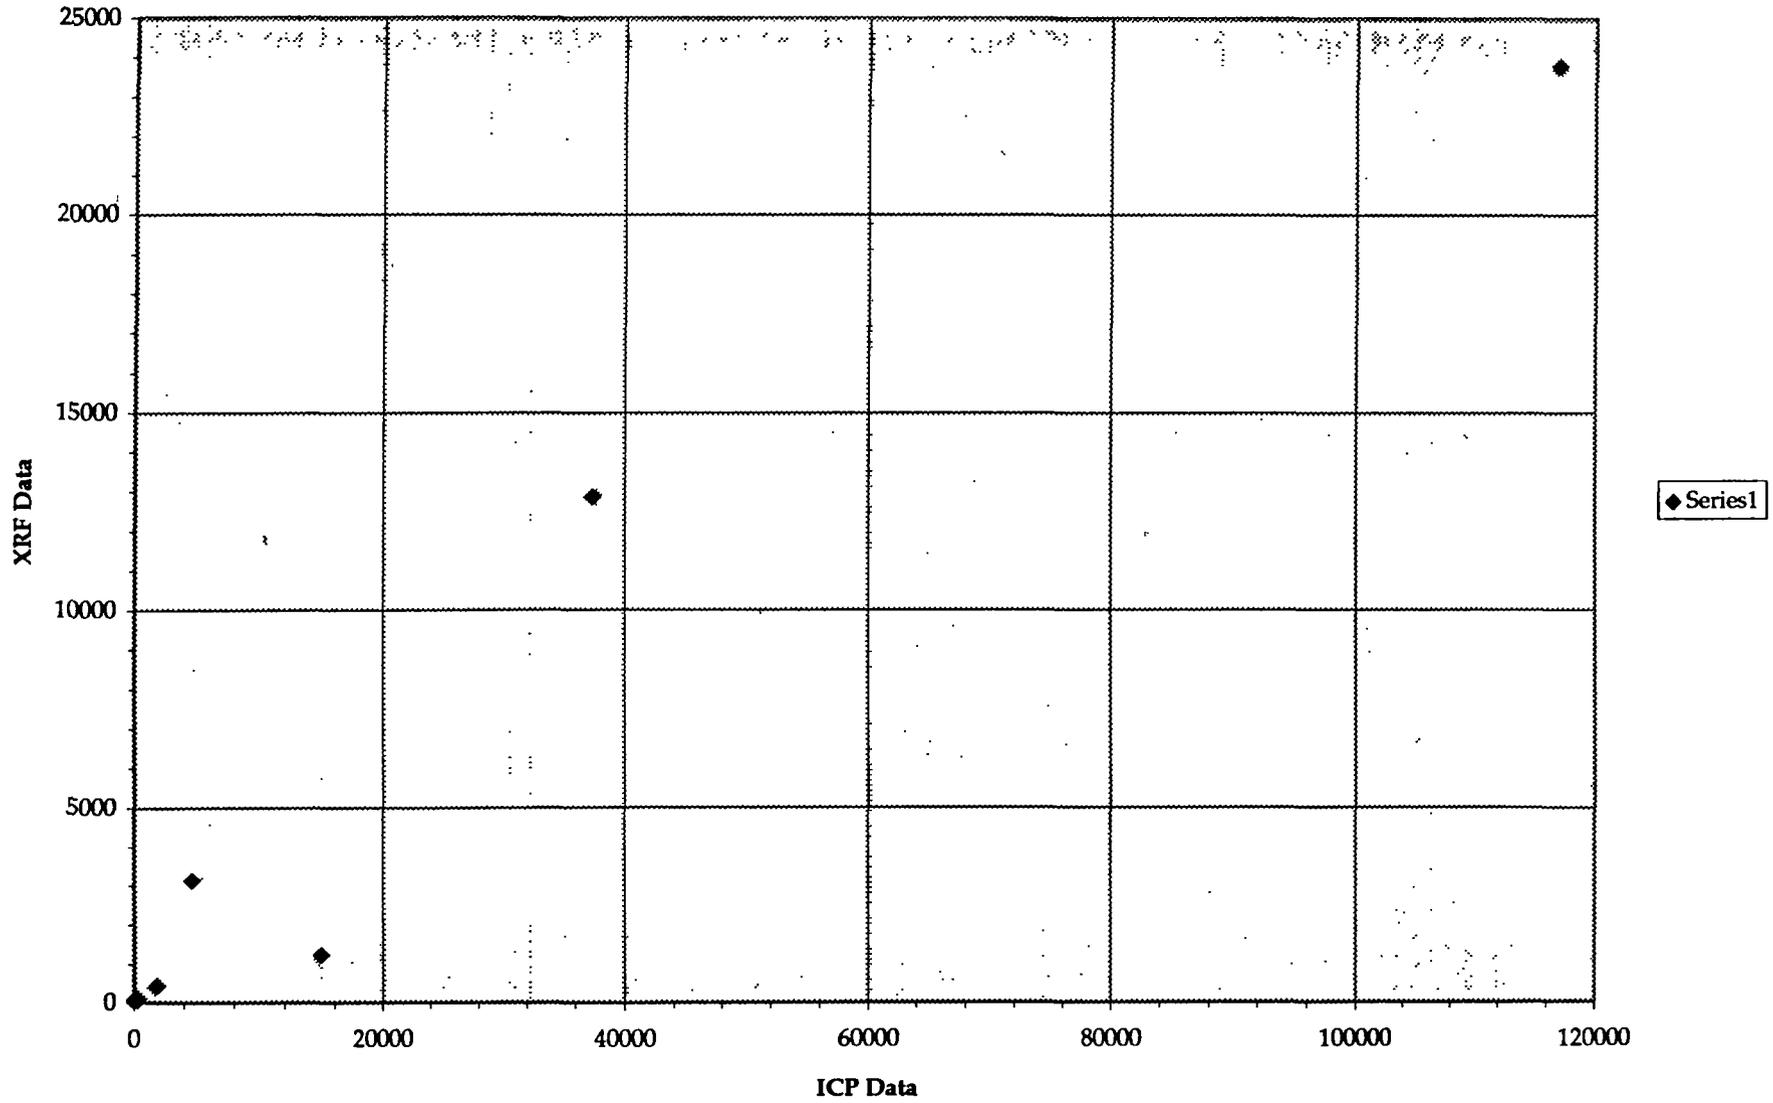
Chart 1
Factory Street Lead Site
Linear Regression Plot

In Table 2 and in Chart 1 it is apparent that the XRF response was considerably lower than the ICP response to lead in the samples. The slope of the linear regression plot is 4.51, outside of the recommended slope value of >0.5 to <2.0. The TAT believes that this is related to matrix interferences of the soils collected. The samples were dense, saturated clays which made homogenization difficult if not impossible and high moisture content is a documented interference for XRF analysis. When the samples were dried in an oven and reanalyzed there was no appreciable increase in instrument response but this could be related to a number of interrelated matrix, sample handling, and analyte factors. The data is accepted by the TAT because of the high r-value (.97) which shows that the XRF and CLP data are directly related and can be converted using the linear equation of the line expressed as:

$$\text{ICP Result} = (4.51) \text{ XRF Result} + (-1176).$$

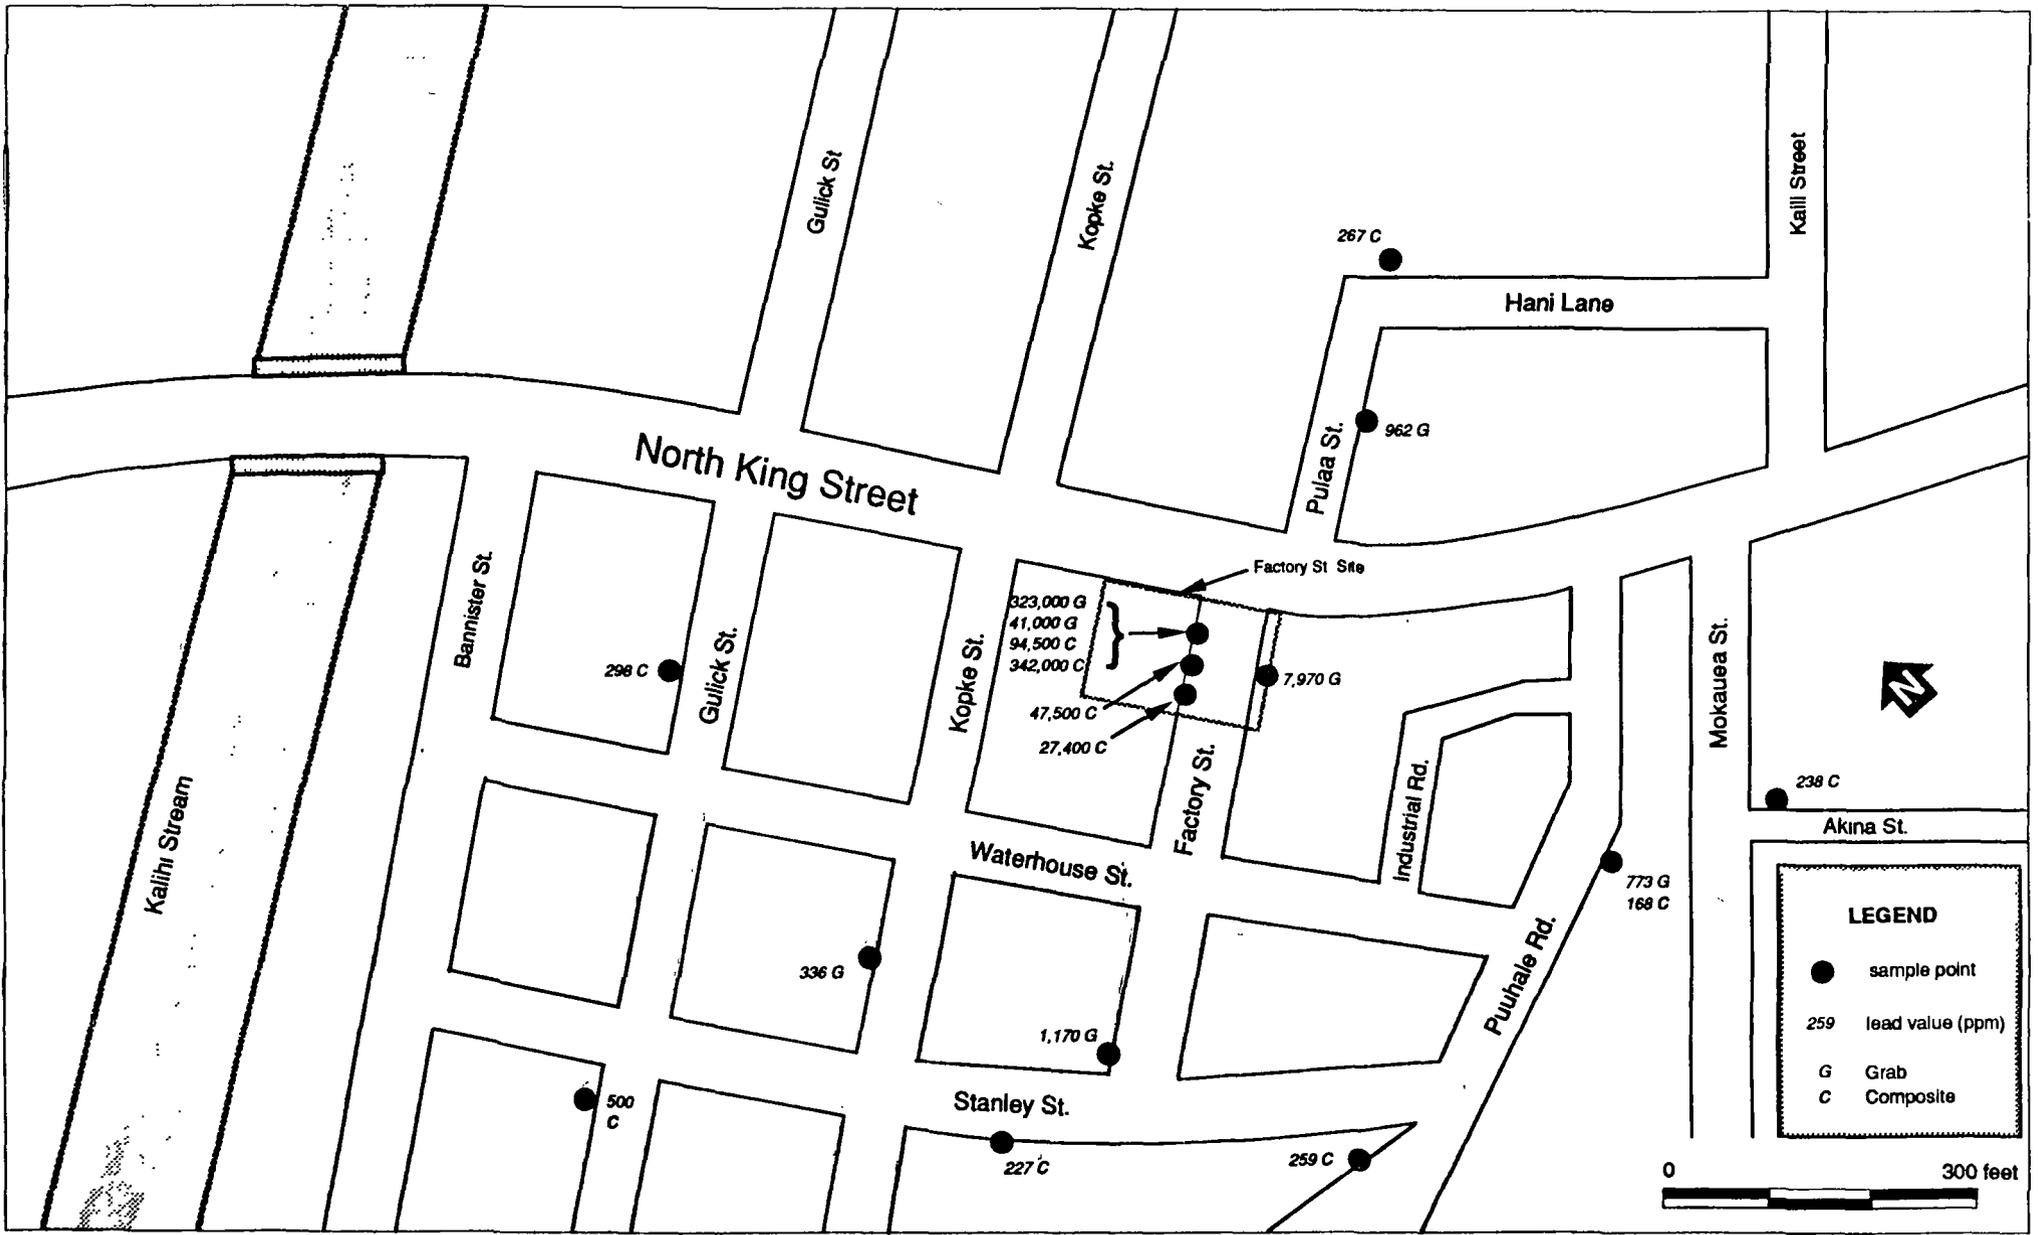
The HEER collected six soil samples in a two block radius around the site on June 6, 1993, which revealed high lead levels (Figure 2). Values ranged from 168 mg/kg to 1,170 mg/kg. Typical background lead levels for soils in this area are not known; they will be determined during the upcoming sampling event. The lateral limits of contamination may have not been found at the Factory Street site. It is also possible that other sources for lead contamination exist in the area. The TAT observed curbside abandonment of automobile batteries during a reconnaissance visit in April 1994. No other industrial sources in the immediate area are known.

Figure 2
HEER SAMPLE LOCATION MAP
Factory Street Lead Site
 Honolulu Hawaii
