# **FACTORY STREET LEAD SITE TIME-CRITICAL REMOVAL ACTION REPORT**

**Factory Street Lead Site Removal Action  
Honolulu, Honolulu County, Hawaii**

**Prepared for:  
U.S. Environmental Protection Agency  
Region 9, Emergency Response Section**

**December 2020**

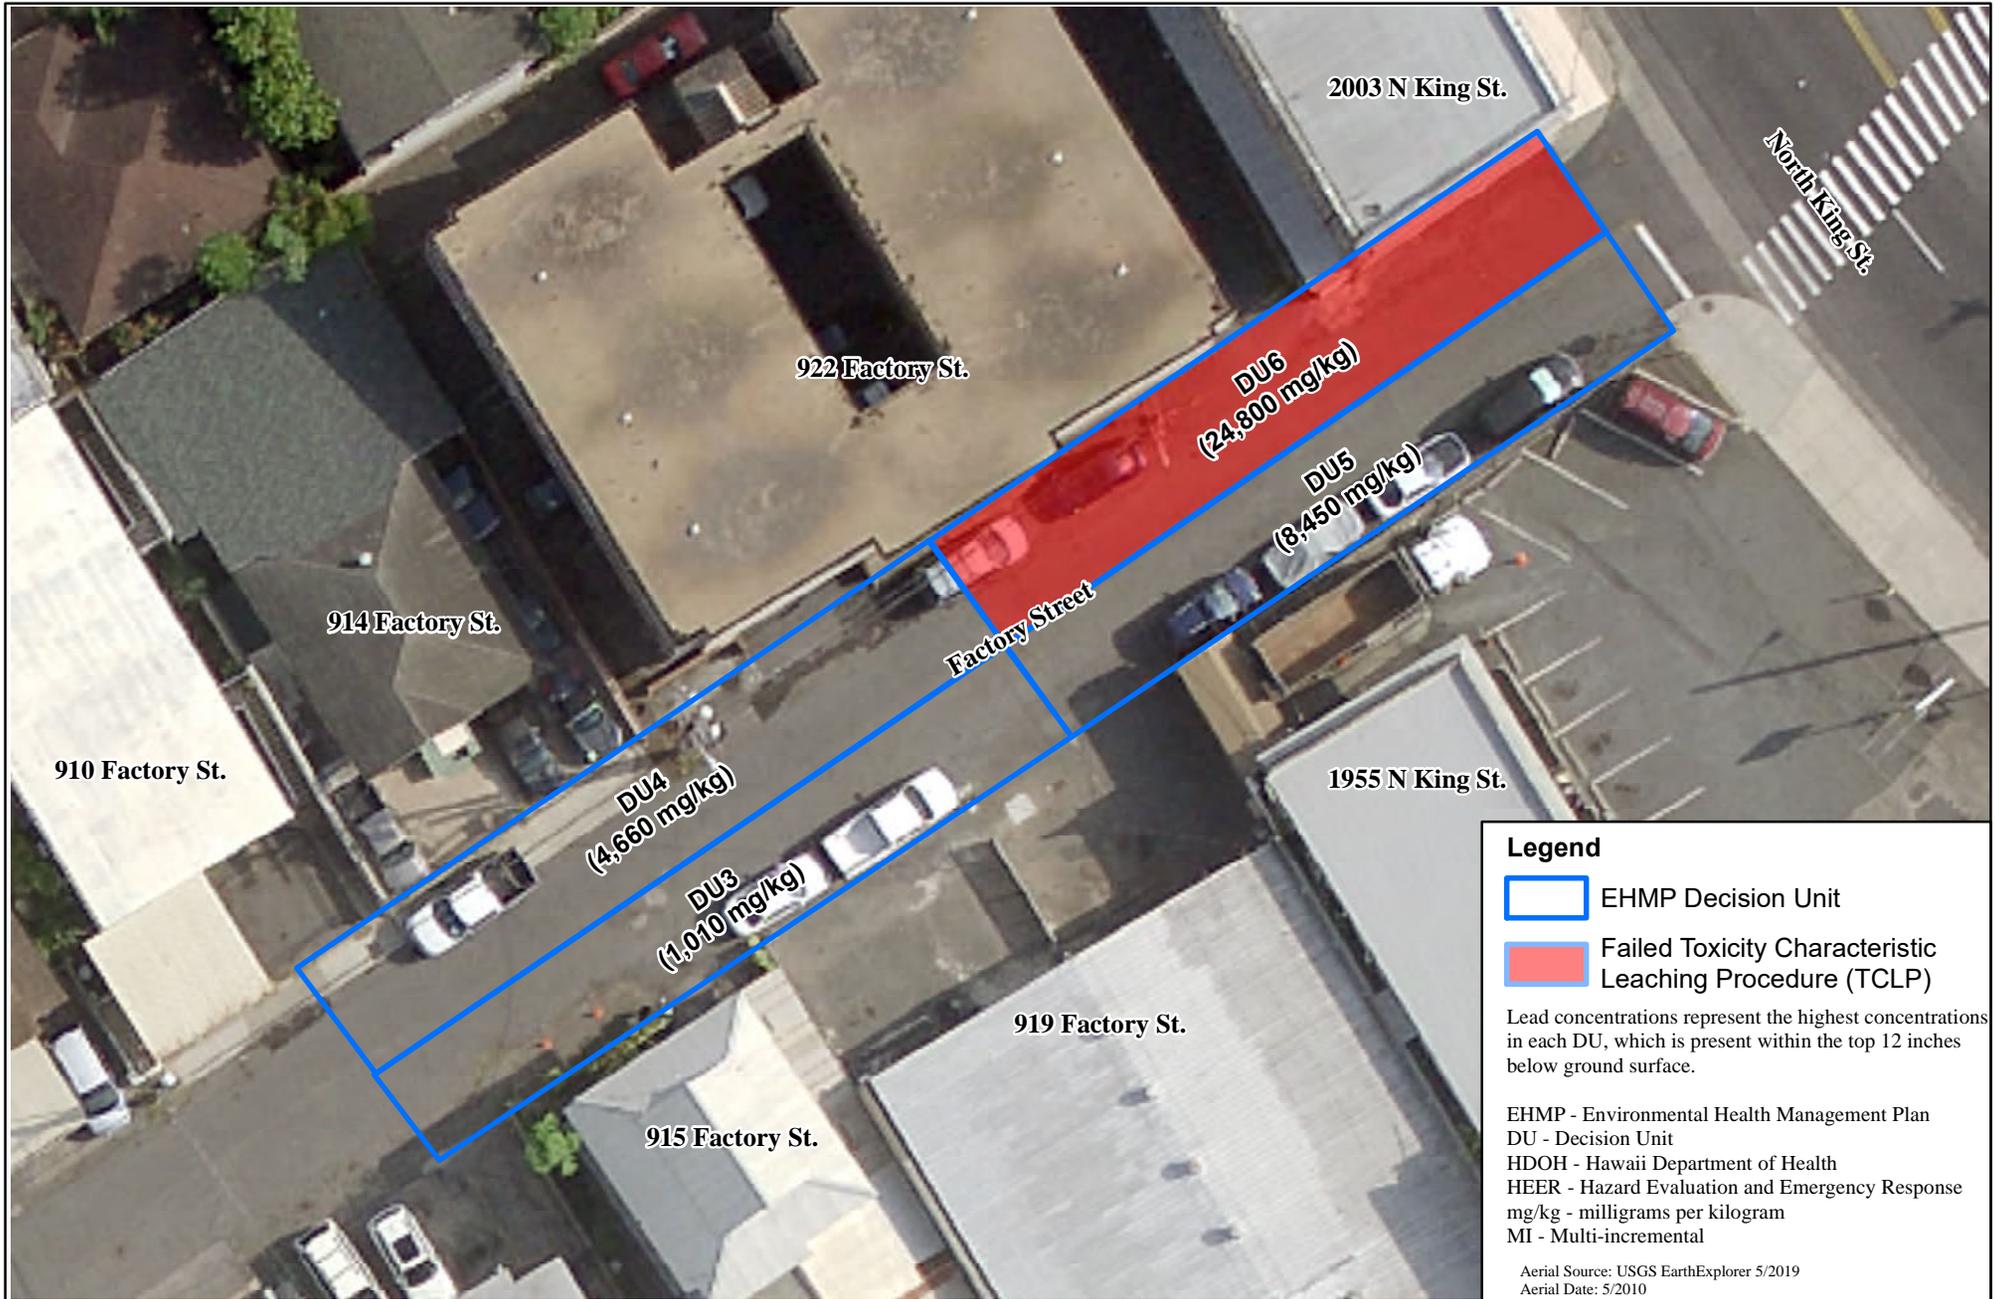
**FIGURE ES-2**  
**2017 HDOH HEER MI SOIL**  
**LEAD CONCENTRATION MAP**  
**FACTORY STREET REMOVAL SITE**  
 HONOLULU, OAHU, HAWAII

The site assessment found lead concentrations in MI samples ranging from 7 to more than 24,000 mg/kg. Many of the results greatly exceed EPA's RSL and HDOH's Tier 1 Environmental Action Level (EAL). The highest lead concentrations were detected in shallow soils close to the intersection of Factory Street and North King Street; these findings were consistent with prior assessment work at the Site. Lead concentrations of MI soil samples for DU-3 through DU-6 from the 2017 HEER assessment are presented in Figure 2-3. The figure depicts the highest lead concentrations in each DU, which is present within the top 12 inches bgs.

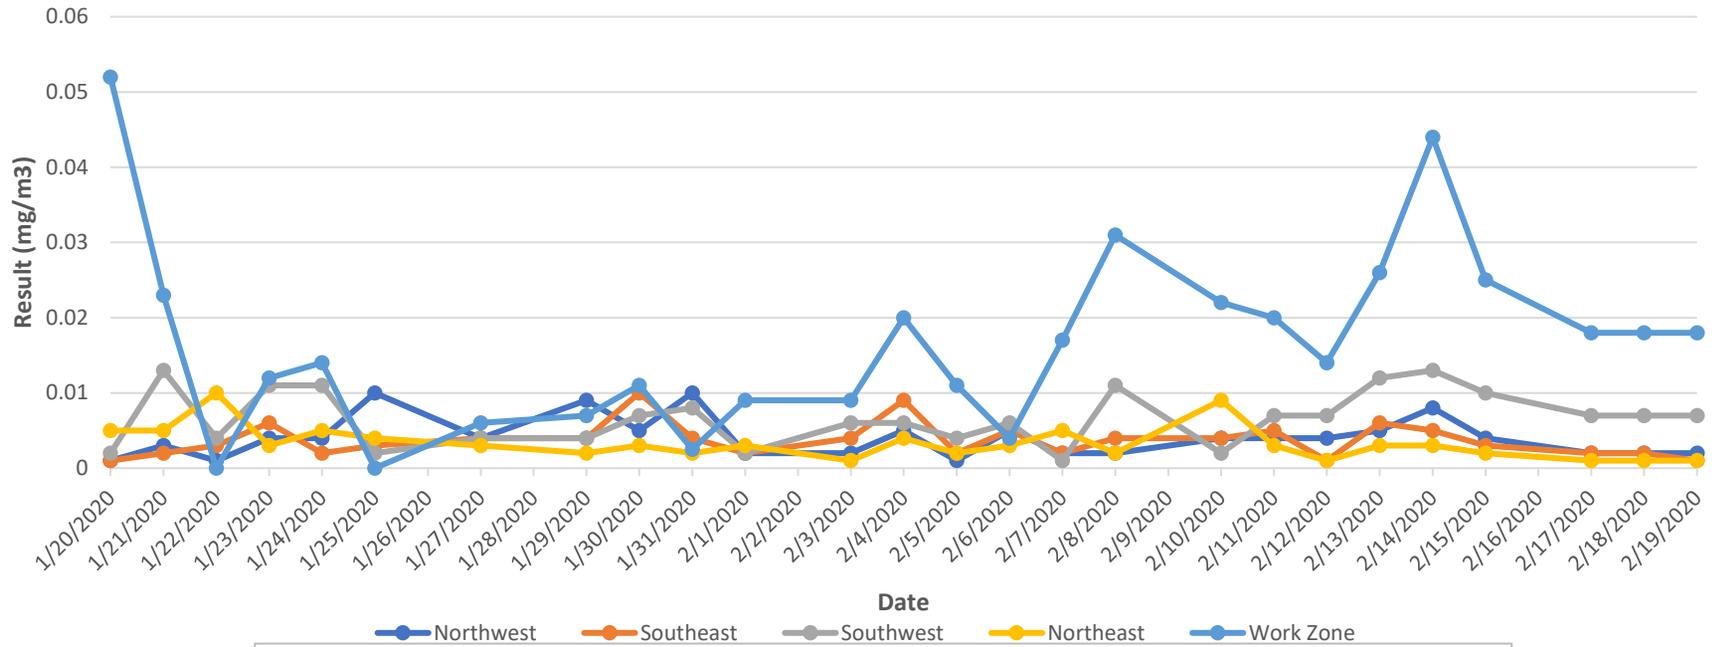
**Figure 4-2**  
**10-Hour Time Weighted Average Air Monitoring Results**

**10 hour time weighted average screening levels (mg/m3): DU-3=8; DU-4=4.29; DU-5=2.37; DU-6=0.81**

DU specific particulate screening levels were back calculated using maximum MI lead concentrations from the HDOH HEER 2017 Site Investigation. Although these concentrations may be underestimated, a safety factor of 2 is built into the screening level essentially allowing for doubling of the concentrations while still being protective. The most conservative DU-specific screening level established for the Site based on a 10-hour TWA was 0.81 mg/m<sup>3</sup> for total airborne particulates in DU-6. The highest total particulate TWA observed during the removal action was 0.052 mg/m<sup>3</sup>, more than an order of magnitude below the most conservative DU-specific screening level established for the project.

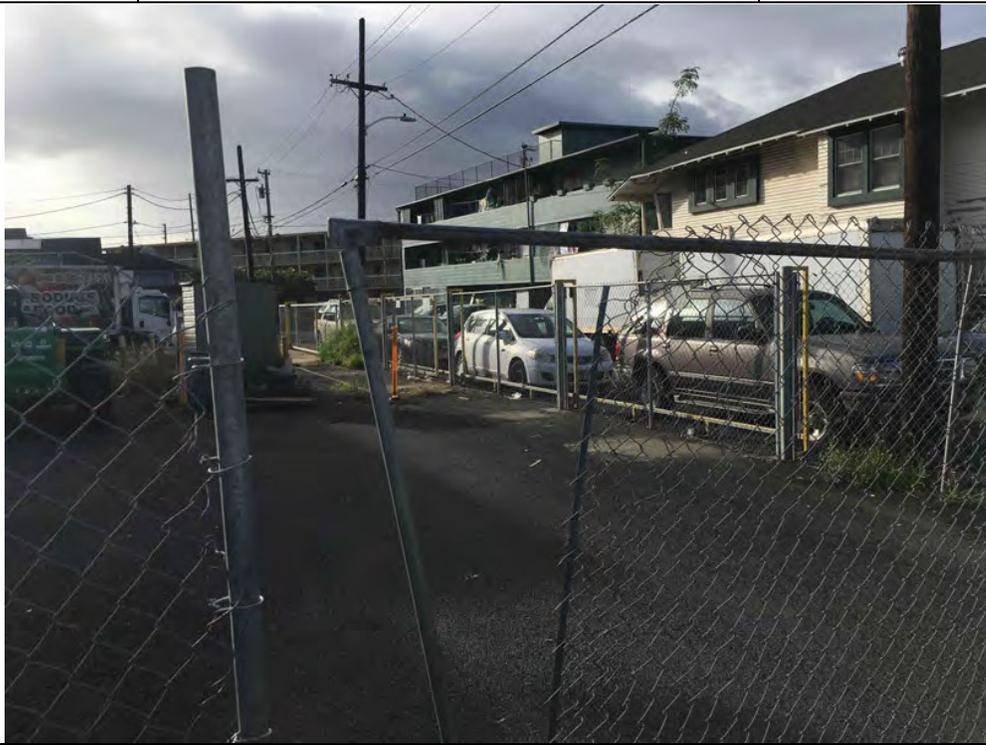
**Description:**  
Prior to mobilization of field equipment, lay-down yards were inspected and photo-documented to note damage and present conditions.

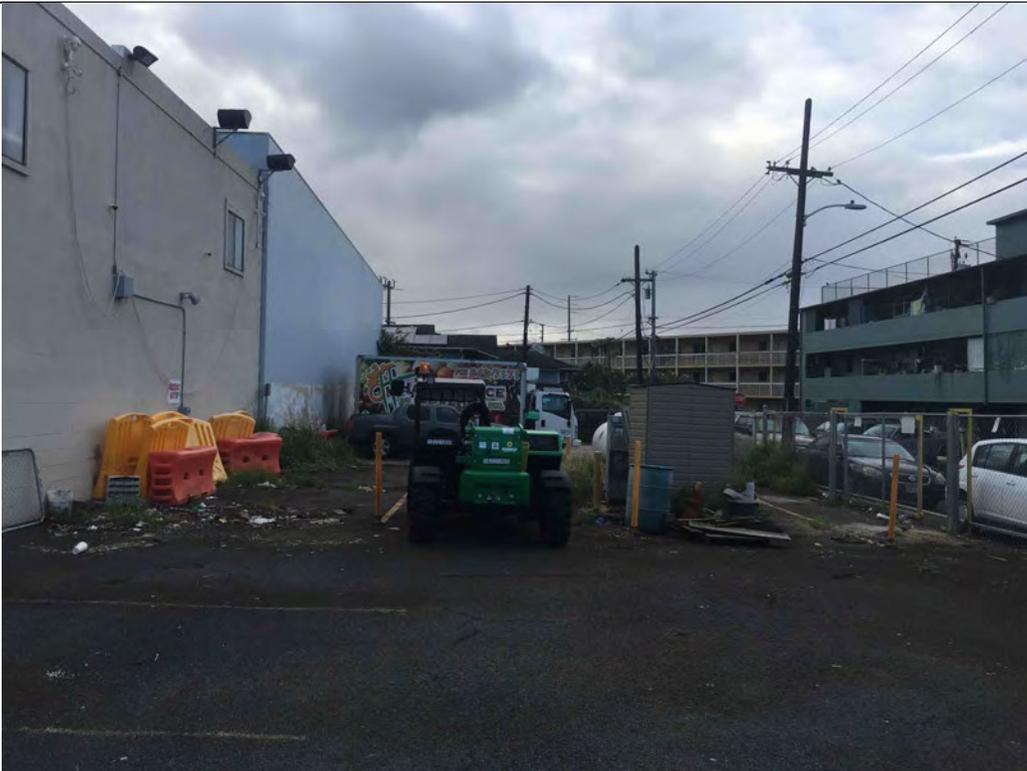
<b>Photo No.</b> <b>2</b>	<b>Date:</b> 01/16/2020
------------------------------	----------------------------

**Description:**  
The lay-down yard at Ham Produce and Seafood Inc. on the corner of Factory Street and Waterhouse Street prior to Site mobilization

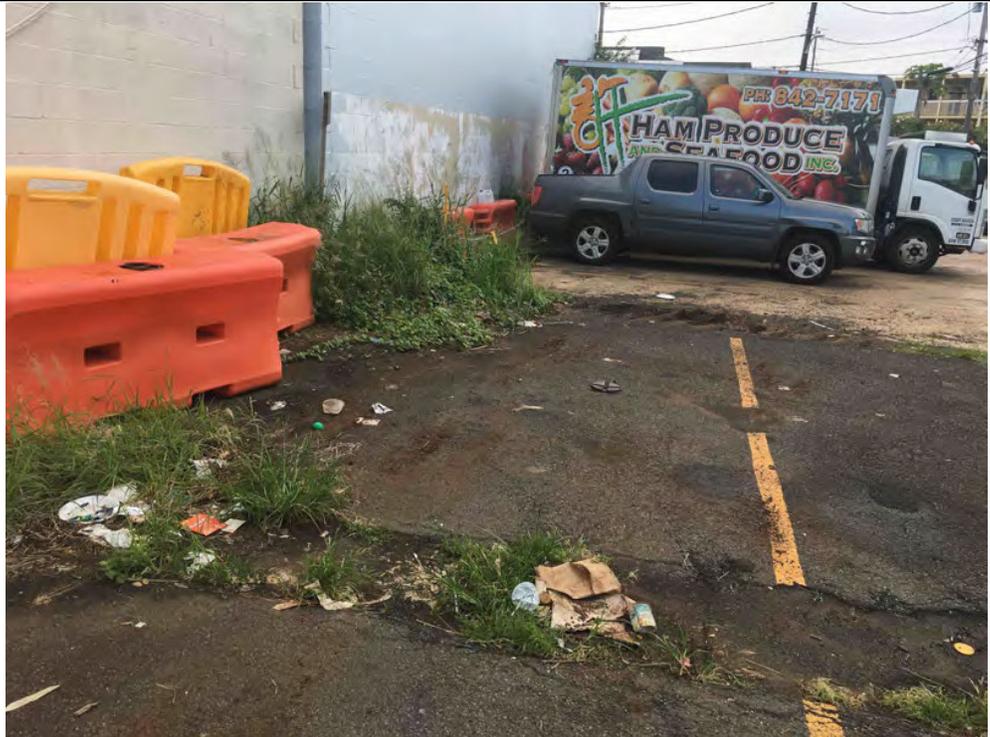
**Description:**  
The Site lay-down area prior to mobilization of office trailer, field equipment, bathroom facilities, and wash station.

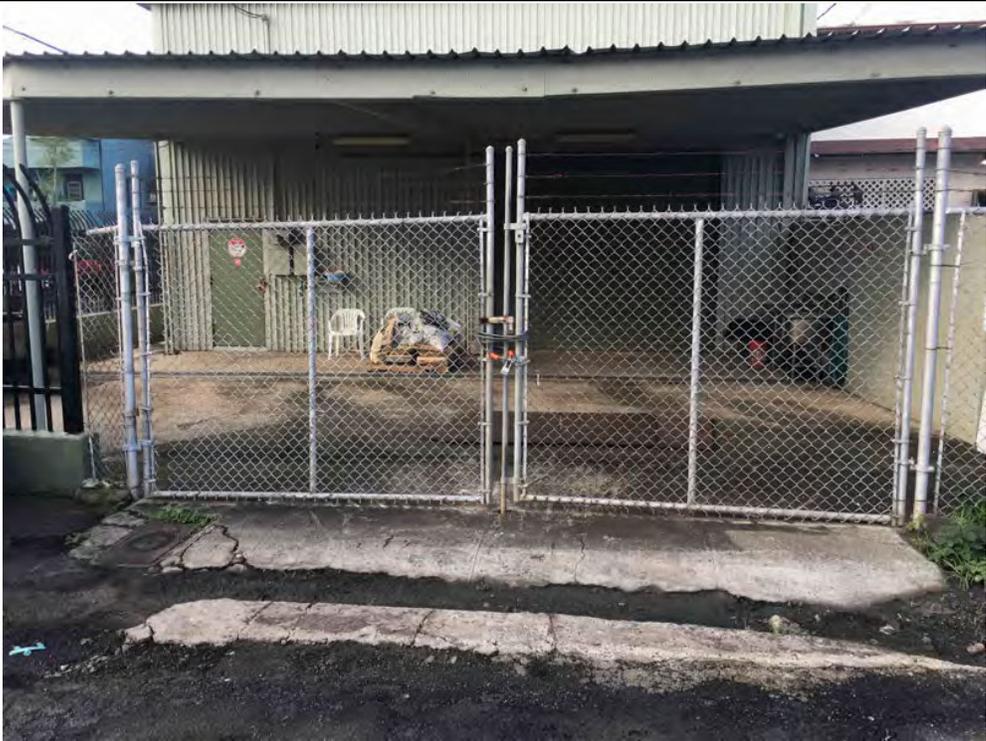
**Description:**  
The Site lay-down yard at the United Food & Commercial Workers (UFCW) Union Local 480 prior to Site mobilization.

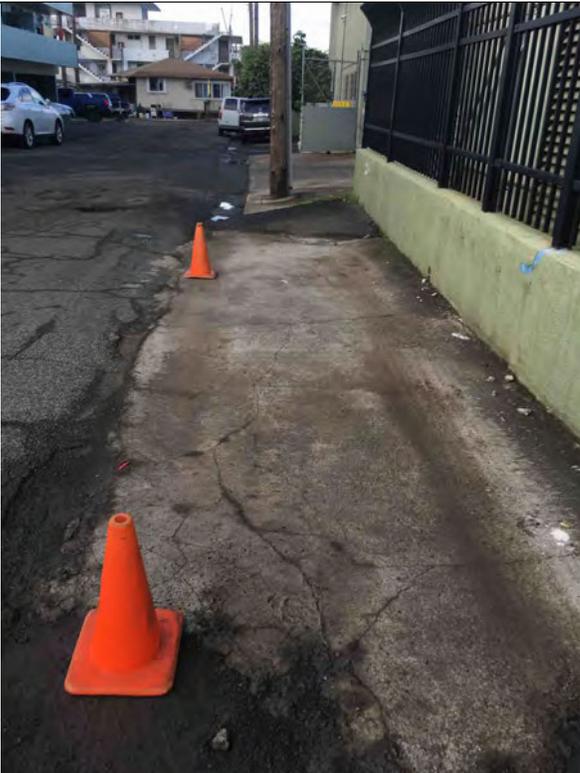
<b>Photo No.</b> <b>6</b>	<b>Date:</b> 01/16/2020
------------------------------	----------------------------

**Description:**  
A location outside of the UFCW Local 480 is coned off where a shipping container will be staged to safely store hazardous lead contaminated soil excavated from decision unit (DU) 6.

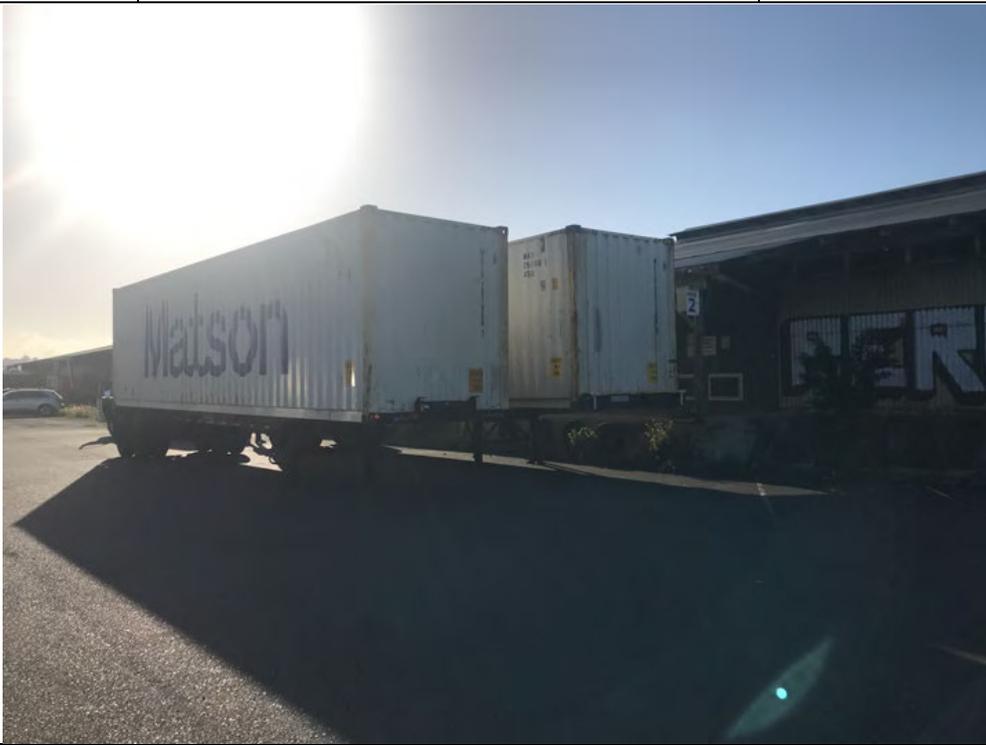
**Description:**  
Shipping containers staged at HDOA will be loaded with cubic yard boxes filled with non-hazardous waste soil excavated from the Project Area for transport off-island to a disposal facility.

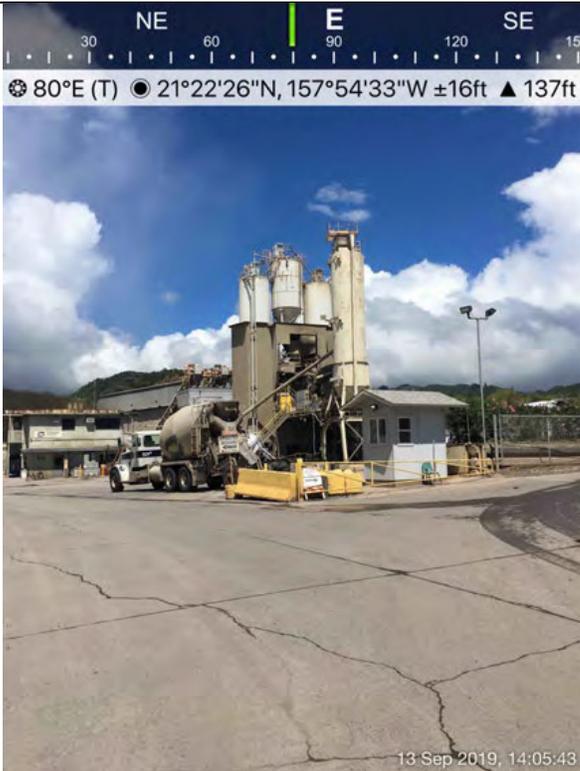
<b>Photo No.</b> <b>12</b>	<b>Date:</b> 09/13/2019
-------------------------------	----------------------------

**Description:**  
Halawa Valley Quarry was visited prior to the commencement of field work. Base course to be used in backfilling of the Project Area was field screened and laboratory analyzed prior to the commencement of excavation operations.

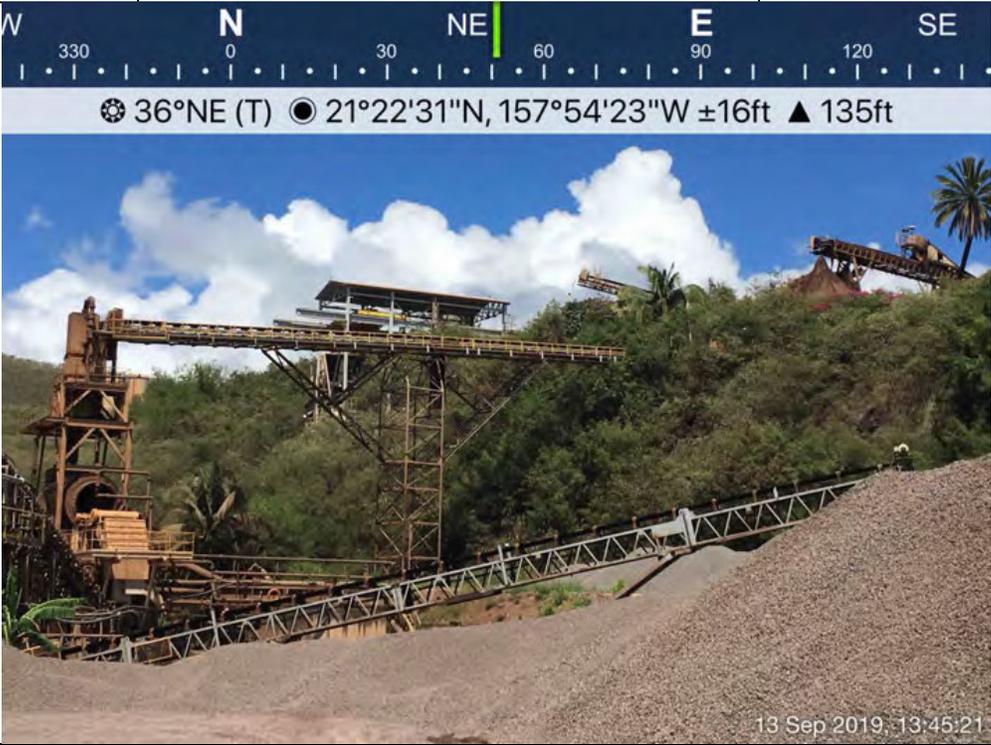
<b>Photo No.</b> <b>13</b>	<b>Date:</b> 09/13/2019
-------------------------------	----------------------------

**Description:**  
Base course to be used for the project was in-situ field tested for heavy metals using an Olympus Delta Professional x-ray fluorescence(XRF) spectrometer. Five point composite samples were collected and submitted to an analytical laboratory for analysis.

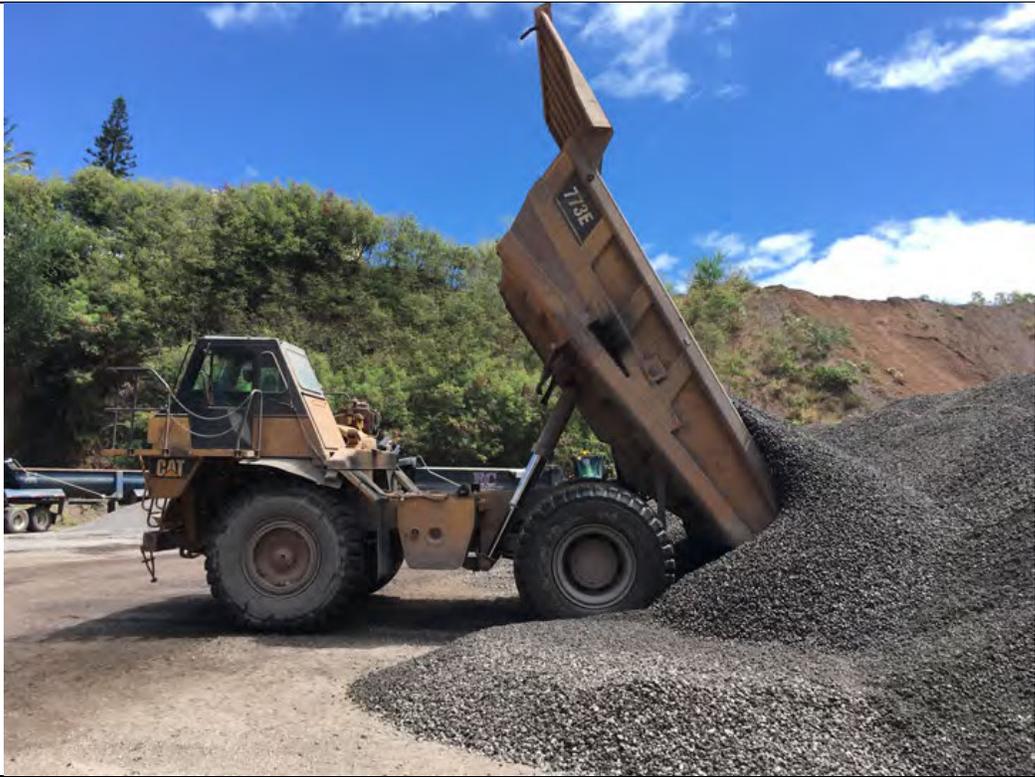
<b>Photo No.</b> <b>14</b>	<b>Date:</b> 09/13/2019
-------------------------------	----------------------------

**Description:**  
Base course being stockpiled at Halawa Valley Quarry.

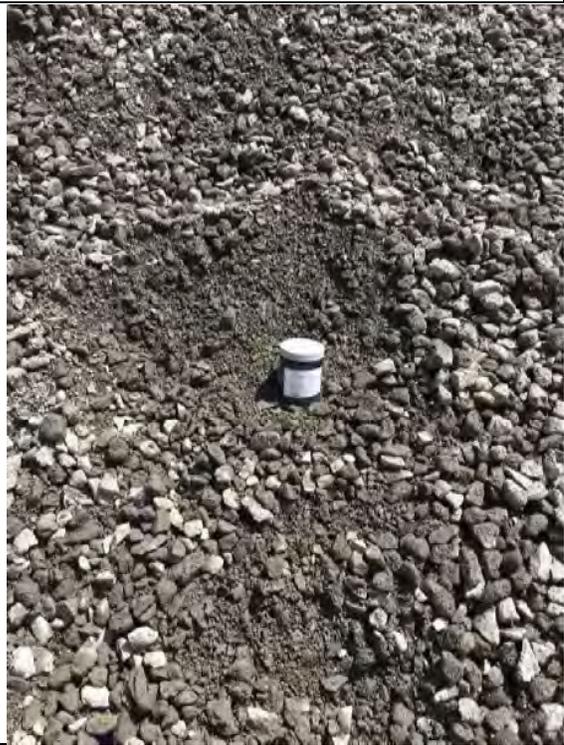
**Description:**  
A total of seven (7) five-point composite samples of base course were collected at Halawa Valley Quarry.

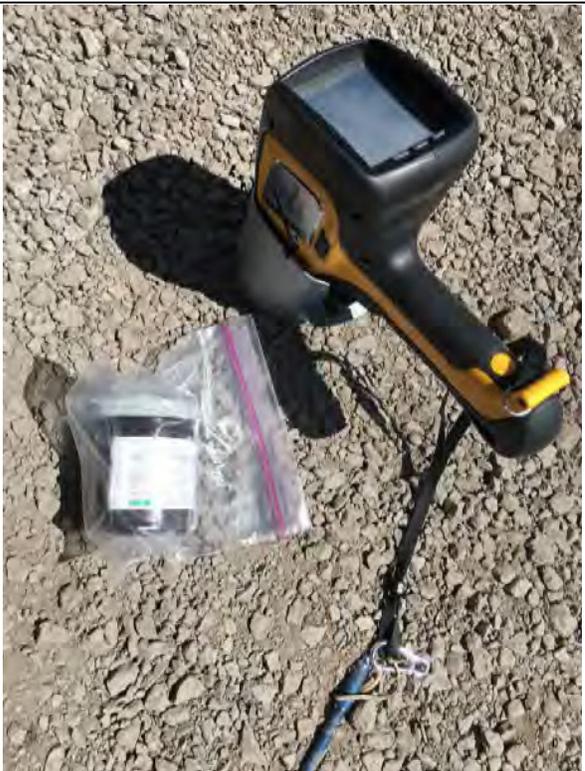
<b>Photo No.</b> <b>22</b>	<b>Date:</b> 09/13/2019
-------------------------------	----------------------------

**Description:**  
Glass jars containing base course were bagged with the same Ziploc used to field screen that particular sample to protect the sample and label during shipment.

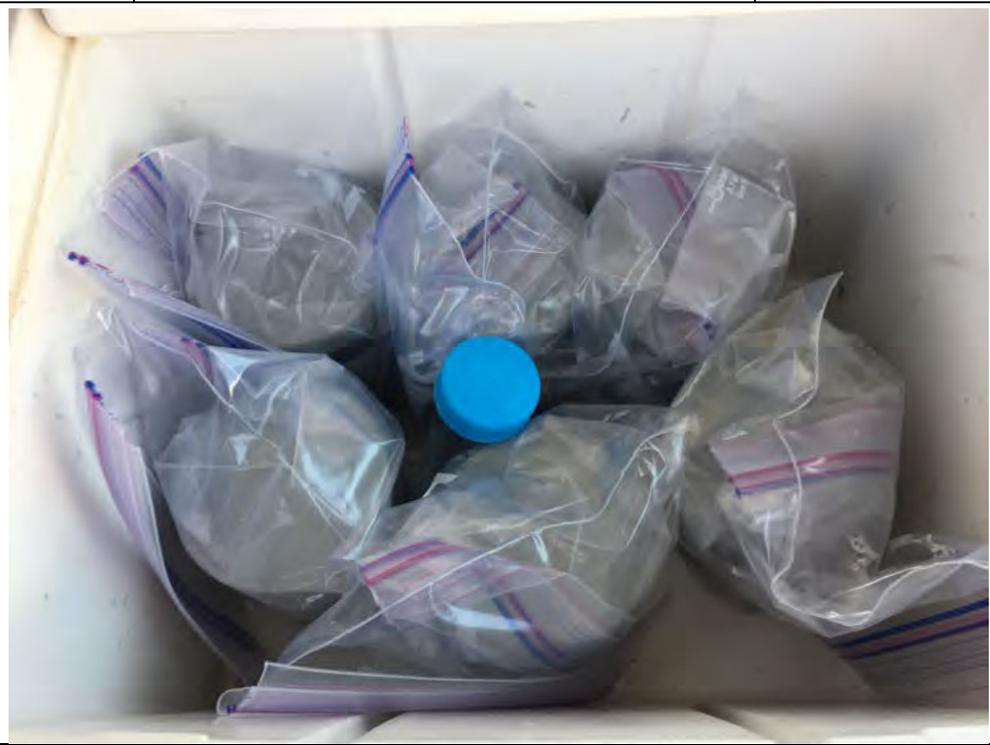
**Photo No. 23**      **Date:** 09/13/2019

**Description:**  
Composite samples were double bagged and place inside a cooler and shipped to laboratory for analysis under chain-of-custody control.

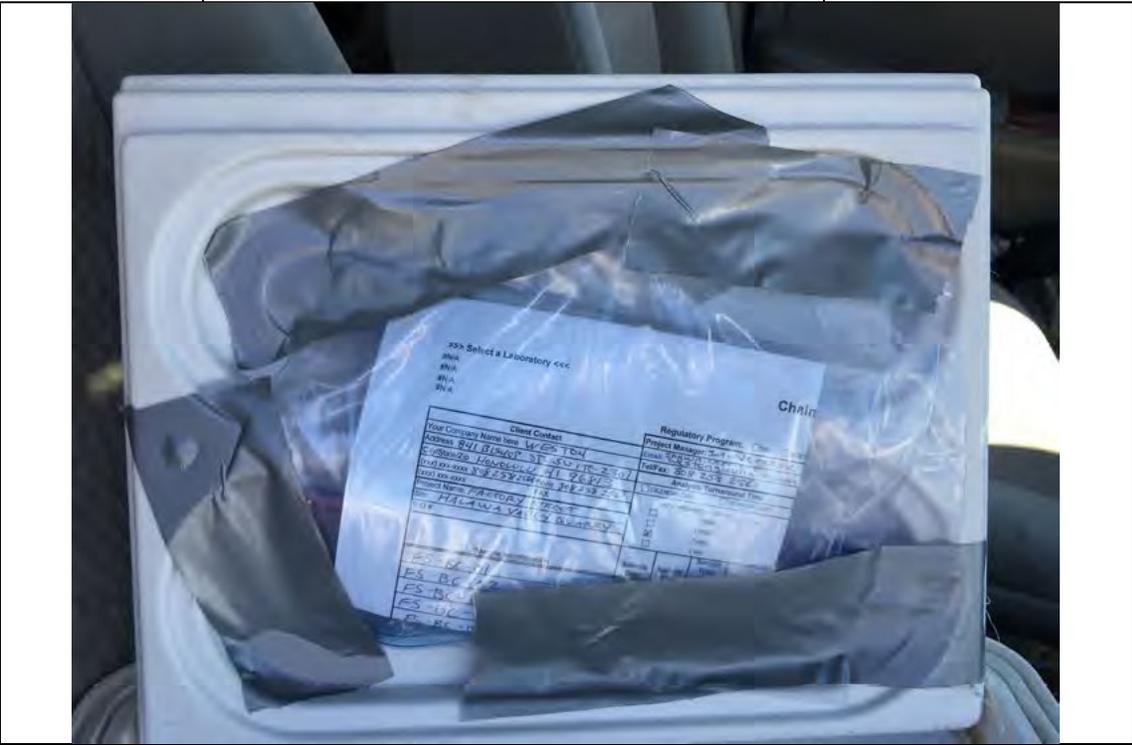
**Description:**  
 Chain-of-custody record taped to the underside of the cooler lid.

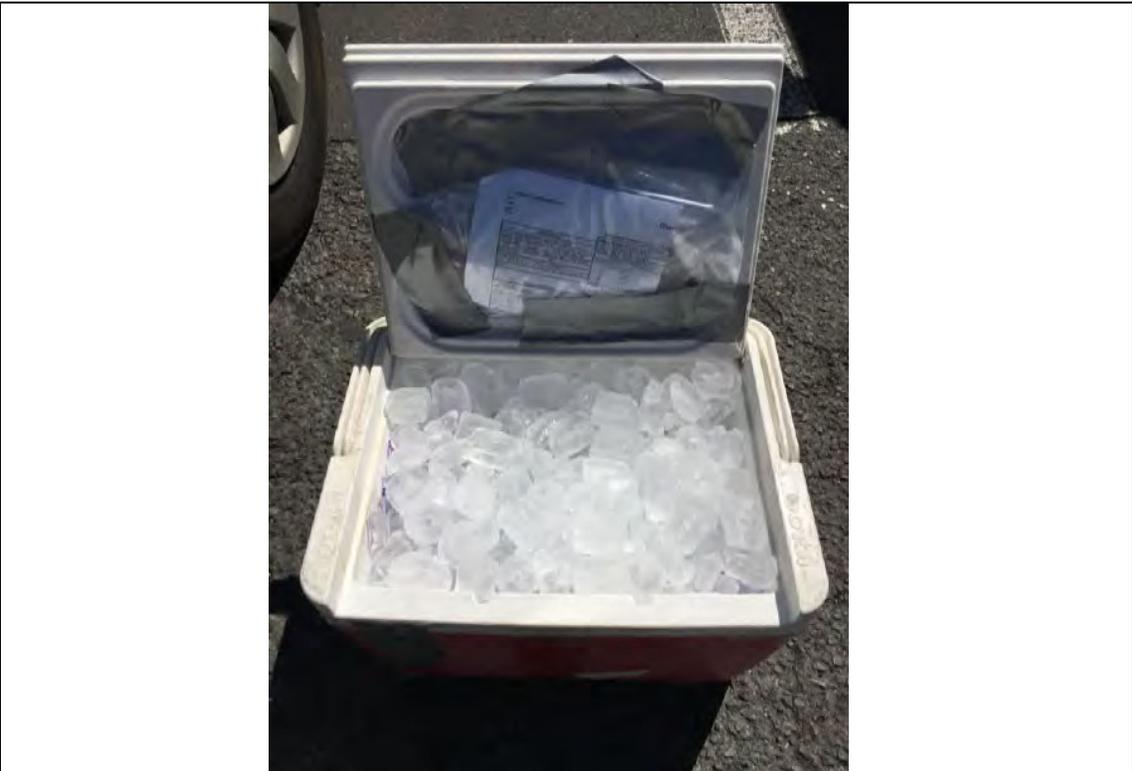
<b>Photo No.</b> <b>26</b>	<b>Date:</b> 09/13/2019
-------------------------------	----------------------------

**Description:**  
 Composite samples placed in a cooler on ice for shipment to laboratory under chain-of-custody control.

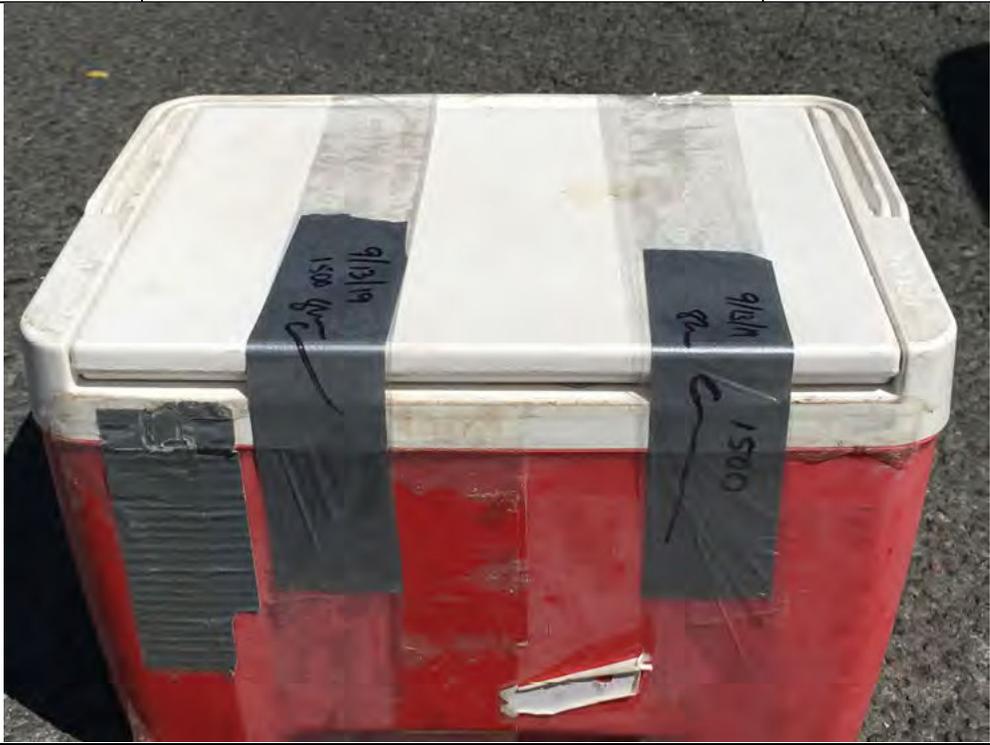
<b>Photo No.</b> <b>27</b>	<b>Date:</b> 09/13/2019
-------------------------------	----------------------------

**Description:**  
 Cooler containing composite samples of base course packed and ready for shipment to laboratory under chain-of-custody control.

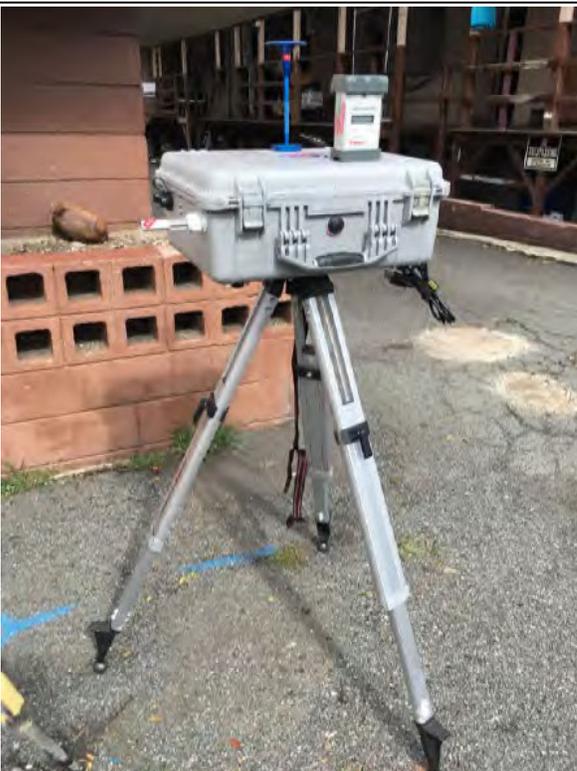
<b>Photo No.</b> <b>28</b>	<b>Date:</b> 01/17/2020
-------------------------------	----------------------------

**Description:**  
 Background air monitoring was conducted prior to the commencement of intrusive activities to provide a baseline.

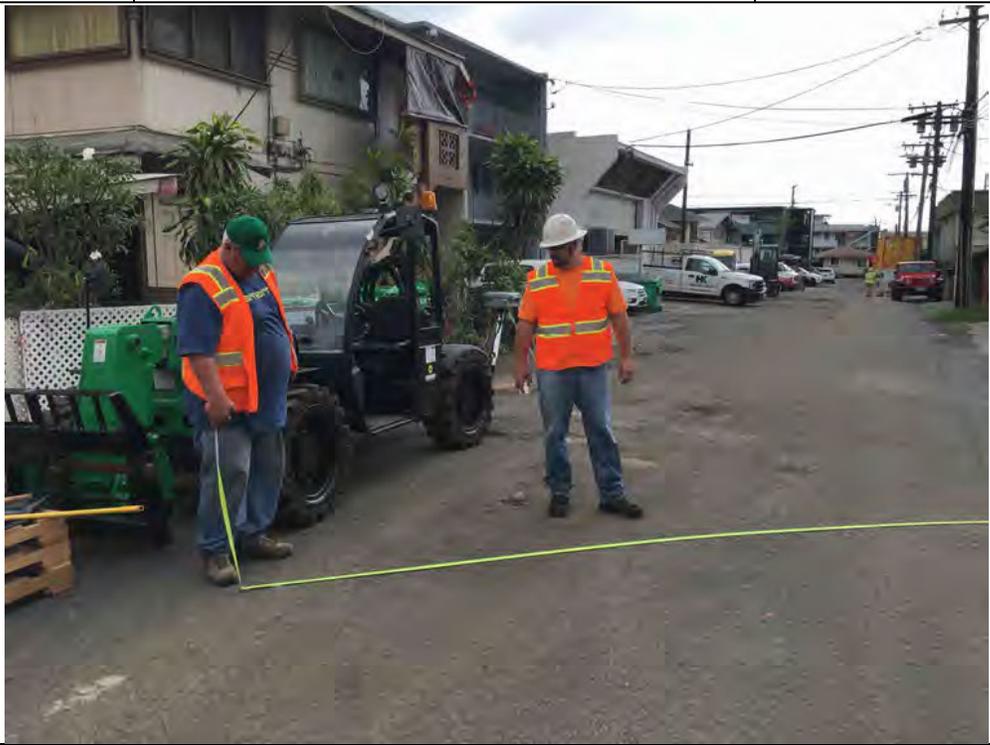
<b>Photo No.</b> <b>31</b>	<b>Date:</b> 01/20/2020
-------------------------------	----------------------------

**Description:**  
 Important features of the Project Area are measured prior to marking with paint.

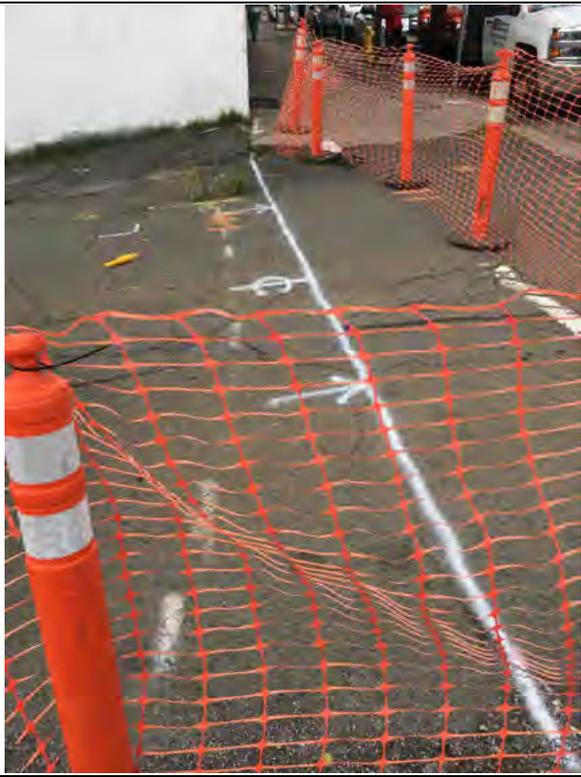
<b>Photo No.</b> <b>32</b>	<b>Date:</b> 01/20/2020
-------------------------------	----------------------------

**Description:**  
 The Project Area boundary of Factory Street at North King Street is marked with white paint.

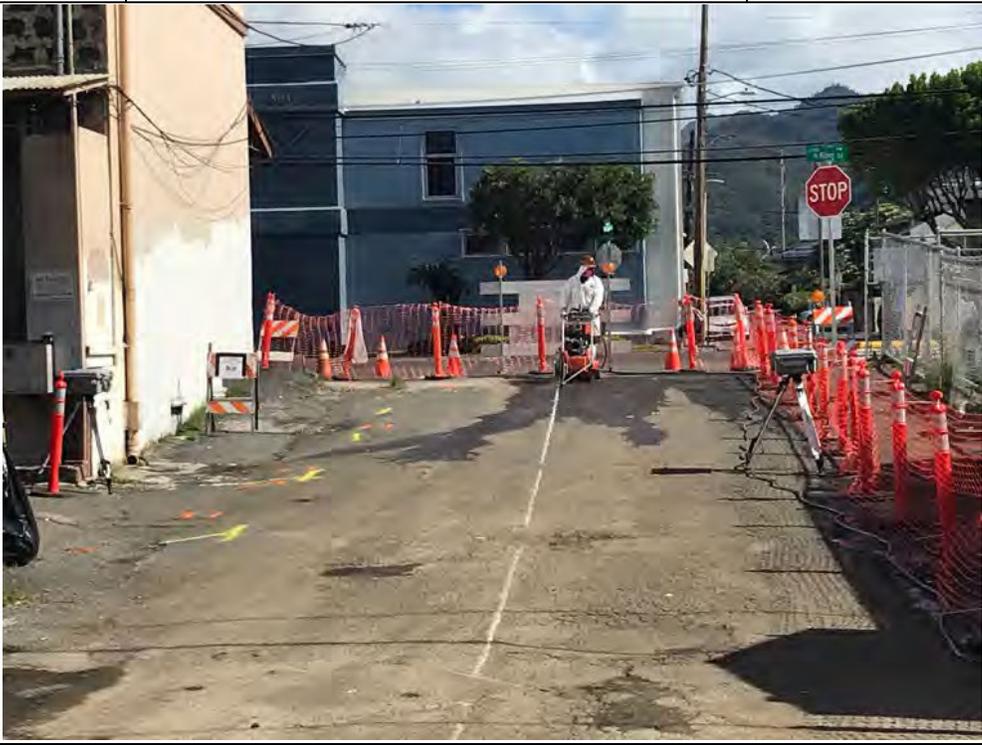
<b>Photo No.</b> <b>33</b>	<b>Date:</b> 01/20/2020
-------------------------------	----------------------------

**Description:**  
A walk behind concrete cutter saw is used to cut the road.

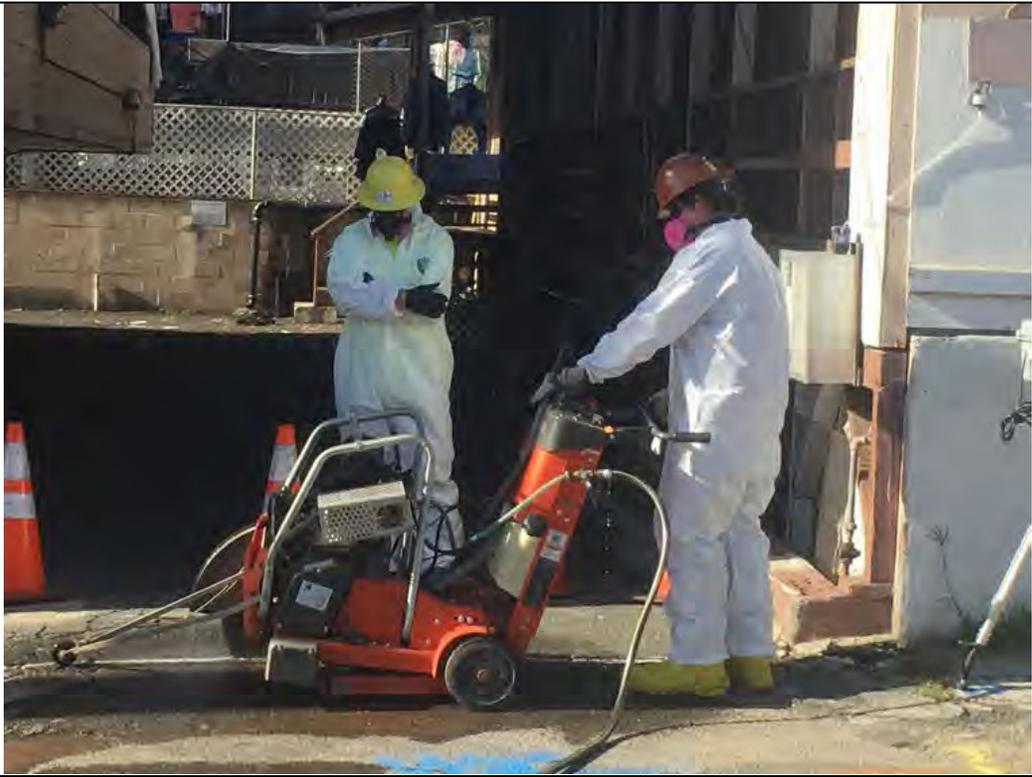
<b>Photo No.</b> <b>34</b>	<b>Date:</b> 01/20/2020
-------------------------------	----------------------------

**Description:**  
The concrete cutter saw is used to make cuts along the boundaries of the Project Area.

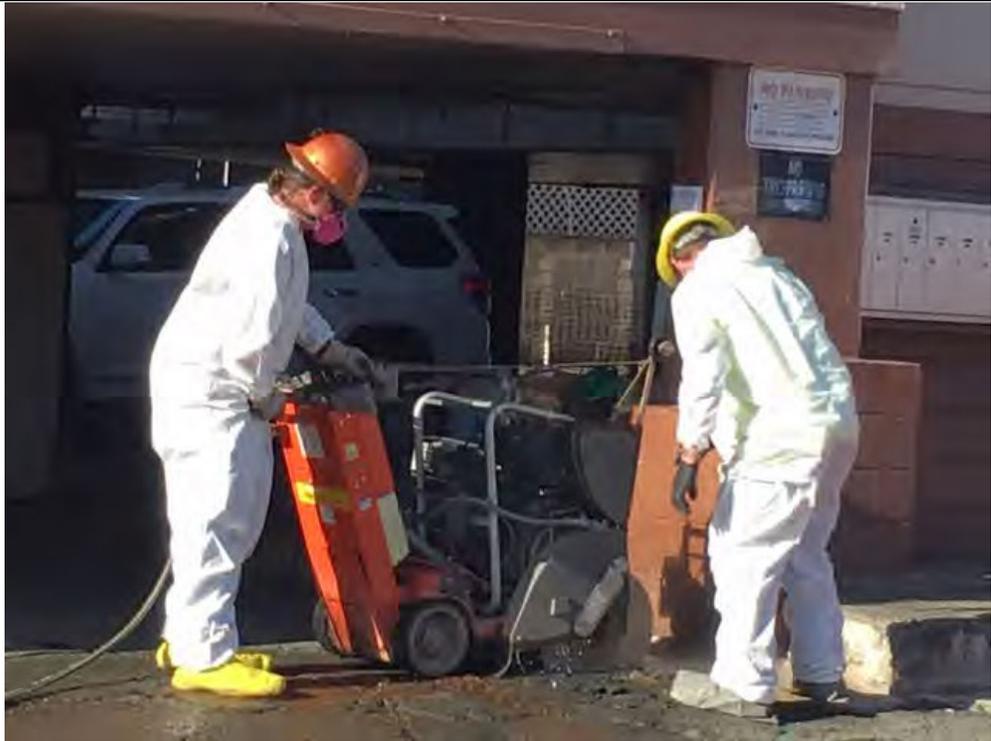
<b>Photo No.</b> <b>35</b>	<b>Date:</b> 01/22/2020
-------------------------------	----------------------------

**Description:**  
The concrete cutter saw is used to cut a boundary of the Factory Street Project Area.

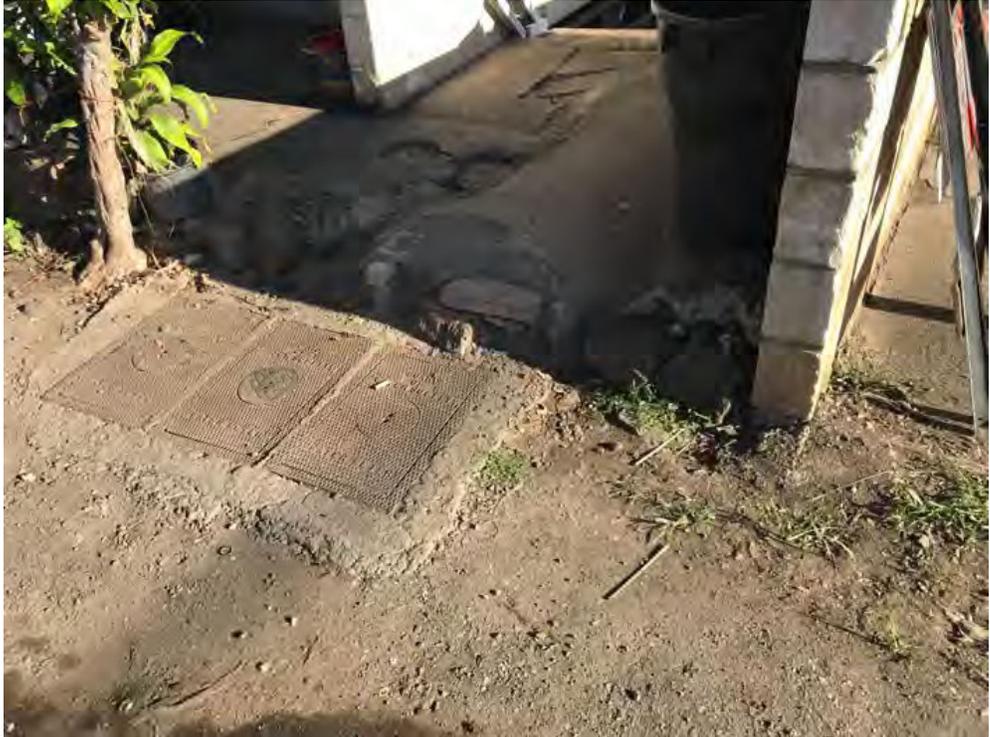
**Description:**  
Other important street features such as meter boxes were also photo documented prior to the commencement of intrusive operations.

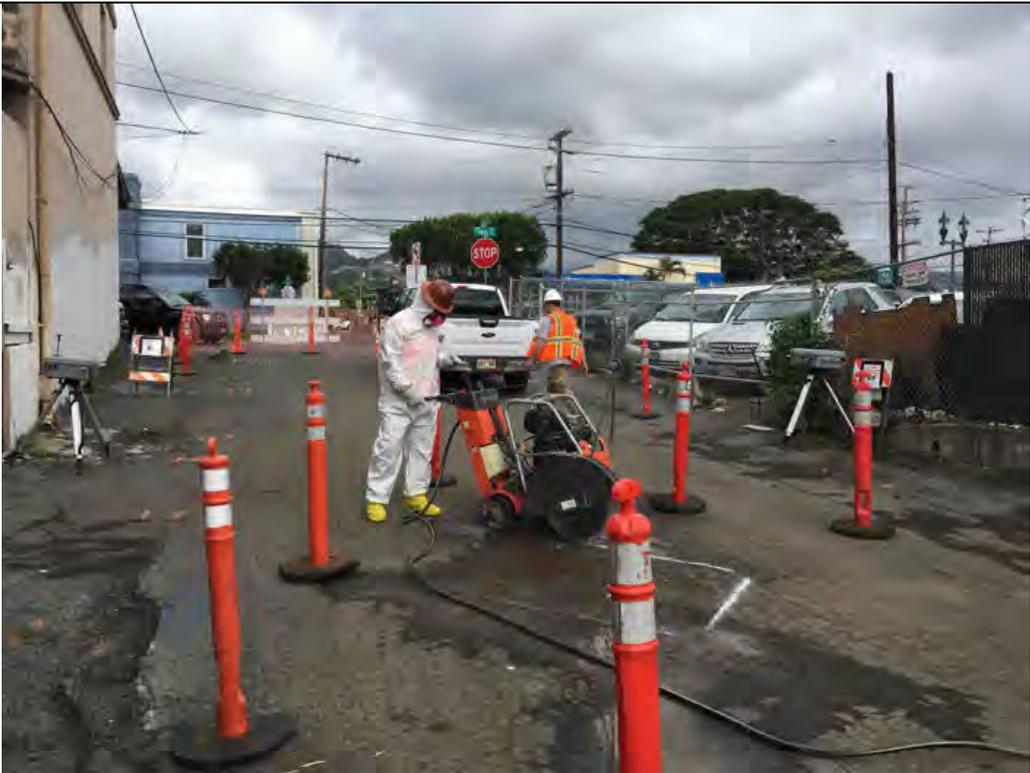
**Description:**  
Temporary anchor foundations to brace utility poles are cut with a concrete cutter saw.

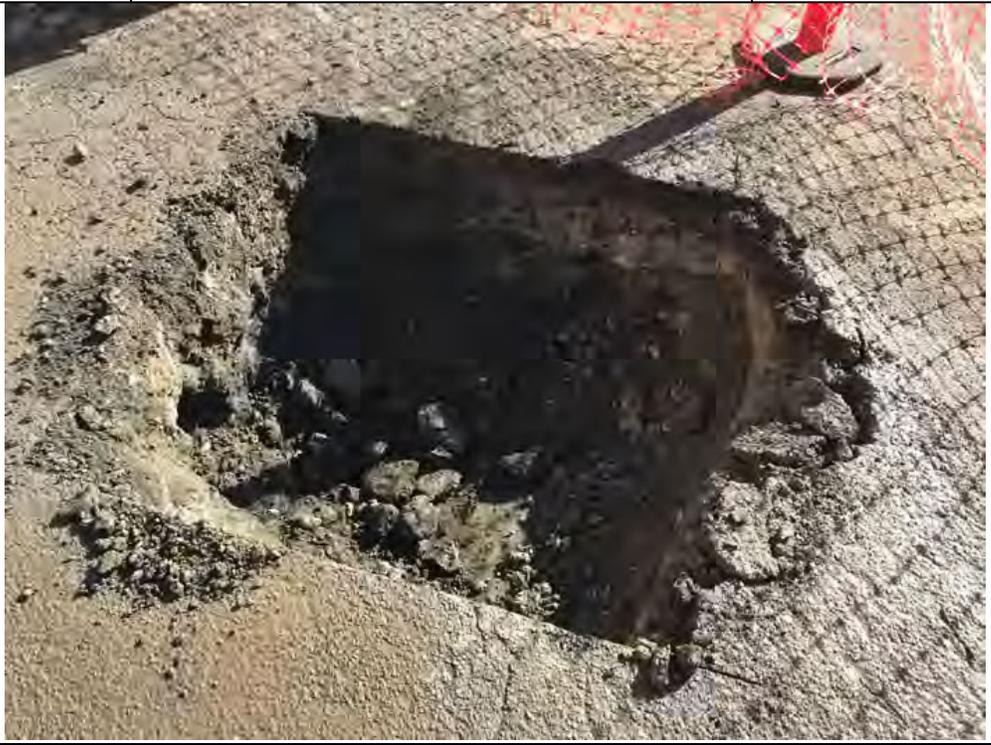
**Description:**  
 Utility pole shoring anchor excavation.

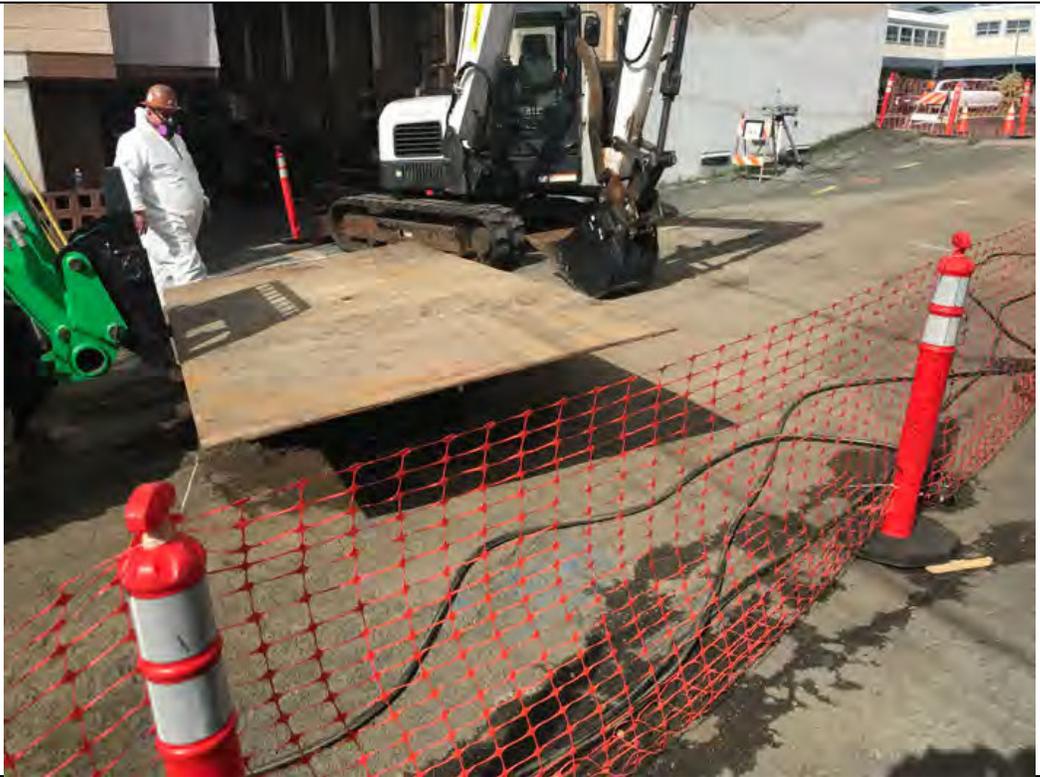
<b>Photo No.</b> <b>44</b>	<b>Date:</b> 01/23/2020
-------------------------------	----------------------------

**Description:**  
 Metal plates were used to cover utility pole shoring anchor excavations.
