# **FACTORY STREET LEAD SITE TIME-CRITICAL REMOVAL ACTION REPORT**

**Factory Street Lead Site Removal Action  
Honolulu, Honolulu County, Hawaii**

**Prepared for:  
U.S. Environmental Protection Agency  
Region 9, Emergency Response Section**

**December 2020**

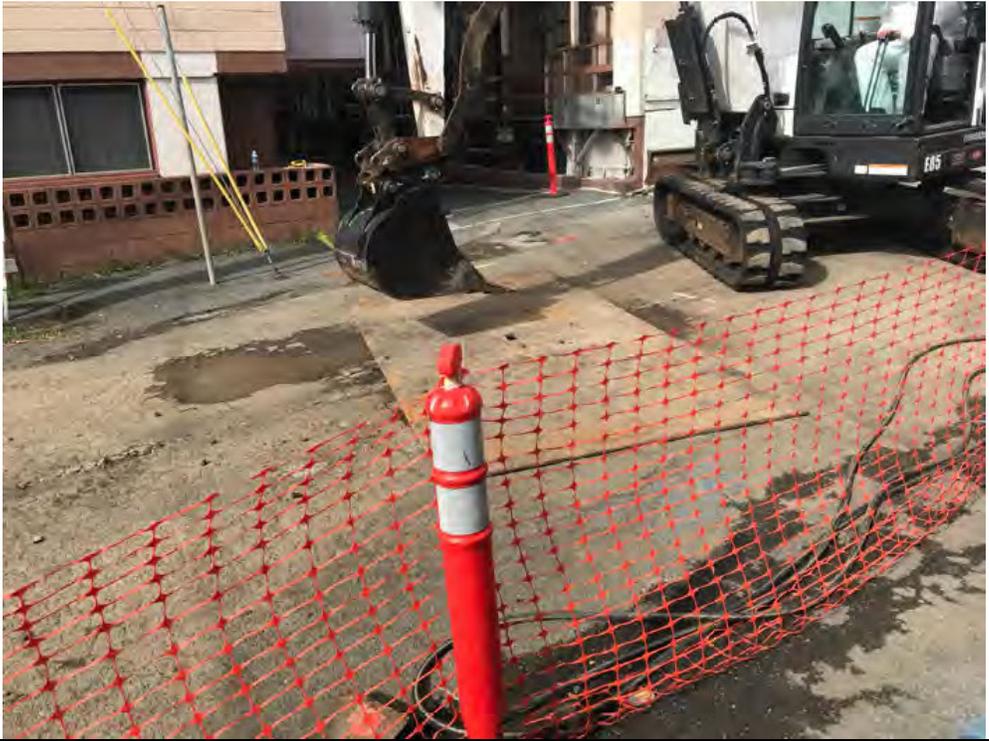
<b>Photo No.</b> <b>45</b>	<b>Date:</b> 01/23/2020
-------------------------------	----------------------------

**Description:**  
Metal plates were used to cover excavated utility pole shorings until cement could be poured.

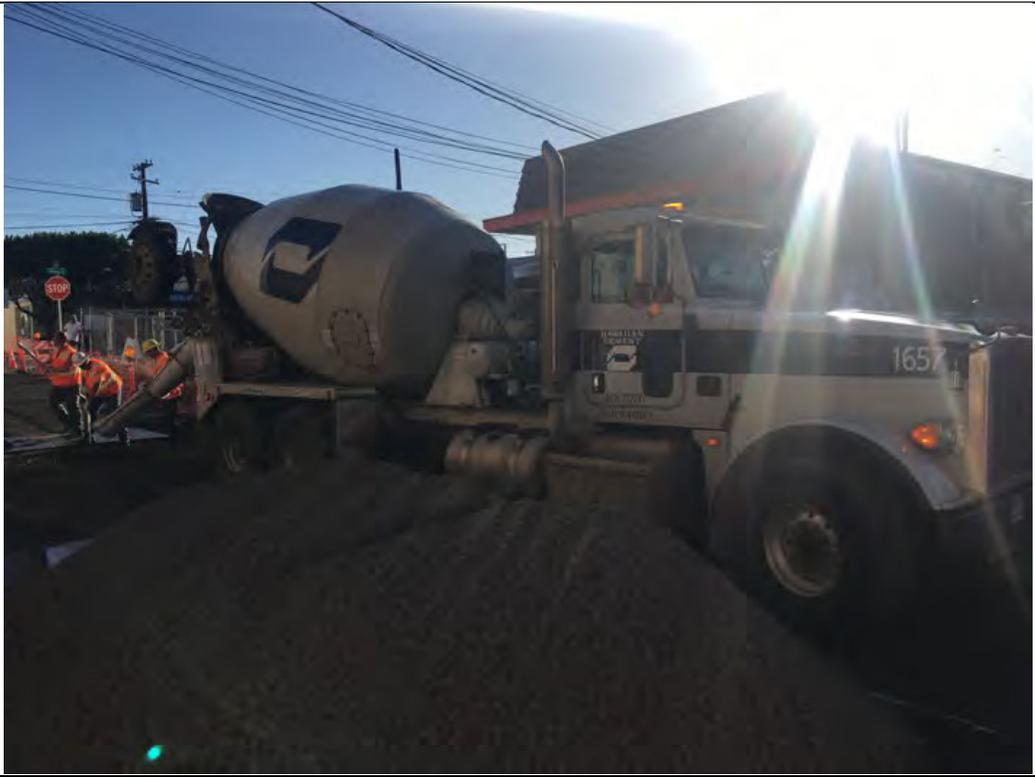
<b>Photo No.</b> <b>46</b>	<b>Date:</b> 01/23/2020
-------------------------------	----------------------------

**Description:**  
Hawaiian cement truck arrives on-site to pour cement for utility pole shoring anchors.

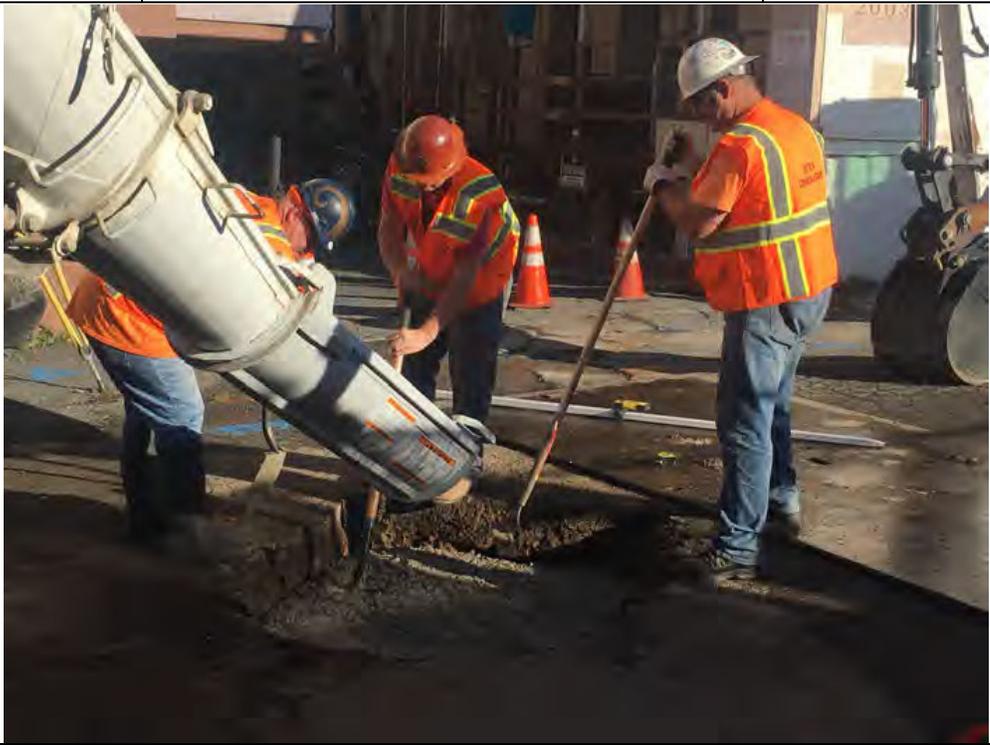
<b>Photo No.</b> <b>47</b>	<b>Date:</b> 01/23/2020
-------------------------------	----------------------------

**Description:**  
Utility pole shoring anchor excavations are filled with cement.

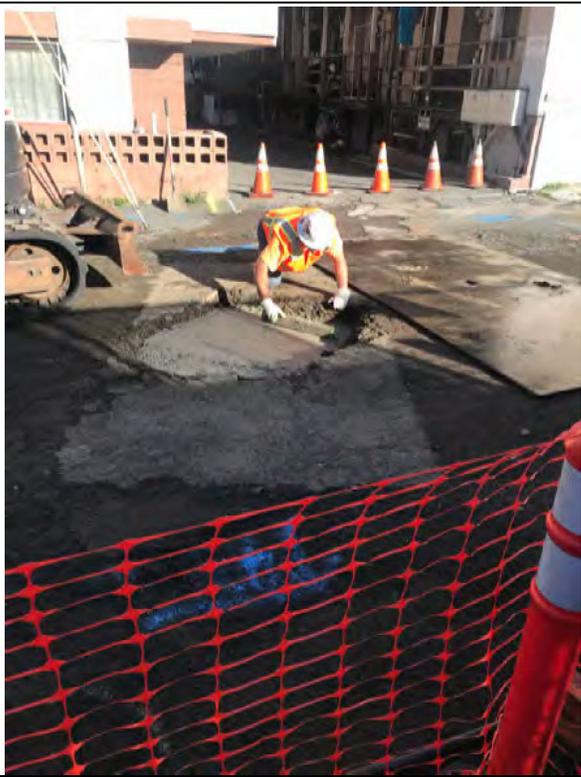
<b>Photo No.</b> <b>48</b>	<b>Date:</b> 01/23/2020
-------------------------------	----------------------------

**Description:**  
Utility pole shoring anchor cement is smoothed prior to curing.

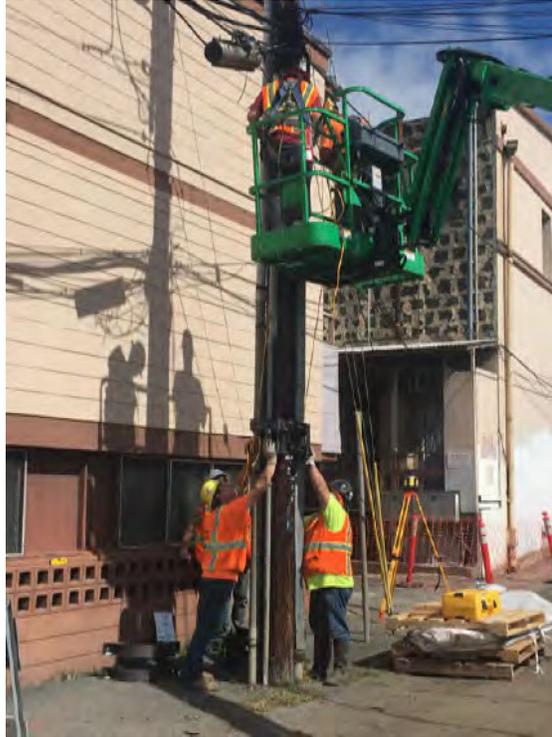
<b>Photo No.</b>	<b>Date:</b>
<b>49</b>	01/28/2020

**Description:**  
Pole shoring collar being affixed to utility pole.

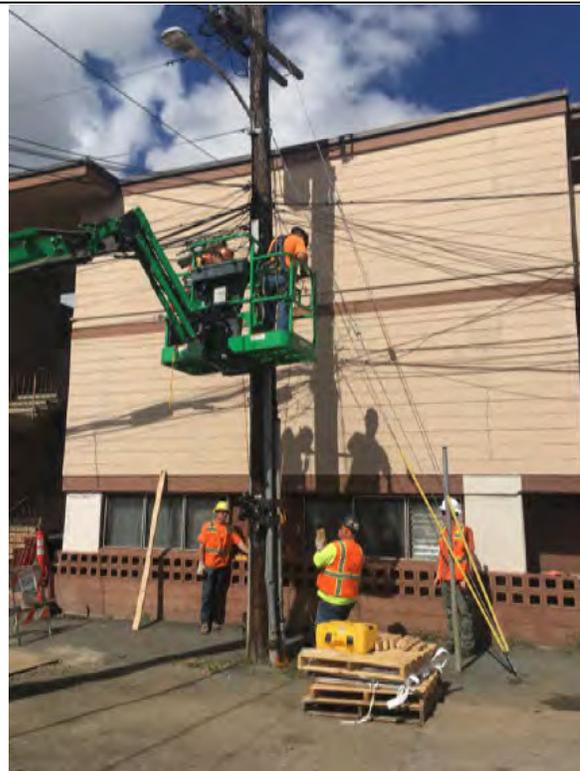
<b>Photo No.</b>	<b>Date:</b>
<b>50</b>	01/28/2020

**Description:**  
Utility pole shoring operations.

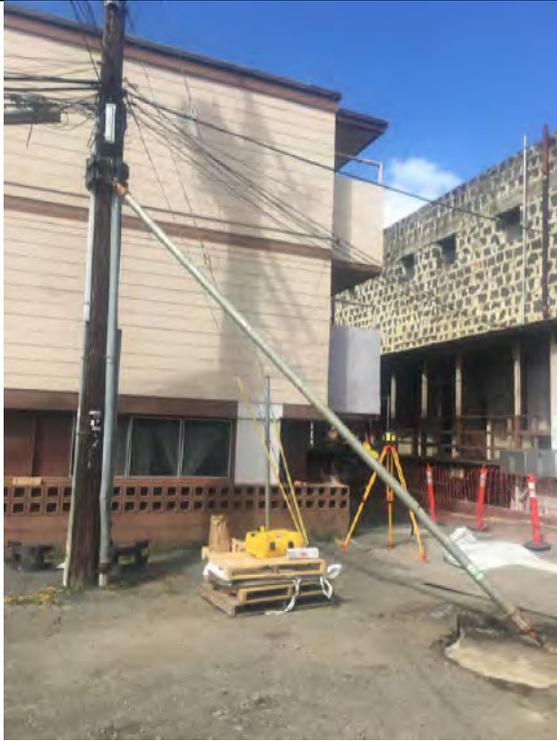
<b>Photo No.</b> <b>51</b>	<b>Date:</b> 01/28/2020
-------------------------------	----------------------------

**Description:**  
 Pole brace affixed to utility pole.

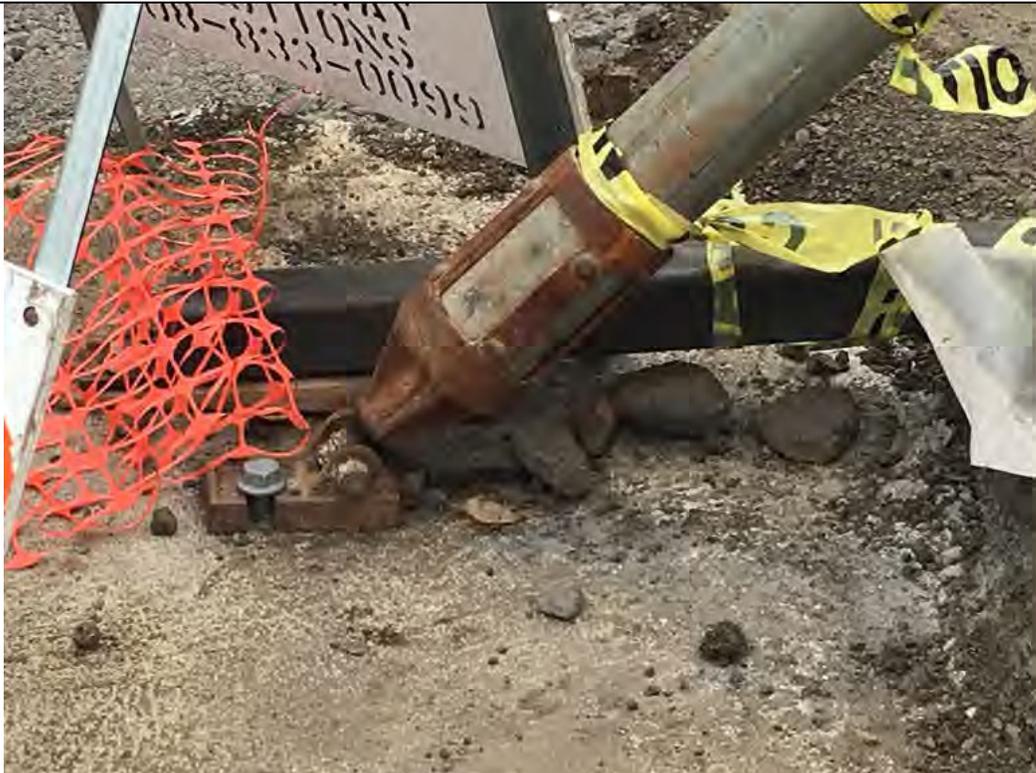
<b>Photo No.</b> <b>52</b>	<b>Date:</b> 01/31/2020
-------------------------------	----------------------------

**Description:**  
 Utility pole brace anchored to cement.

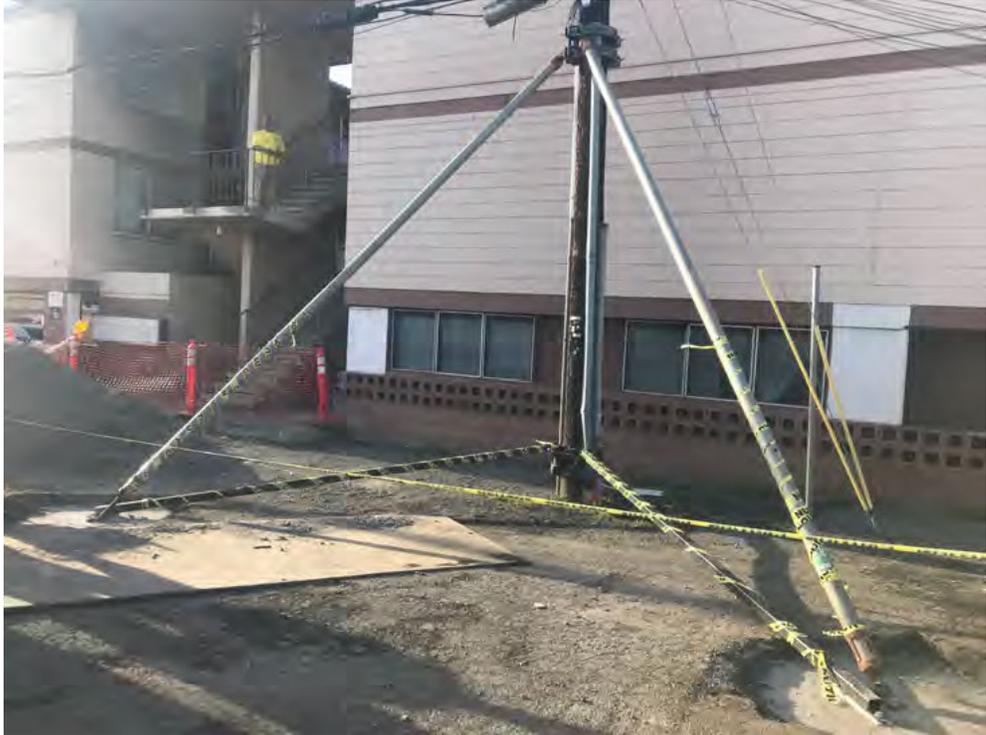
<b>Photo No.</b> <b>53</b>	<b>Date:</b> 01/31/2020
-------------------------------	----------------------------

**Description:**  
Utility pole shoring system.

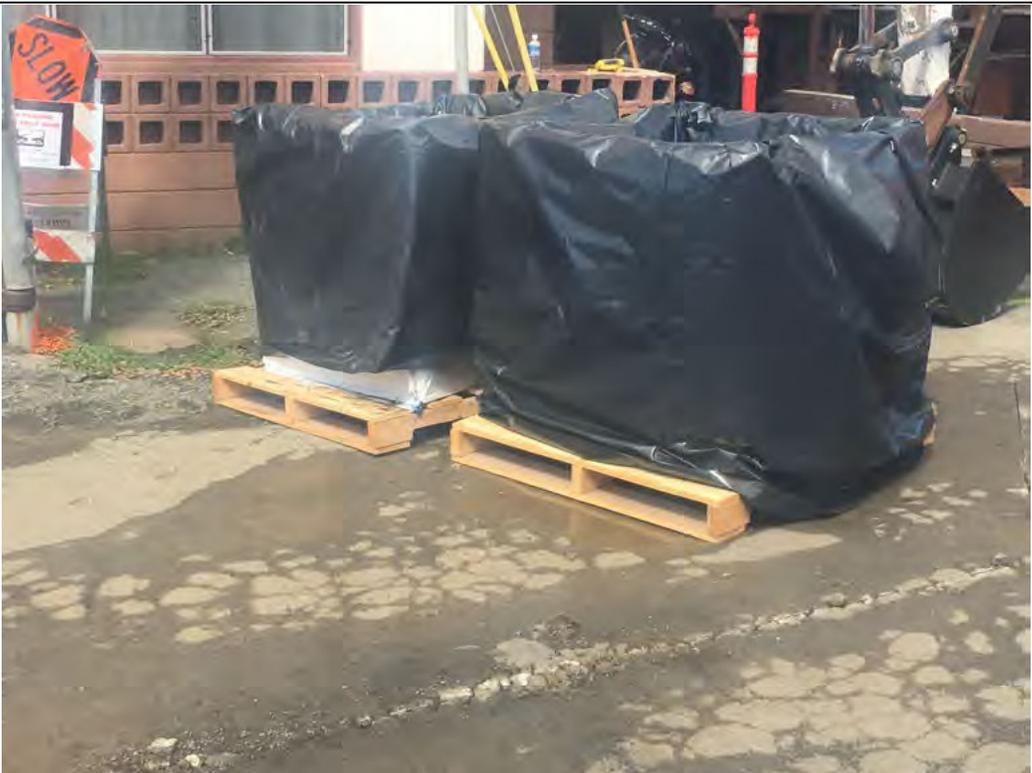
**Description:**  
Material from excavated utility pole shoring anchors was transferred to lined cubic yard boxes and was disposed of as either non-hazardous or hazardous waste dependent upon its origin.

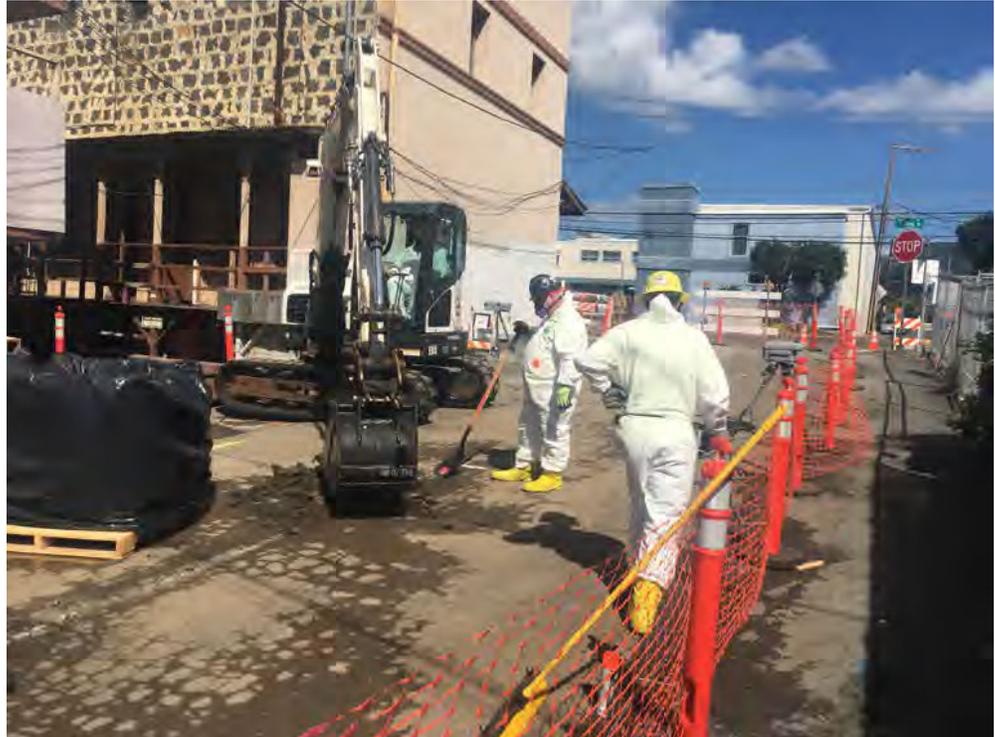
**Description:**  
Excavated soil from utility pole shoring anchors was containerized in lined cubic yard boxes.

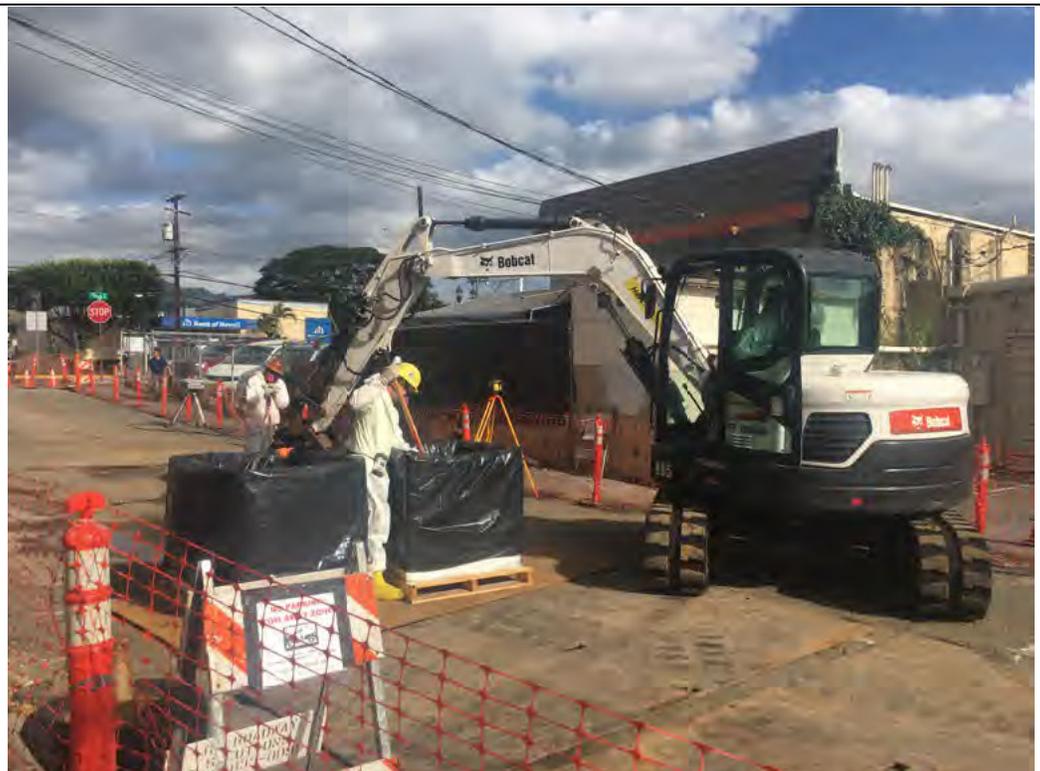
**Photo No.**  
**56**

**Description:**  
Excavated materials from utility pole excavation being containerized.

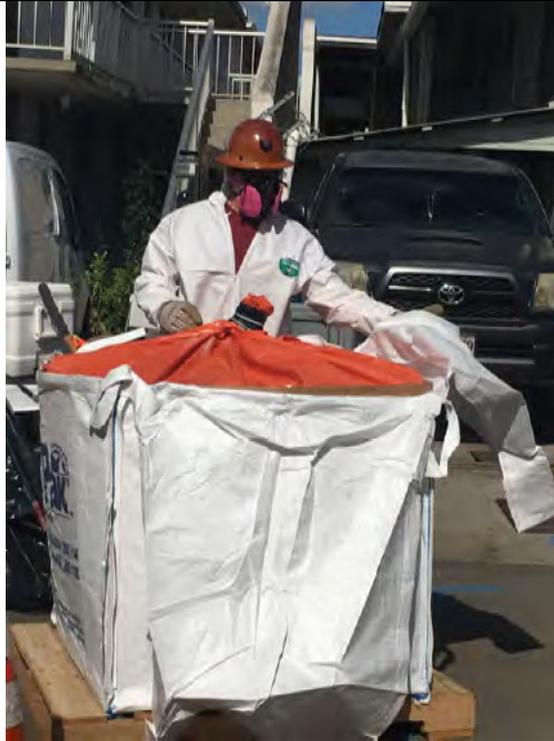
<b>Photo No.</b> <b>57</b>	<b>Date:</b> 01/22/2020
-------------------------------	----------------------------

**Description:**  
 Containerized soil excavated from the Project Area.

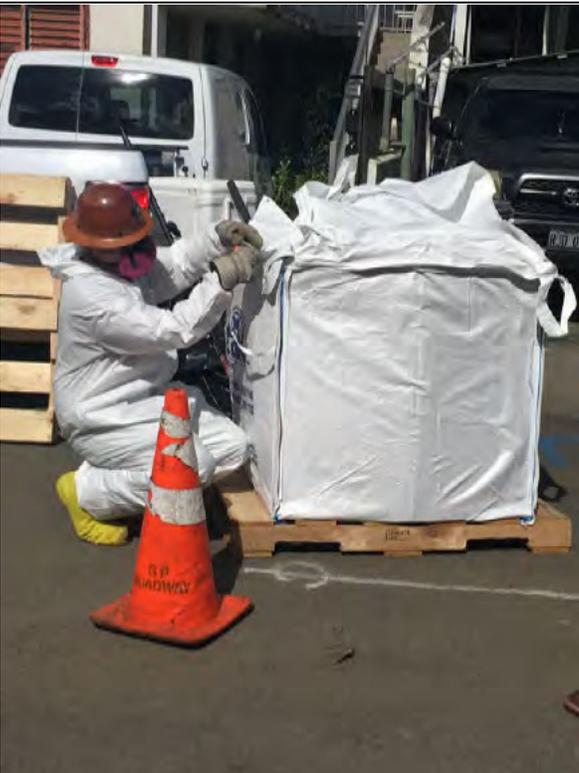
<b>Photo No.</b> <b>58</b>	<b>Date:</b> 01/22/2020
-------------------------------	----------------------------

**Description:**  
 Containerized soil is marked based on container number and whether the soil is hazardous waste or non-hazardous waste.

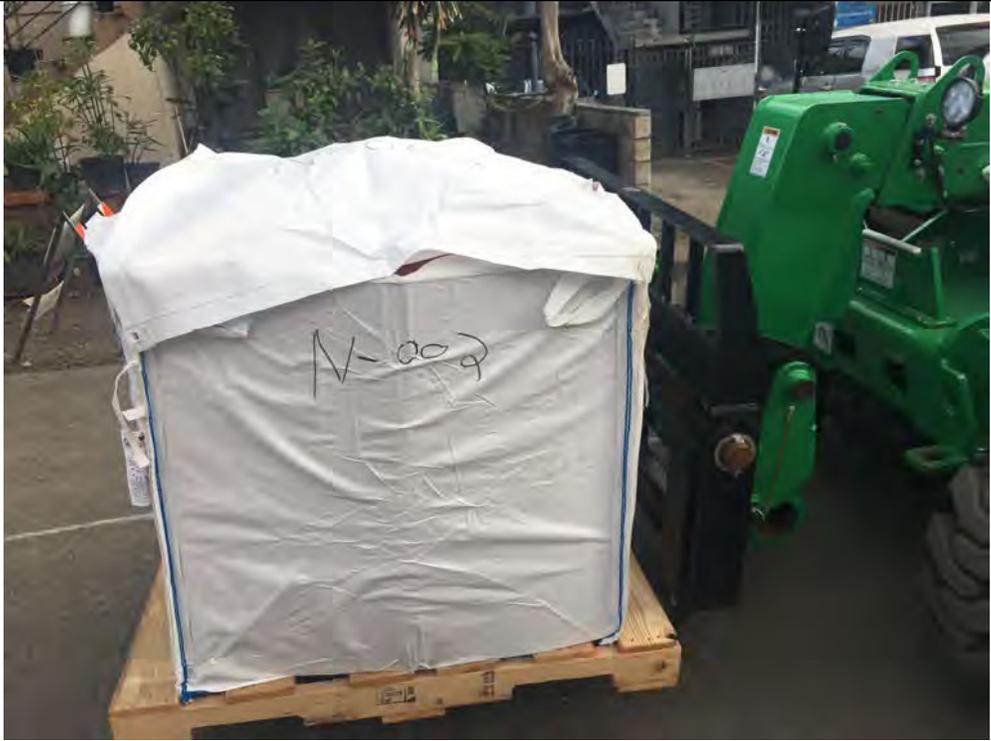
<b>Photo No.</b> <b>59</b>	<b>Date:</b> 01/21/2020
-------------------------------	----------------------------

**Description:**  
 The second lined cubic yard box containing non-hazardous waste soil ID N-002.

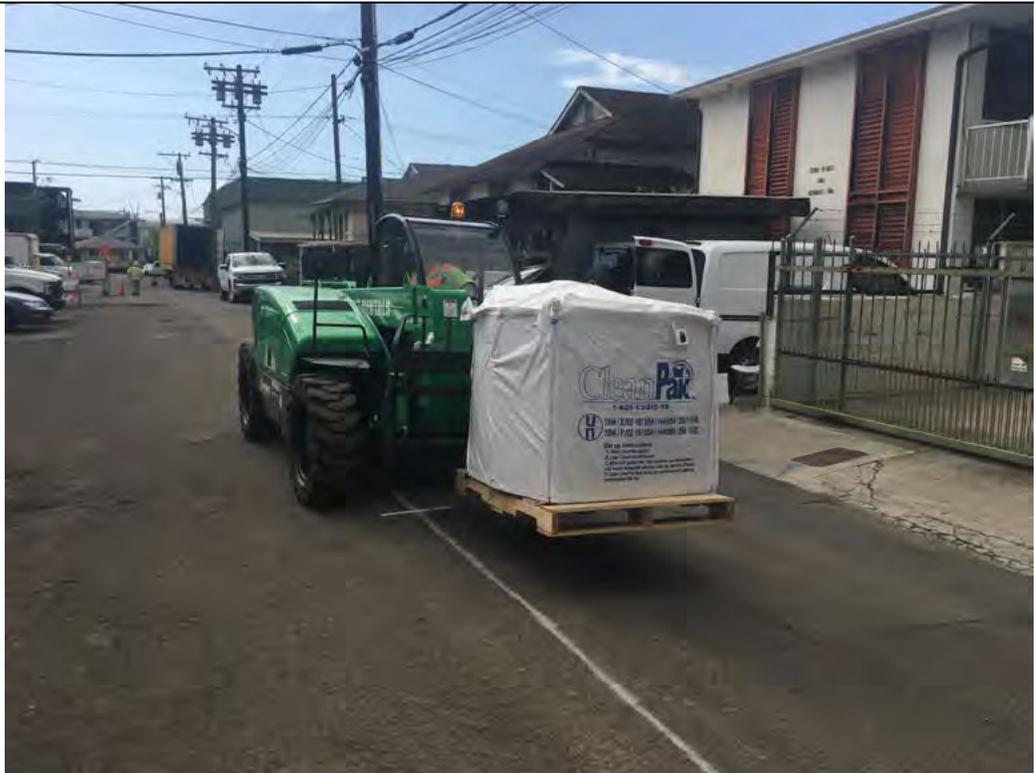
<b>Photo No.</b> <b>60</b>	<b>Date:</b> 01/21/2020
-------------------------------	----------------------------

**Description:**  
 Containerized non-hazardous waste soil from the Project Area being transported to the flatbed truck.

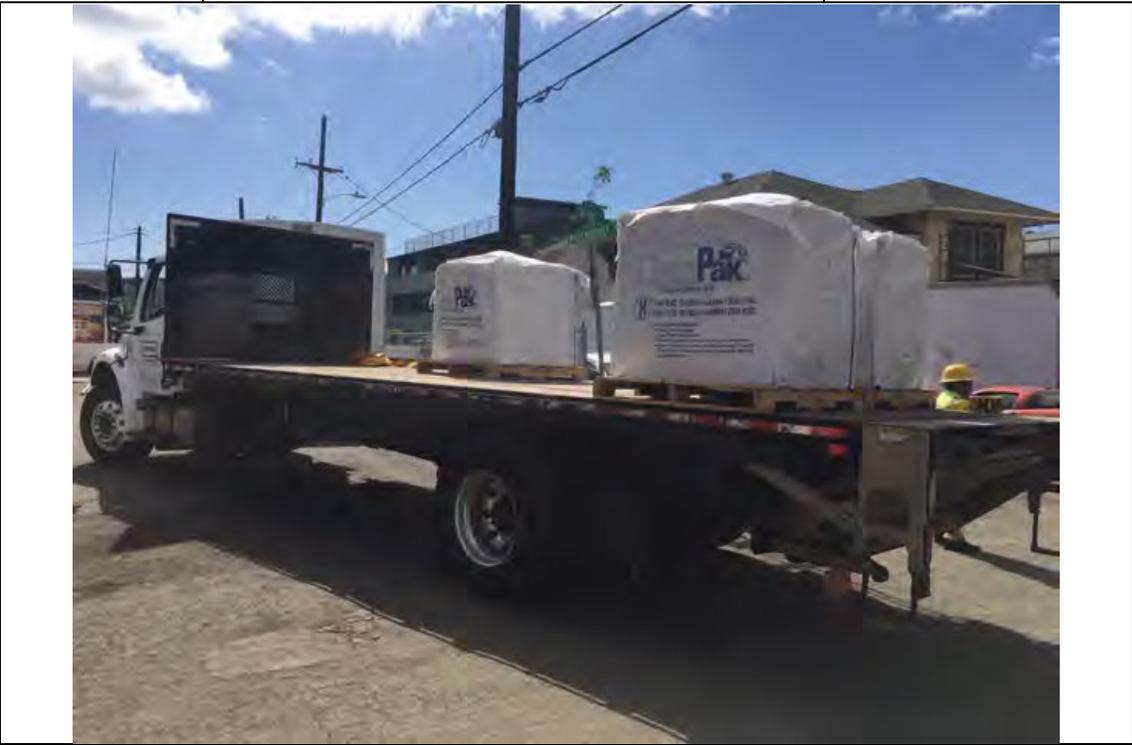
<b>Photo No.</b> <b>61</b>	<b>Date:</b> 01/22/2020
-------------------------------	----------------------------

**Description:**  
Non-hazardous waste soil is transported by flat bed truck to the HDOA lay down yard and transferred to shipping containers for shipment to its disposal facility.

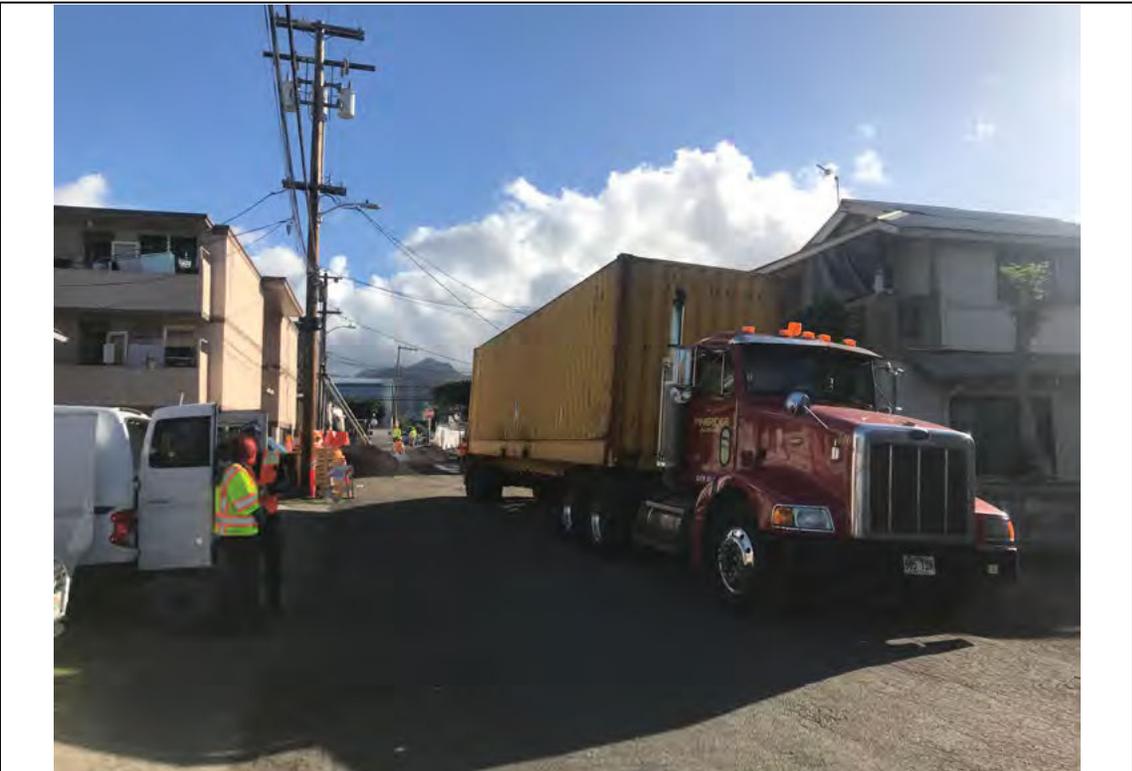
<b>Photo No.</b> <b>62</b>	<b>Date:</b> 02/06/2020
-------------------------------	----------------------------

**Description:**  
Shipping container being delivered to the Site where hazardous waste soil excavated from DU-6 of the Project Area will be staged prior to being shipped to a hazardous waste disposal facility.

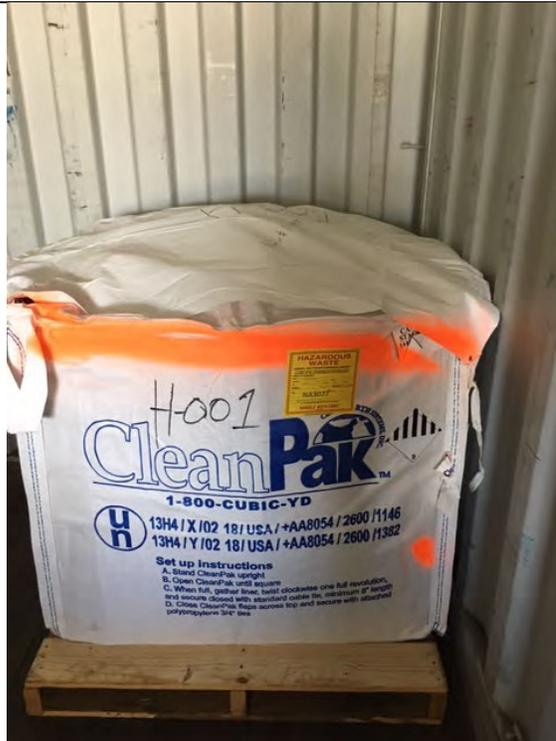
<b>Photo No.</b> <b>63</b>	<b>Date:</b> 01/22/2020
-------------------------------	----------------------------

**Description:**  
 Hazardous waste soil is staged on-site in a secured shipping container until full. Once full the shipping container is transported to a hazardous waste disposal facility.

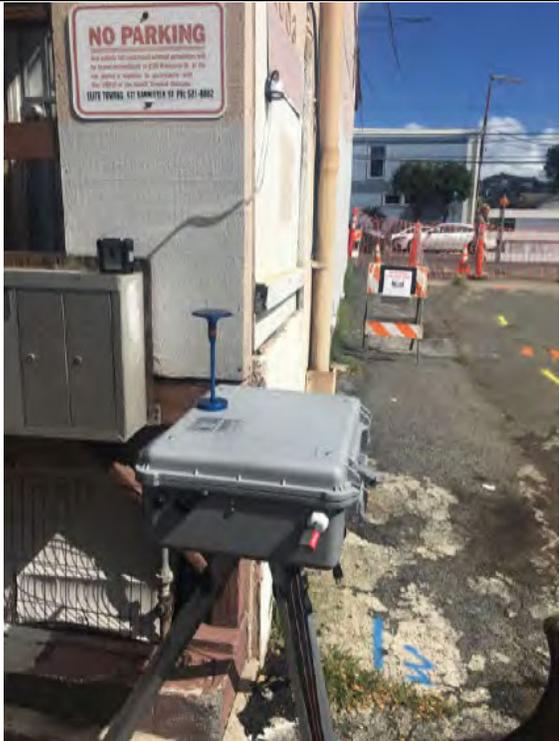
**Description:**  
 An air monitoring station containing a TSI DustTrak aerosol monitor and an SKC AirChek Touch air sampling pump.

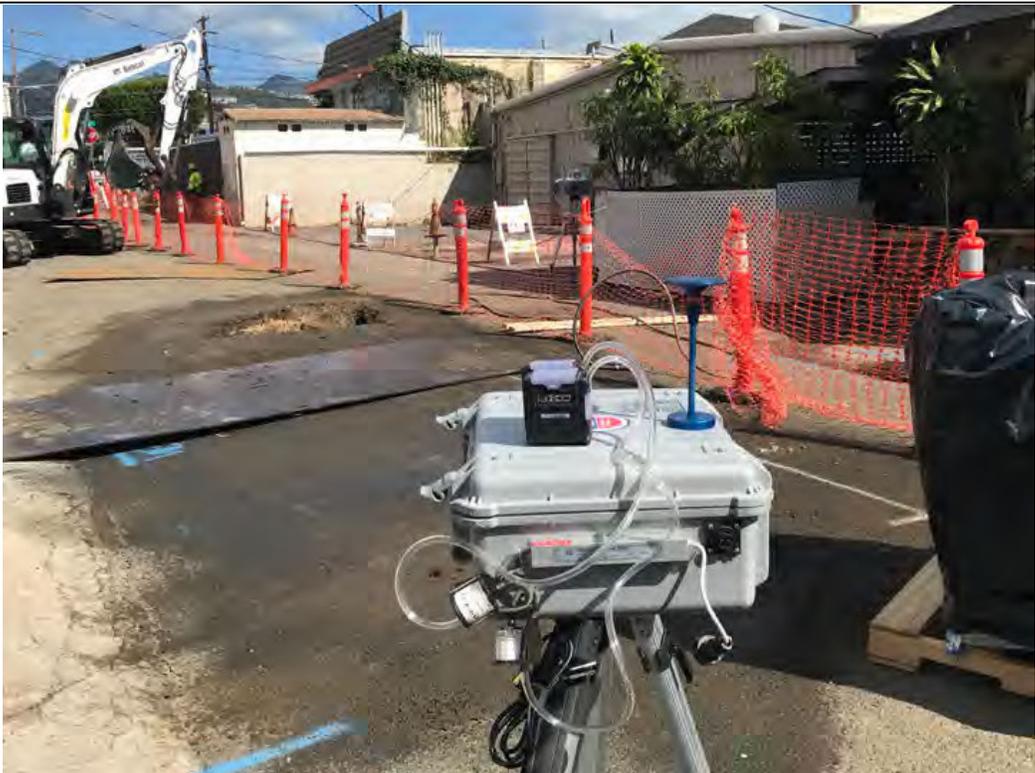
<b>Photo No.</b> <b>68</b>	<b>Date:</b> 01/23/2020
-------------------------------	----------------------------

**Description:**  
 A second air monitoring station containing a TSI DustTrak aerosol monitor and an SKC AirChek Touch air sampling pump.

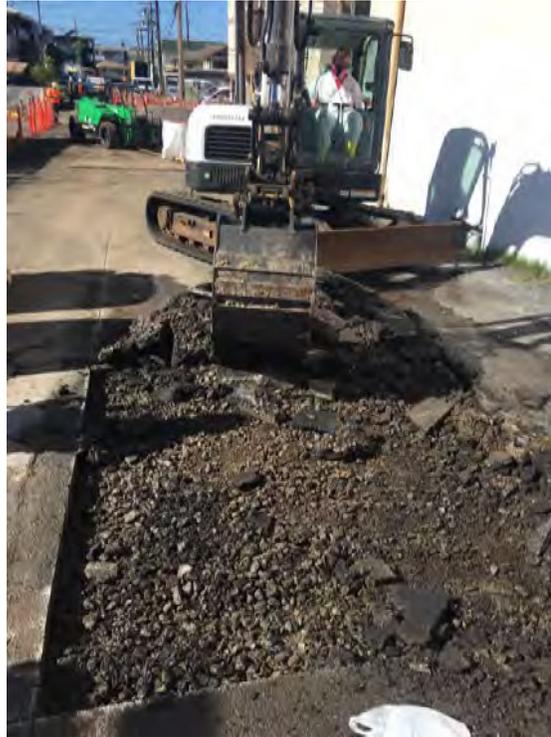
<b>Photo No.</b> <b>69</b>	<b>Date:</b> 01/23/2020
<b>Direction Photo Taken:</b> West	
<b>Description:</b>  The excavator removing the asphalt covering in DU-6, the DU with the highest lead in soil concentration.

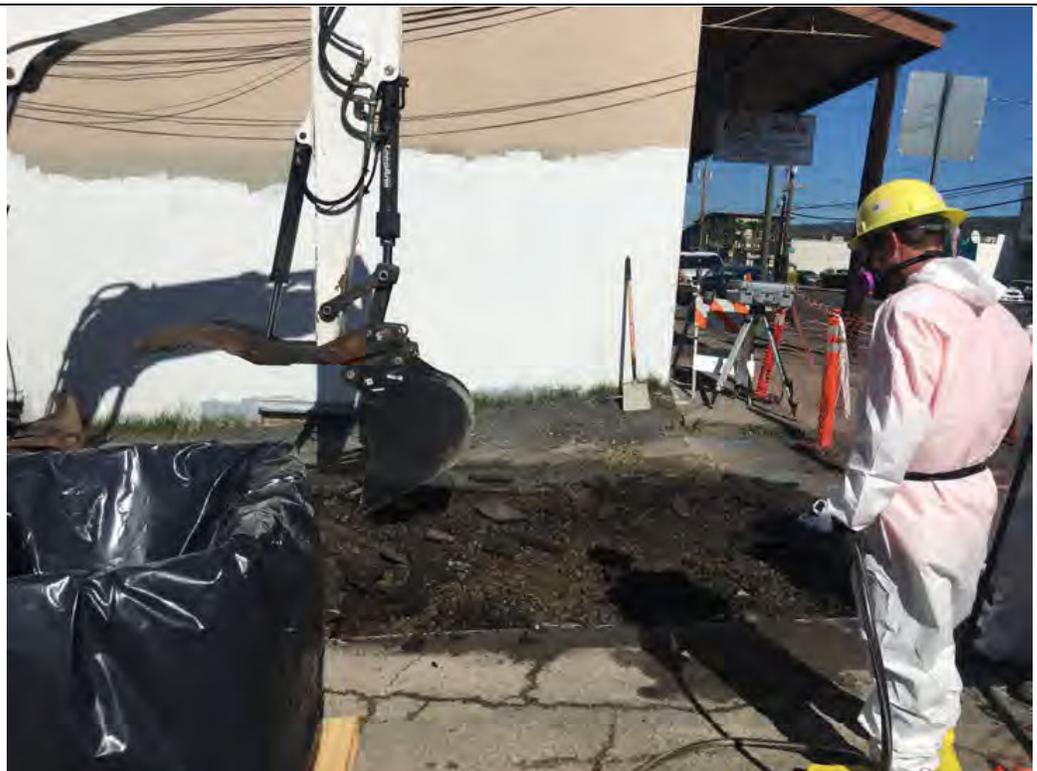
<b>Photo No.</b> <b>70</b>	<b>Date:</b> 01/23/2020
<b>Direction Photo Taken:</b> North	
<b>Description:</b>  At the onset of intrusive activities, removal work was conducted in level C personal protective equipment (PPE) until sufficient data was collected to support PPE downgrade decisions.

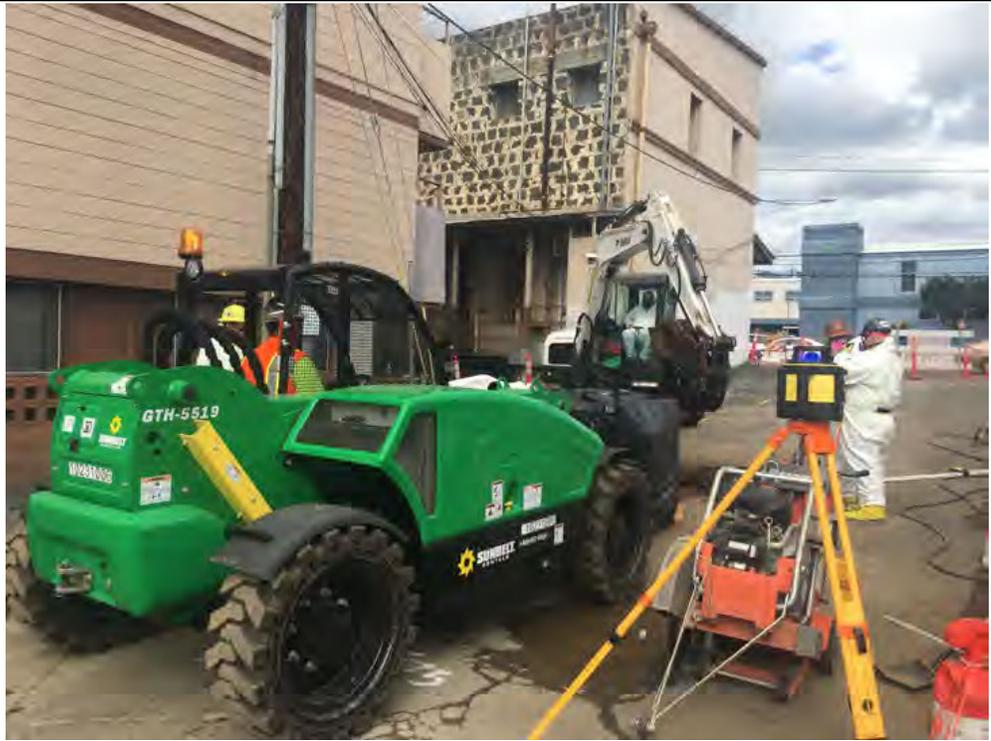
<b>Photo No.</b> <b>71</b>	<b>Date:</b> 01/21/2020
-------------------------------	----------------------------

**Description:**  
Project equipment and personnel work in DU-6.

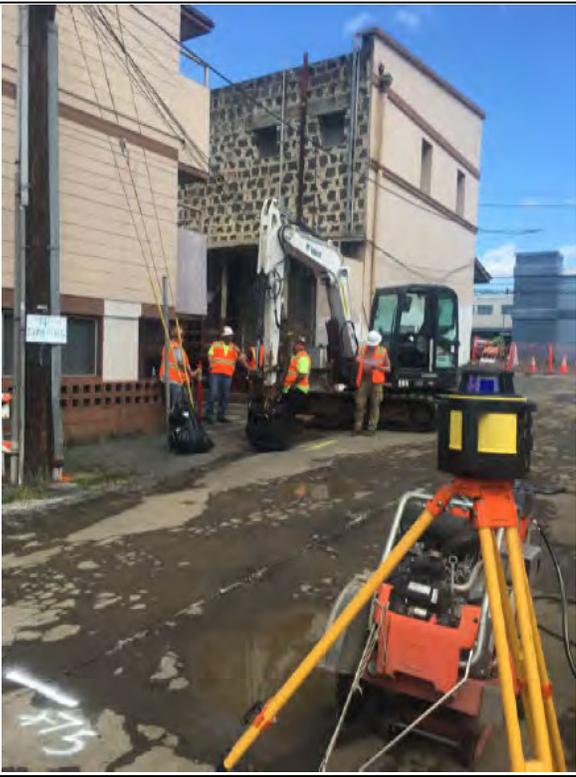
<b>Photo No.</b> <b>72</b>	<b>Date:</b> 01/21/2020
-------------------------------	----------------------------

**Description:**  
A self leveling rotary laser level is used to establish depth of excavation.

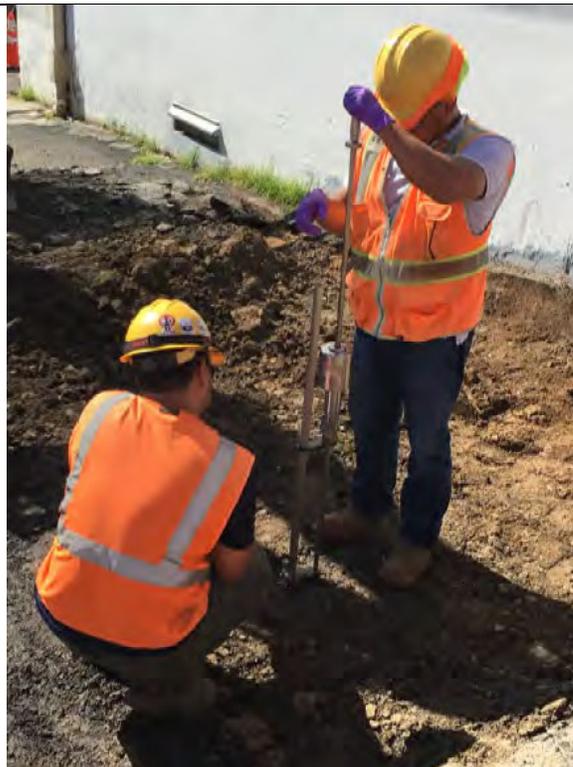
**Description:**  
Testing the stiffness of the native material at the limits of excavation in DU-6.

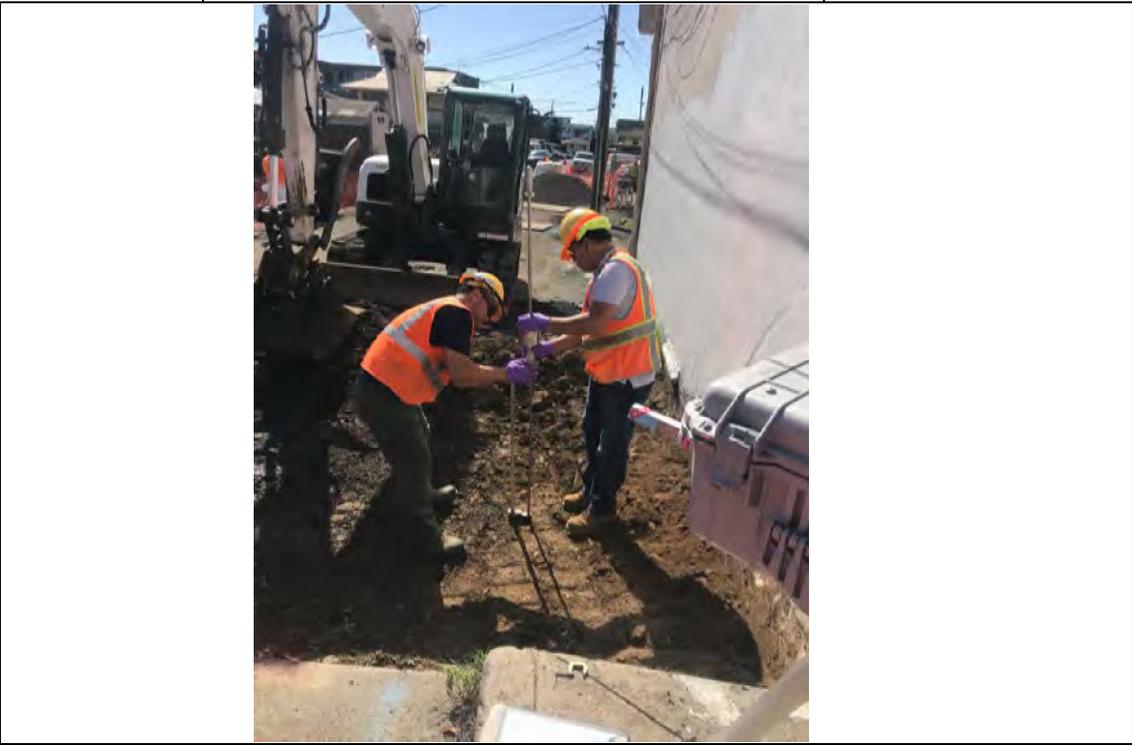
<b>Photo No.</b> <b>75</b>	<b>Date:</b> 01/24/2020
-------------------------------	----------------------------

**Description:**  
 Testing the stiffness of the native material at the limits of excavation in DU-6.

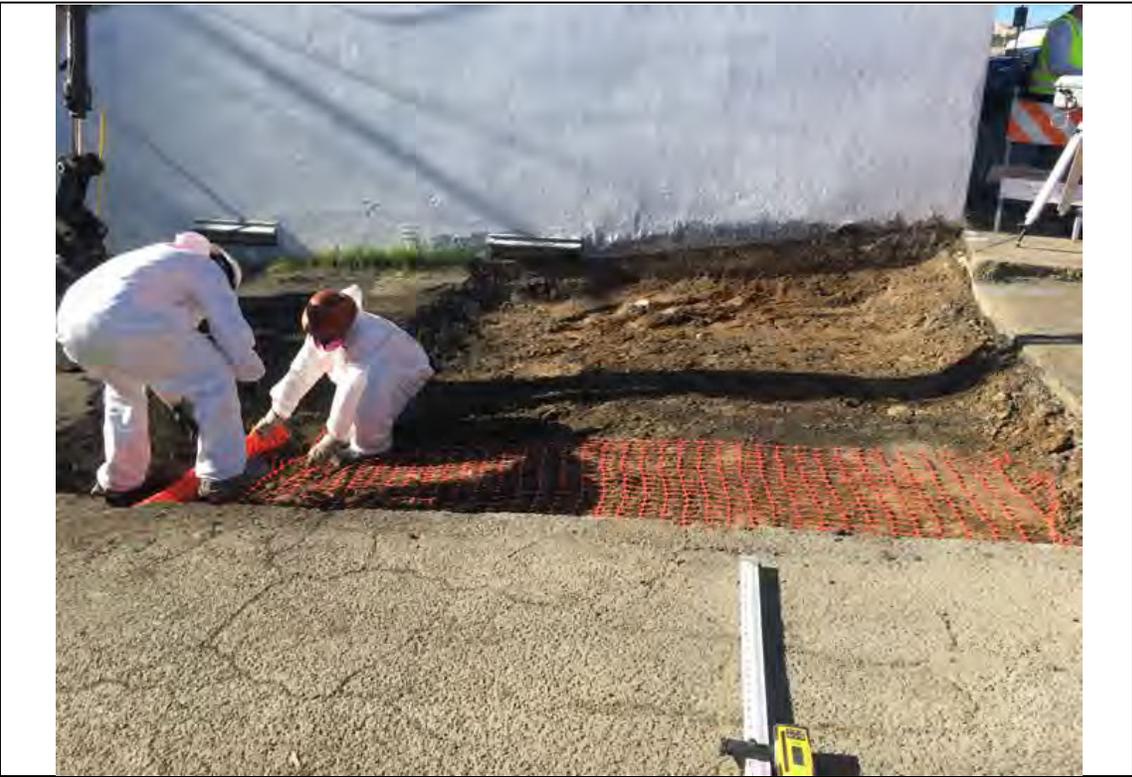
<b>Photo No.</b> <b>76</b>	<b>Date:</b> 01/23/2020
-------------------------------	----------------------------

**Description:**  
 Once daily soil increments were collected, construction fencing is laid to demarcate the limits of excavation.

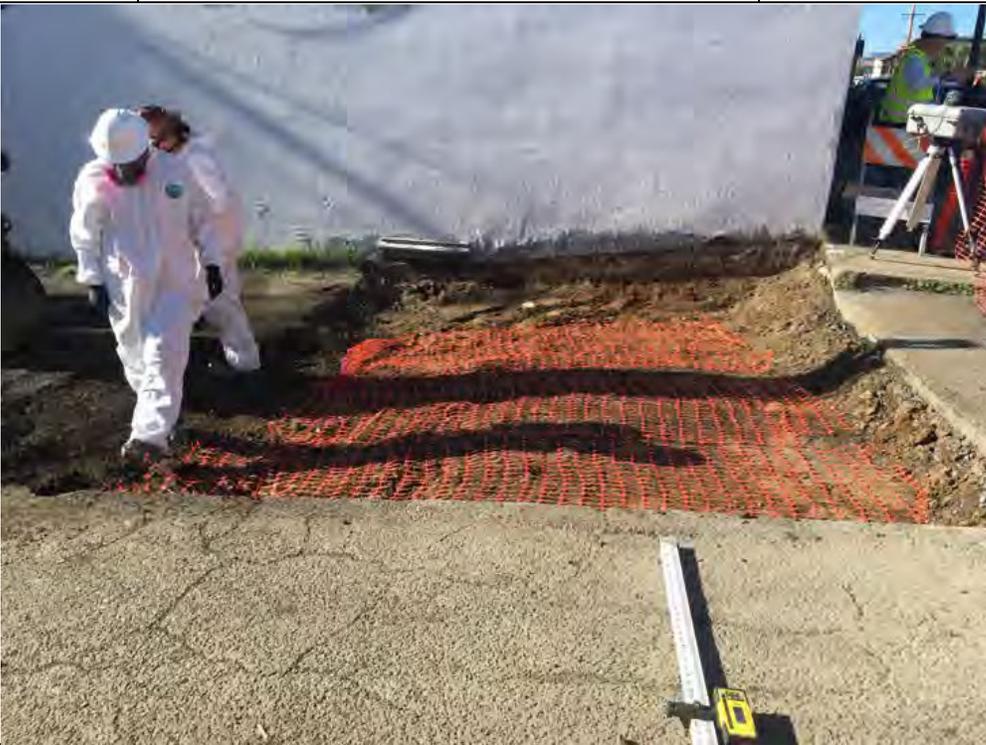
<b>Photo No.</b> <b>77</b>	<b>Date:</b> 01/23/2020
-------------------------------	----------------------------

**Description:**  
 Construction fencing is used to delineate excavation limits prior to backfill.

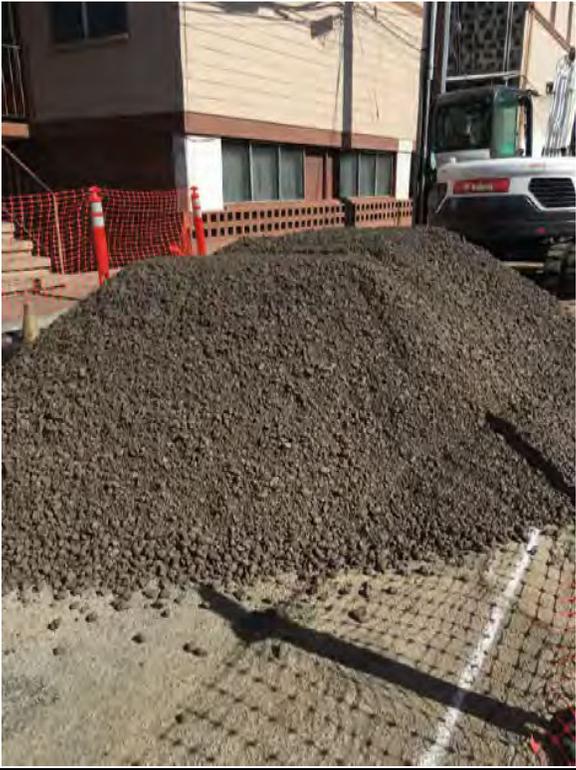
<b>Photo No.</b> <b>78</b>	<b>Date:</b> 01/22/2020
-------------------------------	----------------------------

**Description:**  
 Base course stockpiled on-site is used to backfill excavations at the end of each day.

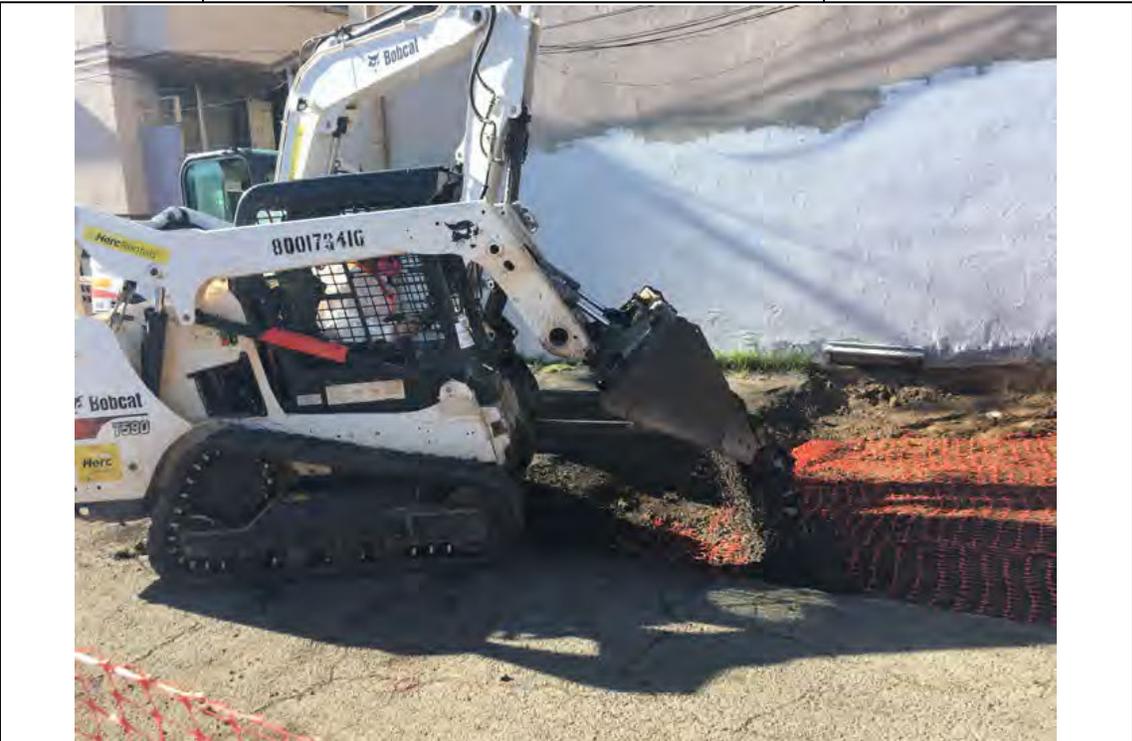
<b>Photo No.</b> <b>79</b>	<b>Date:</b> 01/23/2020
<b>Direction Photo Taken:</b> Northwest

**Description:**  
Excavations were backfilled at the end of each day.

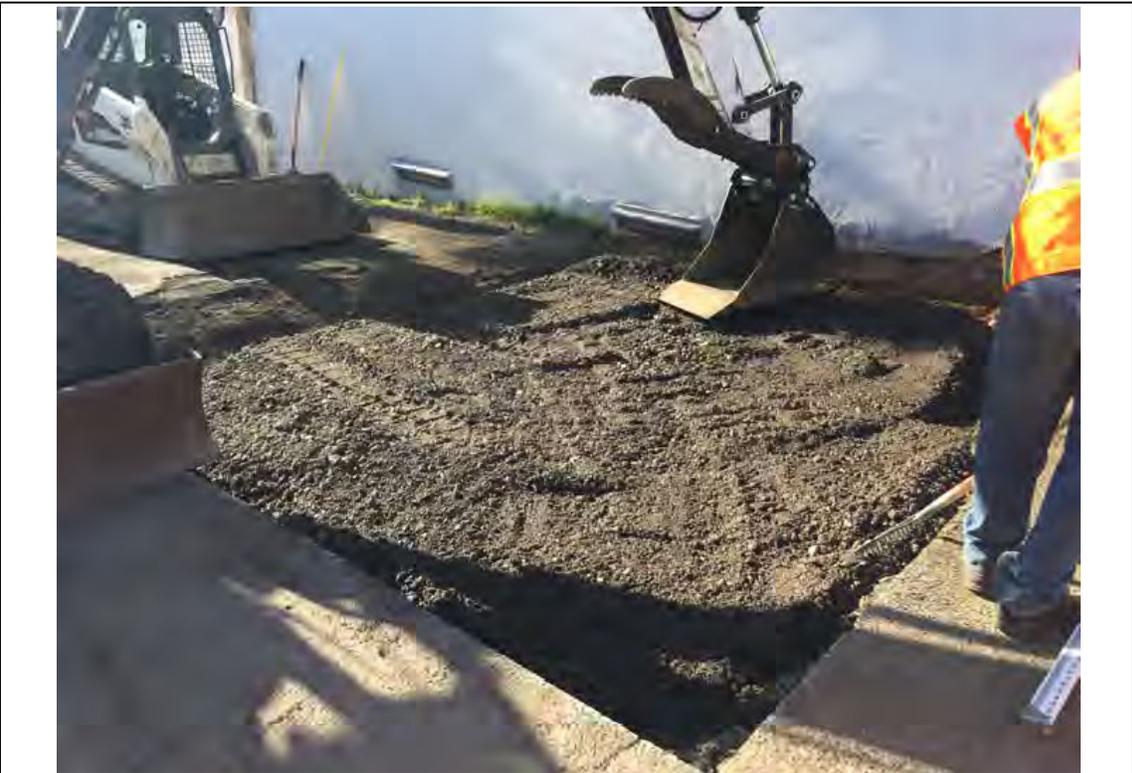
<b>Photo No.</b> <b>80</b>	<b>Date:</b> 01/23/2020
<b>Direction Photo Taken:</b> Northwest

**Description:**  
The excavator bucket is used to tamp down backfill.
