# **FACTORY STREET LEAD SITE TIME-CRITICAL REMOVAL ACTION REPORT**

**Factory Street Lead Site Removal Action  
Honolulu, Honolulu County, Hawaii**

**Prepared for:  
U.S. Environmental Protection Agency  
Region 9, Emergency Response Section**

**December 2020**

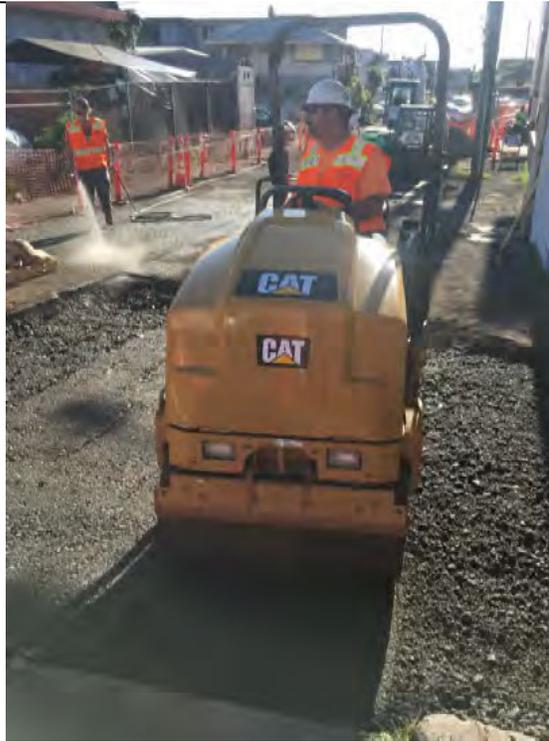
<b>Photo No.</b> <b>81</b>	<b>Date:</b> 01/23/2020
<b>Direction Photo Taken:</b> West

A roller is used for compaction of backfill.

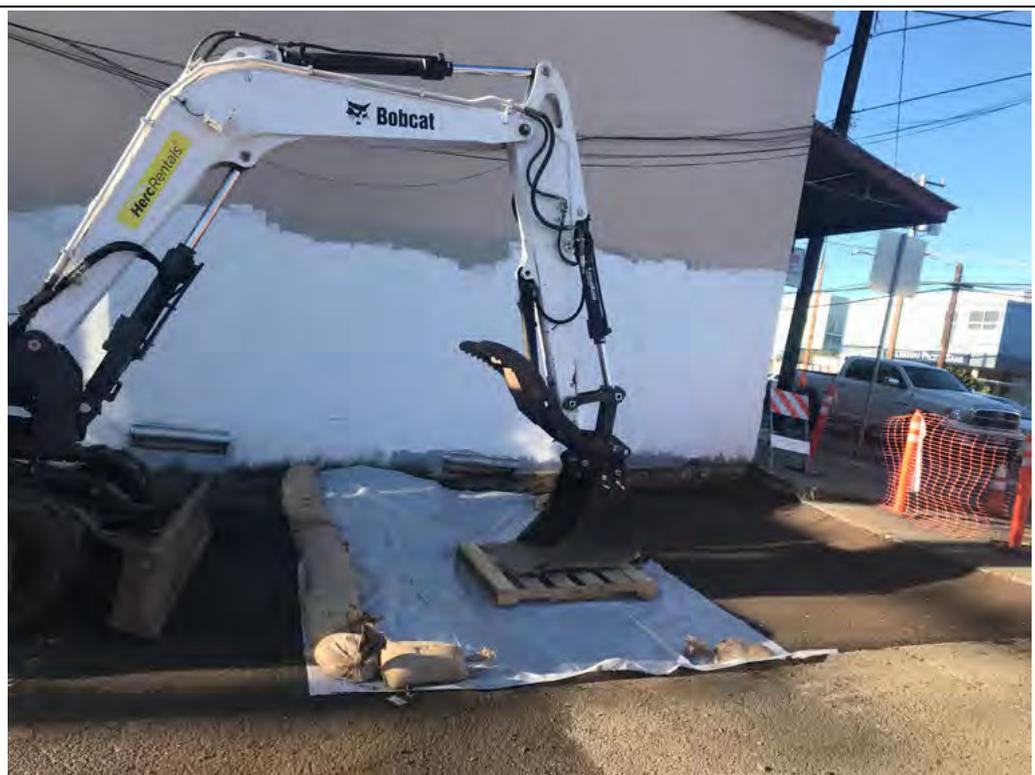
<b>Photo No.</b> <b>82</b>	<b>Date:</b> 01/24/2020
<b>Direction Photo Taken:</b> North

The newly backfilled and compacted excavation is covered with plastic sheeting and weighed down by sandbags at the end of each day to prevent potential run-off in the event of rain.

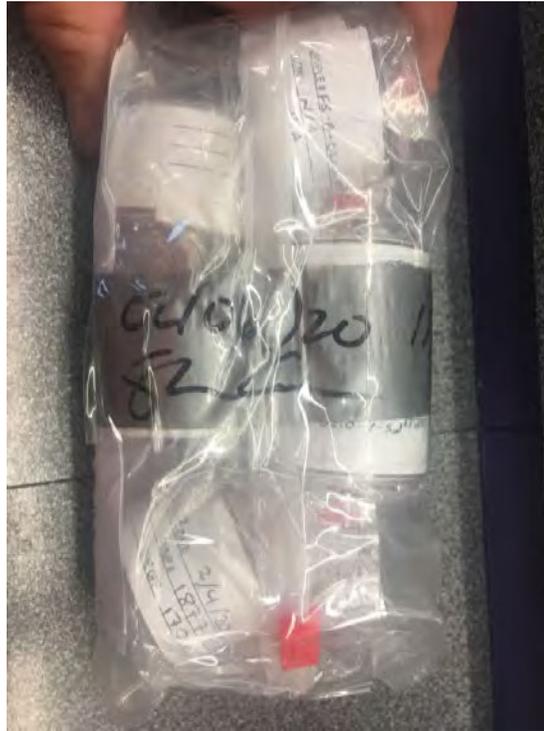
<b>Photo No.</b> <b>83</b>	<b>Date:</b> 02/06/2020
-------------------------------	----------------------------

**Description:**  
 Air samples collected were packaged and shipped to the laboratory the following day for expedited analysis.

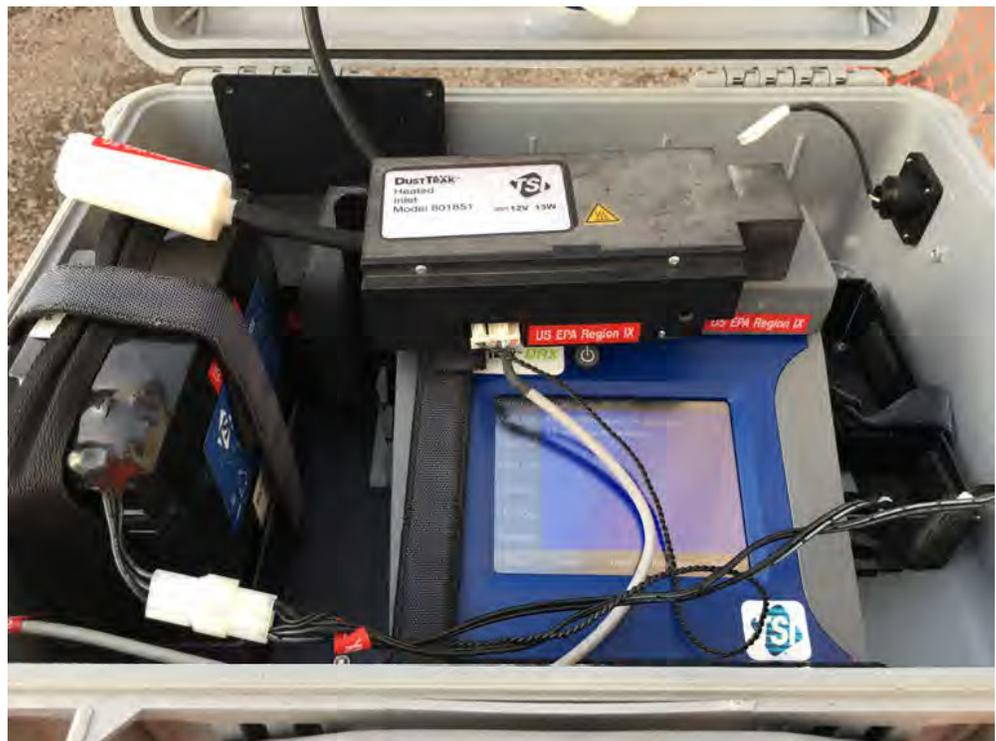
<b>Photo No.</b> <b>84</b>	<b>Date:</b> 01/30/2020
-------------------------------	----------------------------

**Description:**  
 TSI DustTrak aerosol monitors were zero air calibrated at the beginning of each day.

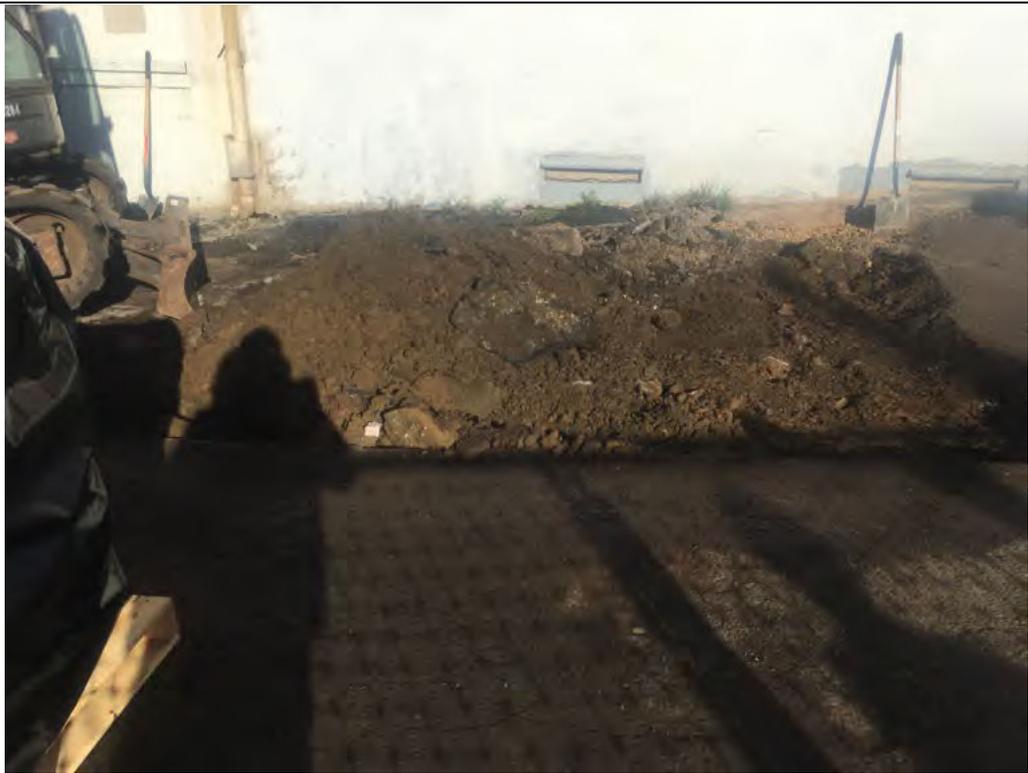
**Description:**  
Excavation the following day would begin where the previous day finished.

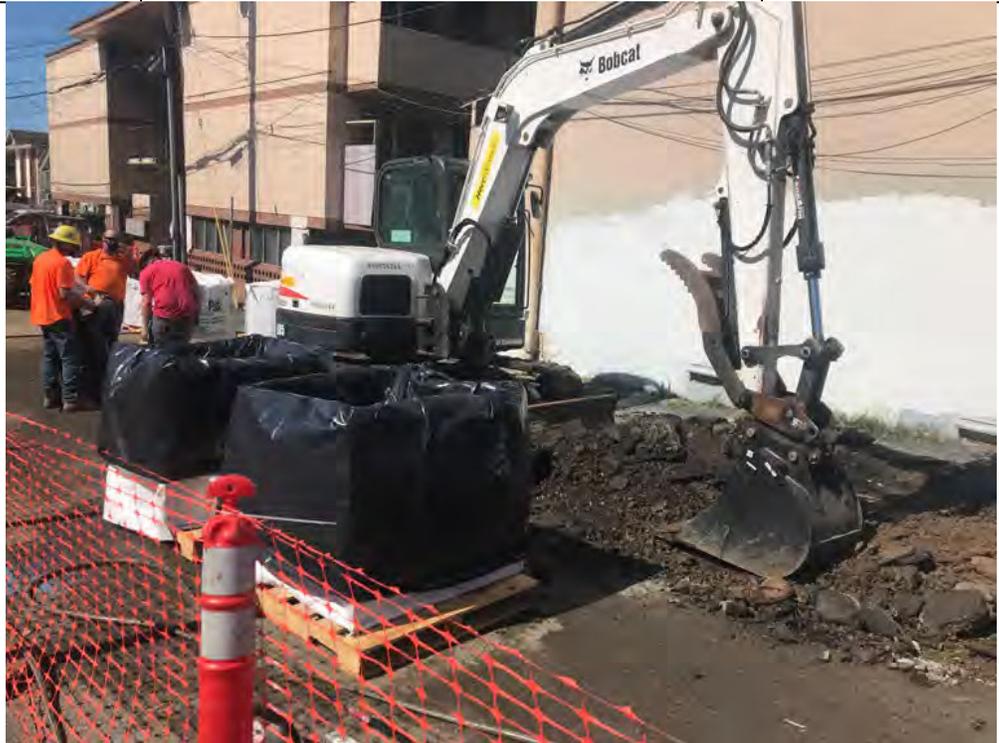
**Description:**  
Excavator and lined cubic yard boxes in DU-6.

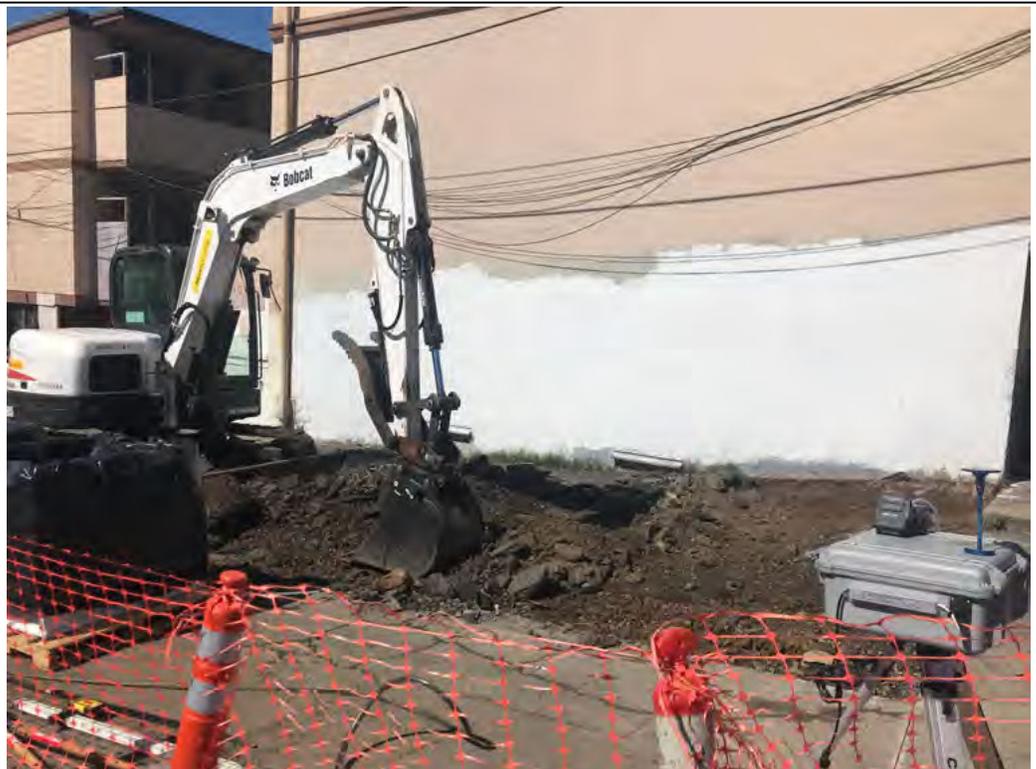
**Photo No.**  
**88**

**Description:**  
DU-6 intrusive operations with DustTrak aerosol monitor and SKC AirChek Touch air sampling pump pictured in the bottom right.

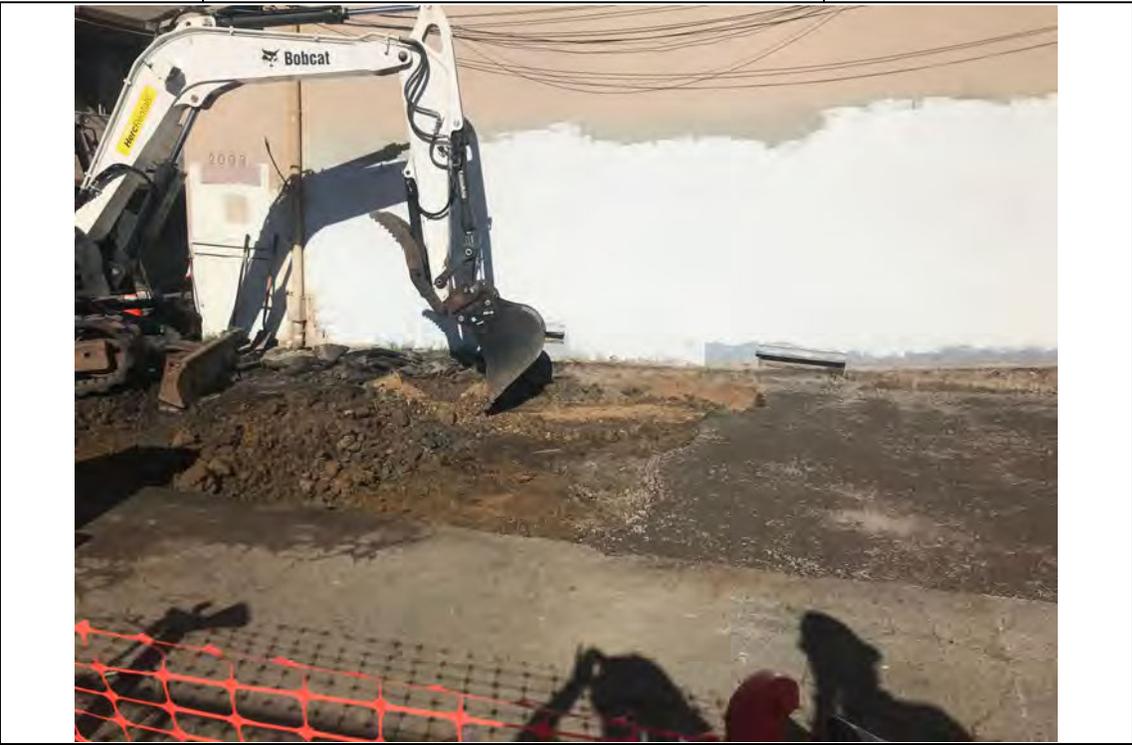
<b>Photo No.</b> <b>89</b>	<b>Date:</b> 01/24/2020
<b>Direction Photo Taken:</b> North	
<b>Description:</b> Excavating lead contaminated soil in DU-6.

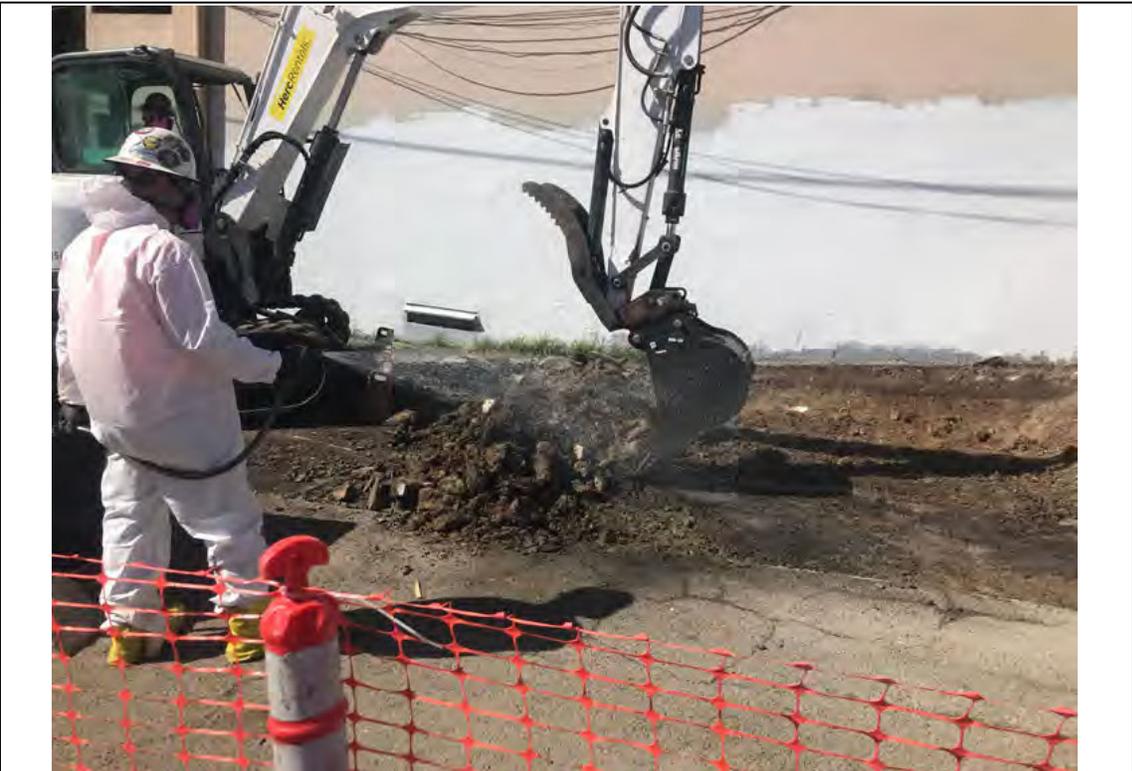
<b>Photo No.</b> <b>90</b>	<b>Date:</b> 01/24/2020
<b>Direction Photo Taken:</b> North	
<b>Description:</b> Water is sprayed on the excavation to wet the soil as an engineering control to prevent lead contaminated particulates from becoming airborne.

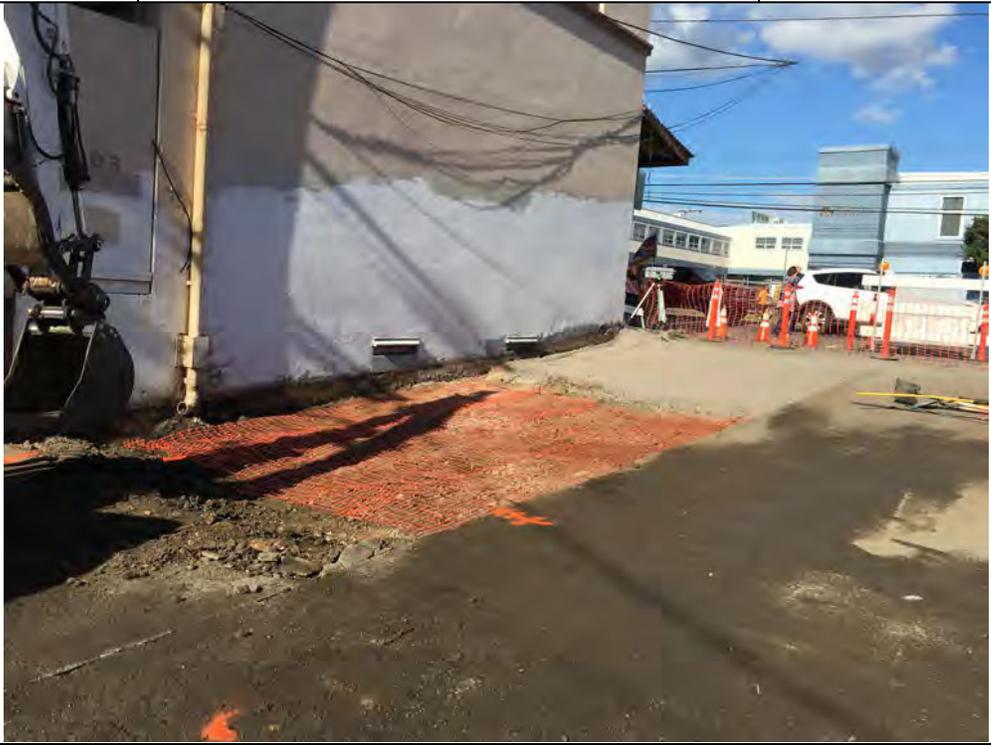
**Description:**  
 Construction fencing demarcating excavation limits in DU-6.

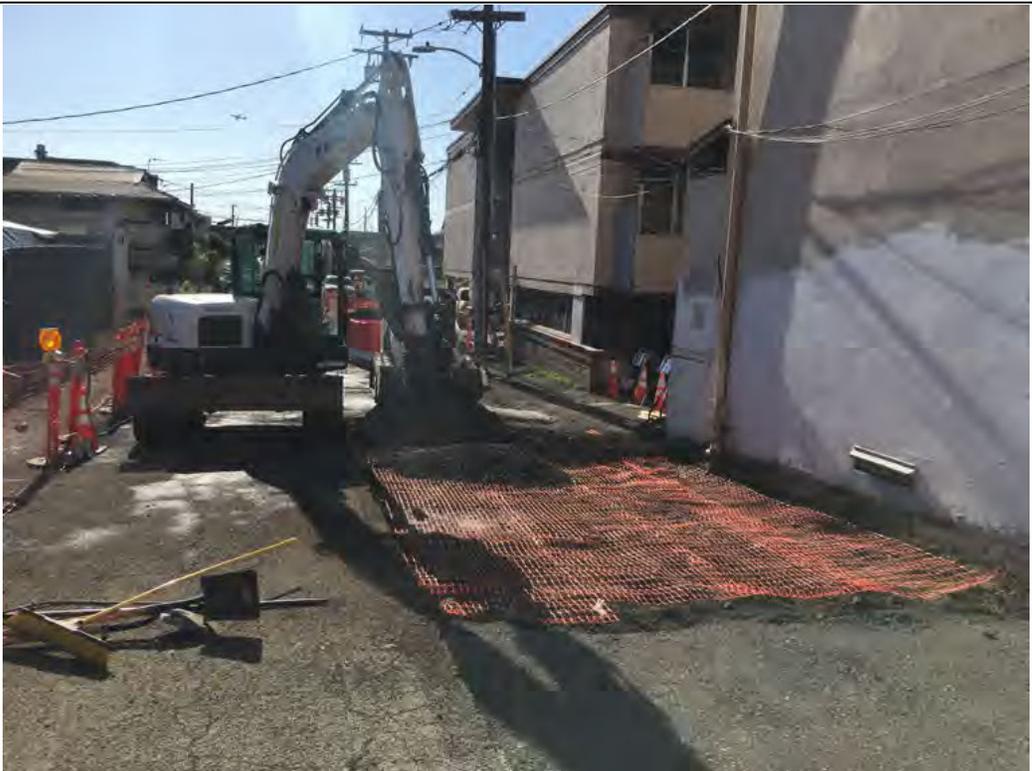
<b>Photo No.</b> <b>94</b>	<b>Date:</b> 01/24/2020
-------------------------------	----------------------------

**Description:**  
 Daily backfill operations DU-6.

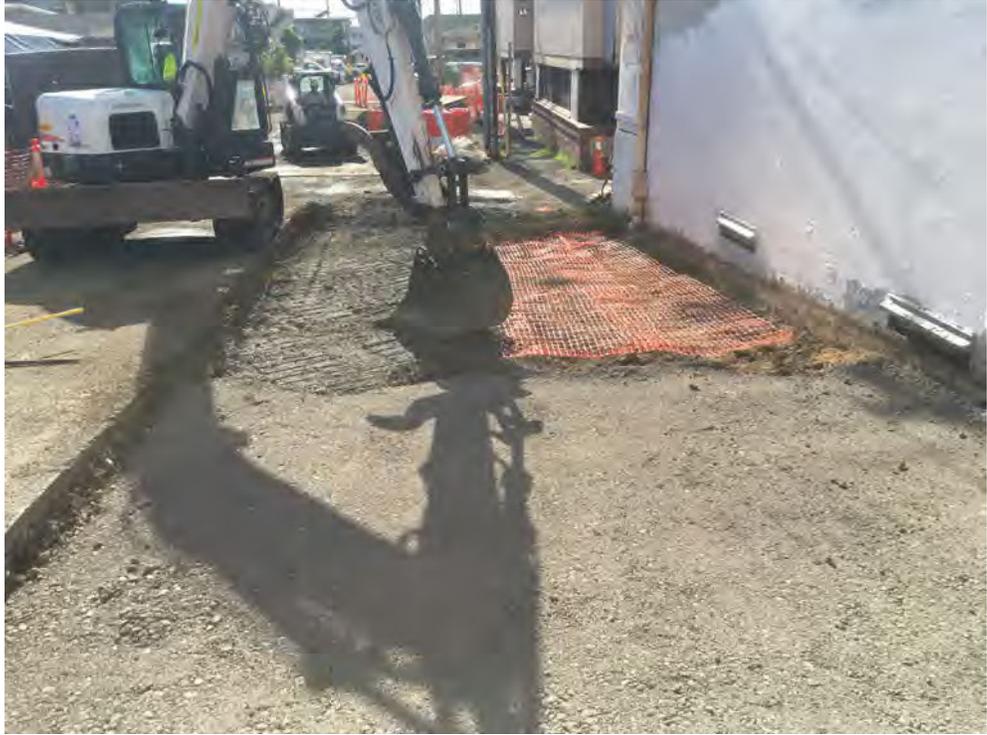
<b>Photo No.</b> <b>95</b>	<b>Date:</b> 01/24/2020
-------------------------------	----------------------------

**Description:**  
The excavator bucket is used to spread and tamp base coarse during backfill operations.

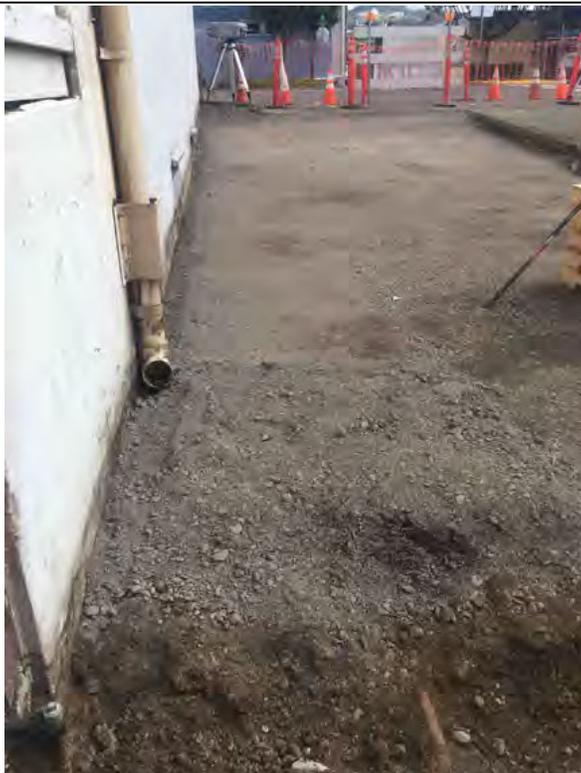
<b>Photo No.</b> <b>96</b>	<b>Date:</b> 01/25/2020
-------------------------------	----------------------------

**Description:**  
DU-6 facing North King Street.

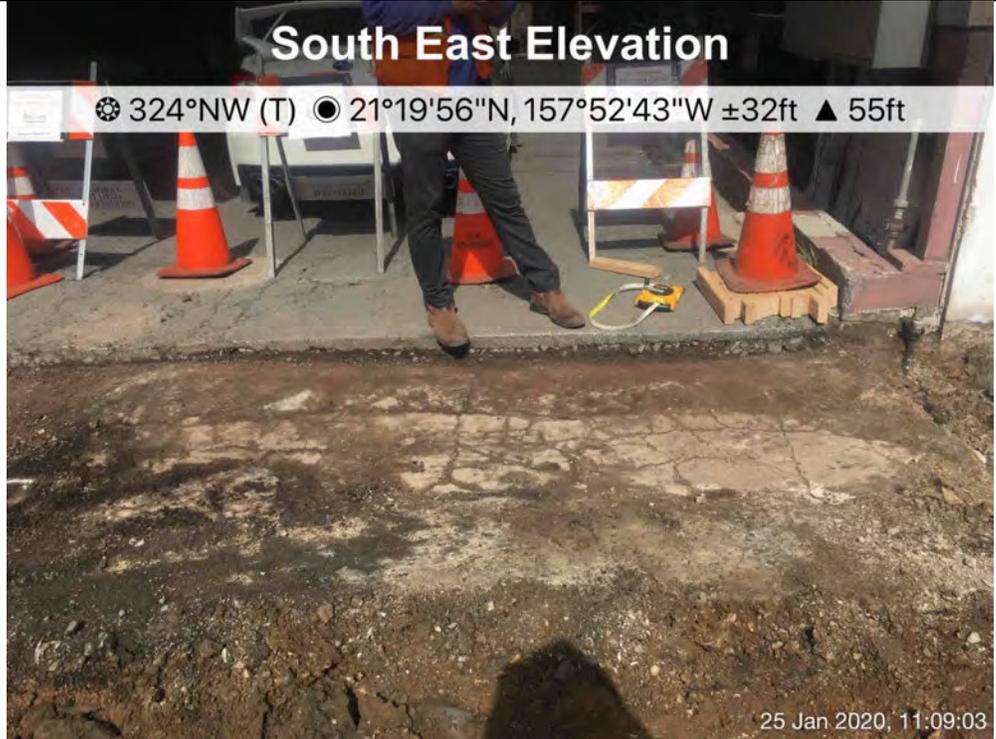
**Description:**  
A concrete pad was unearthed in DU-6 in front of the entrance to parking for the 2003 North King Street businesses.

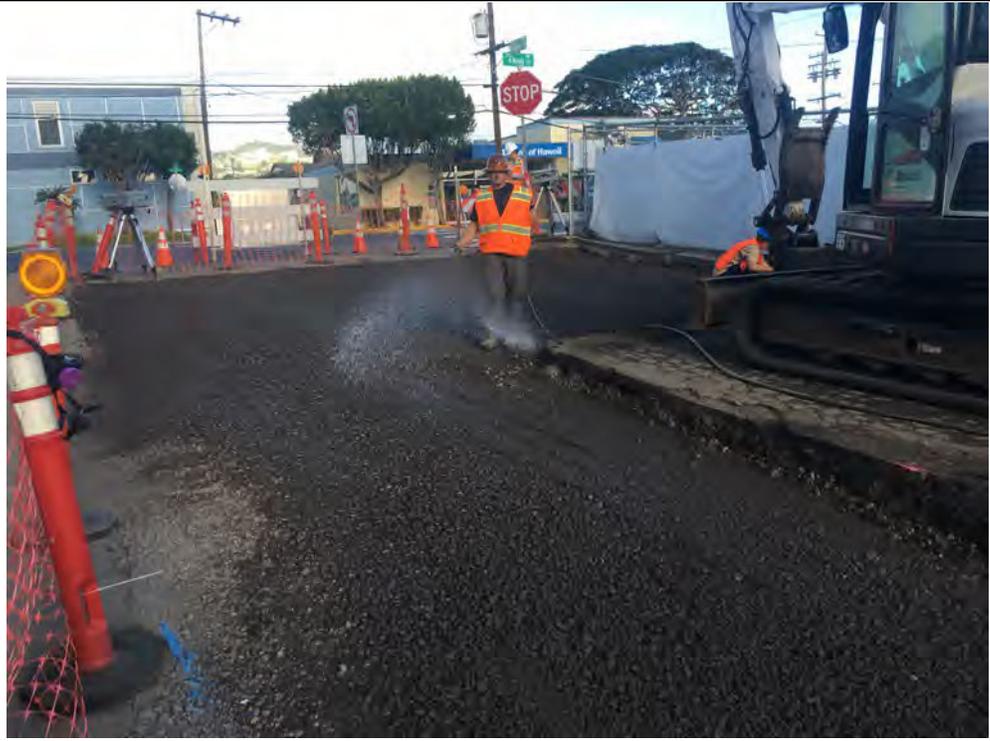
**Description:**  
Water was applied to the Project Area periodically throughout the day to aid in dust suppression.

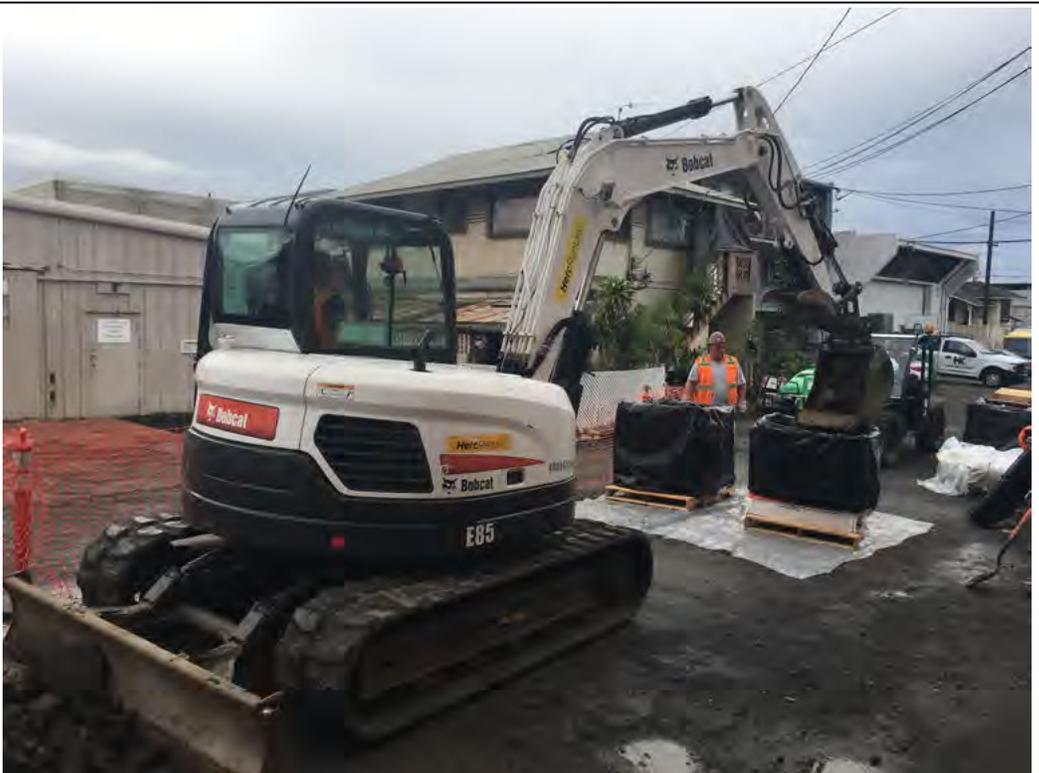
<b>Photo No.</b> <b>100</b>	<b>Date:</b> 02/06/2020
--------------------------------	----------------------------

**Description:**  
Lined cubic yard boxes are filled with excavated soil.

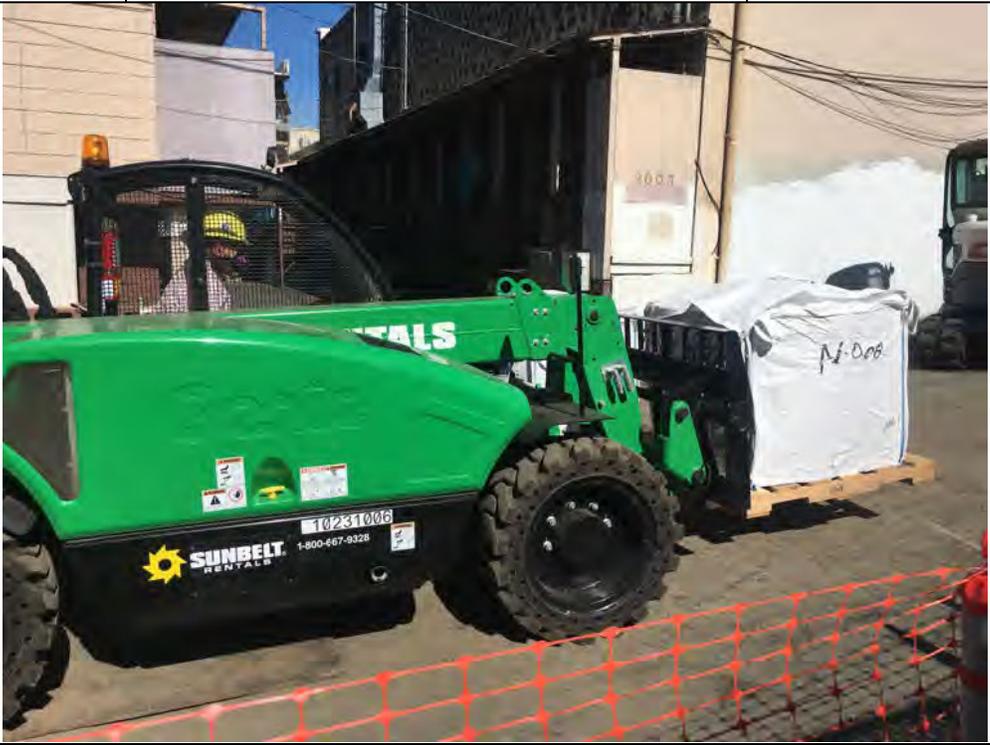
<b>Photo No.</b> <b>101</b>	<b>Date:</b> 01/23/2020
--------------------------------	----------------------------

**Description:**  
Once filled, cubic yard boxes are stored on-site if hazardous waste in a secured shipping container or transported by flatbed truck to the HDOA lay-down yard if nonhazardous waste to be stored in separate secured shipping containers.

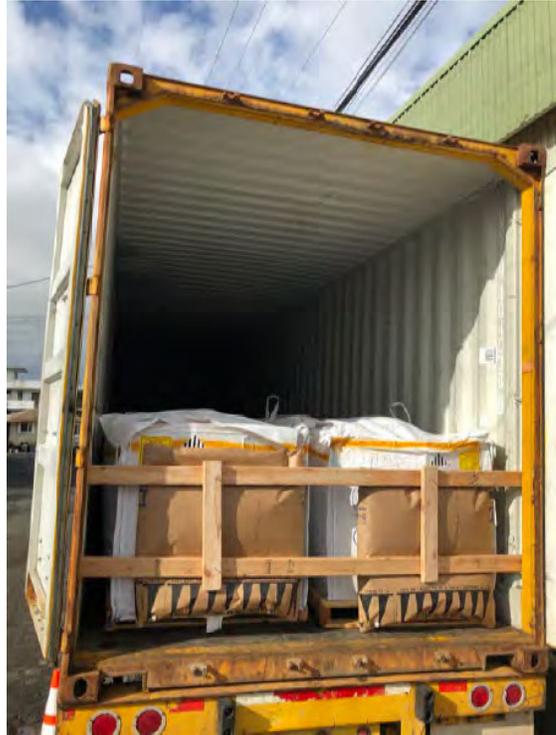
<b>Photo No.</b> <b>106</b>	<b>Date:</b> 02/05/2020
--------------------------------	----------------------------

**Description:**  
 Shipping container loaded with hazardous waste soil from DU-6.

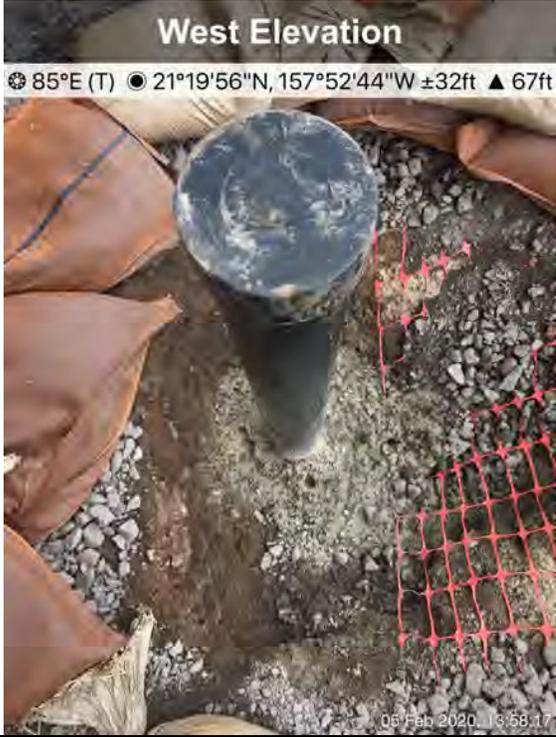
<b>Direction Photo Taken:</b> N/A		
<p><b>Description:</b></p> <p>A polyvinyl chloride extension was attached to the broken sewer clean-out port and a concrete collar was poured around the repaired clean-out port.</p>

During excavation on February 4, 2020, a broken and buried 4-inch diameter sewer clean-out port was unexpectedly discovered in DU-6 in front of 922 Factory Street. The sewer clean-out was connected to a private sewer line originating at the 922 Factory Street apartment complex, adjacent to the Site. The broken section of the sewer clean-out port had surface oxidation indicating it was broken prior to EPA excavation. EPA's ERRS contractors excavated down to the intact portion of the clean-out, fitted it with a new coupling and polyvinyl chloride extension pipe, then poured a concrete collar around the area. This repair allowed the clean-out to be functional moving forward. A City & County of Honolulu Sewer Construction Inspector was on-site and determined this would be an appropriate fix. EPA believed the repair was necessary to ensure there were no Site impacts to the upgradient water system, including any debris that may have fallen into the clean-out when it was discovered during excavation operations. ERRS personnel determined that the sewer flow was beginning to back up at the site of the clean-out, cleared the sewer line of any soil that may have inadvertently fallen in during excavation operations, and restored flow. The location of the repaired clean-out port is depicted in Figure 3-2.

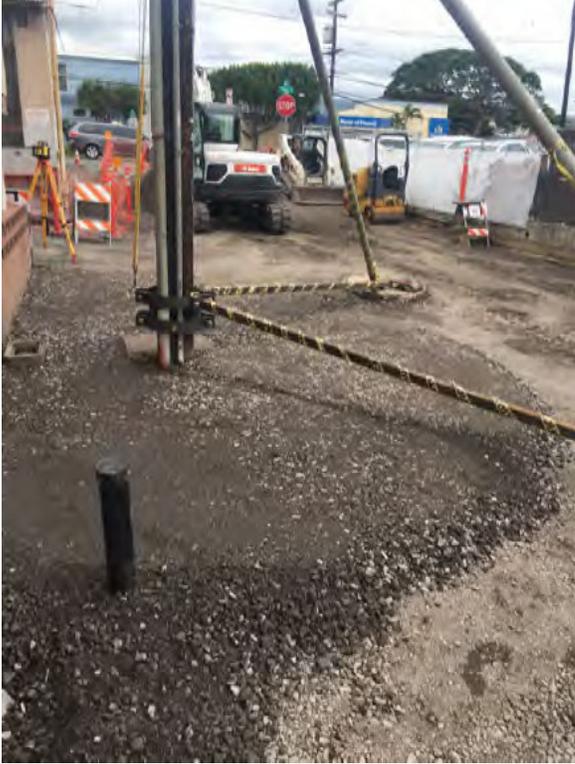
<b>Photo No.</b> <b>122</b>	<b>Date:</b> 02/05/2020

<b>Direction Photo Taken:</b> East		
<p><b>Description:</b></p> <p>Clean backfill was used to further reinforce the repaired clean-out port.</p>

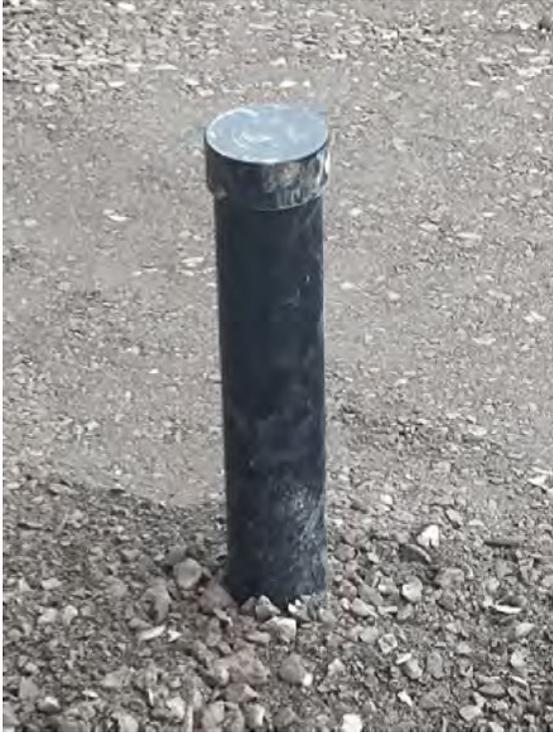
<b>Direction Photo Taken:</b> N/A		
<b>Description:</b> A close-up photo of the repaired sewer clean-out port

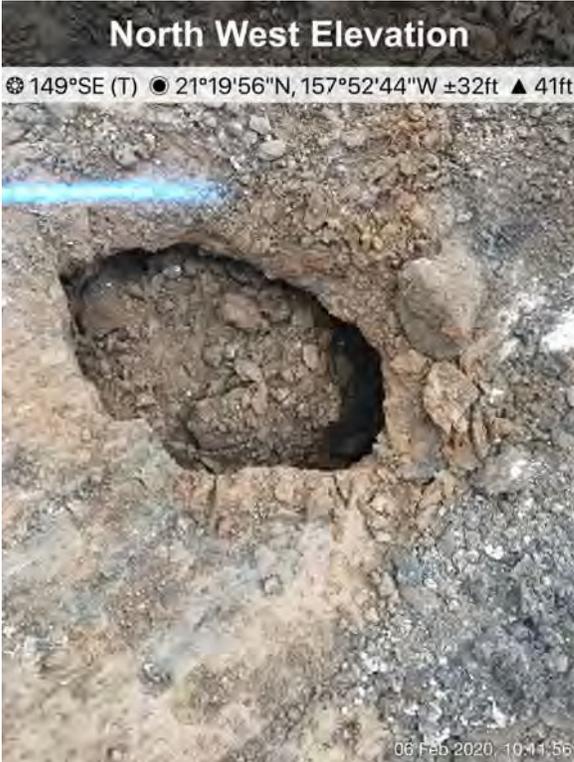
<div style="text-align: right; font-size: small;">           06 Feb 2020, 10:11:56         </div>
<b>Direction Photo Taken:</b> N/A		
<b>Description:</b> During excavation on February 6, 2020, a substantial void space was encountered directly in front of the mailboxes at 922 Factory Street.

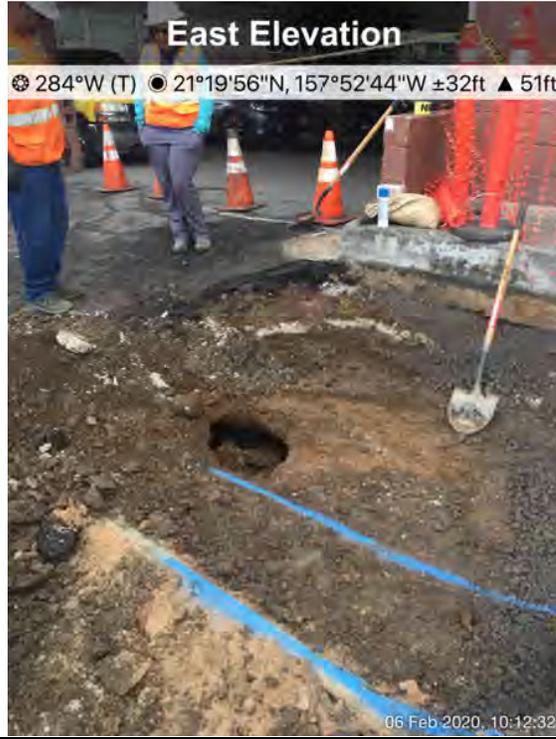
<b>Photo No.</b> <b>126</b>	<b>Date:</b> 01/24/2020
--------------------------------	----------------------------

**Description:**  
A MultiRae photoionizing detector was used to assess the void for volatile organic compounds and noxious gases.

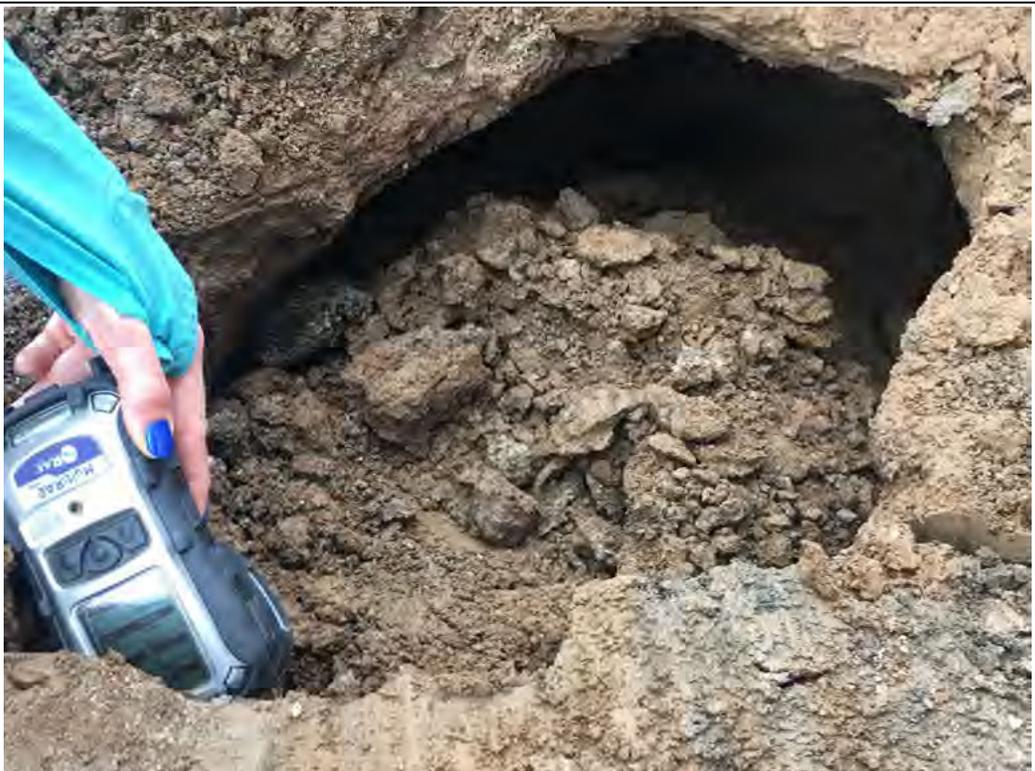
<b>Photo No.</b> <b>127</b>	<b>Date:</b> 02/06/2020
--------------------------------	----------------------------

**Description:**  
 A close-up of the void space.

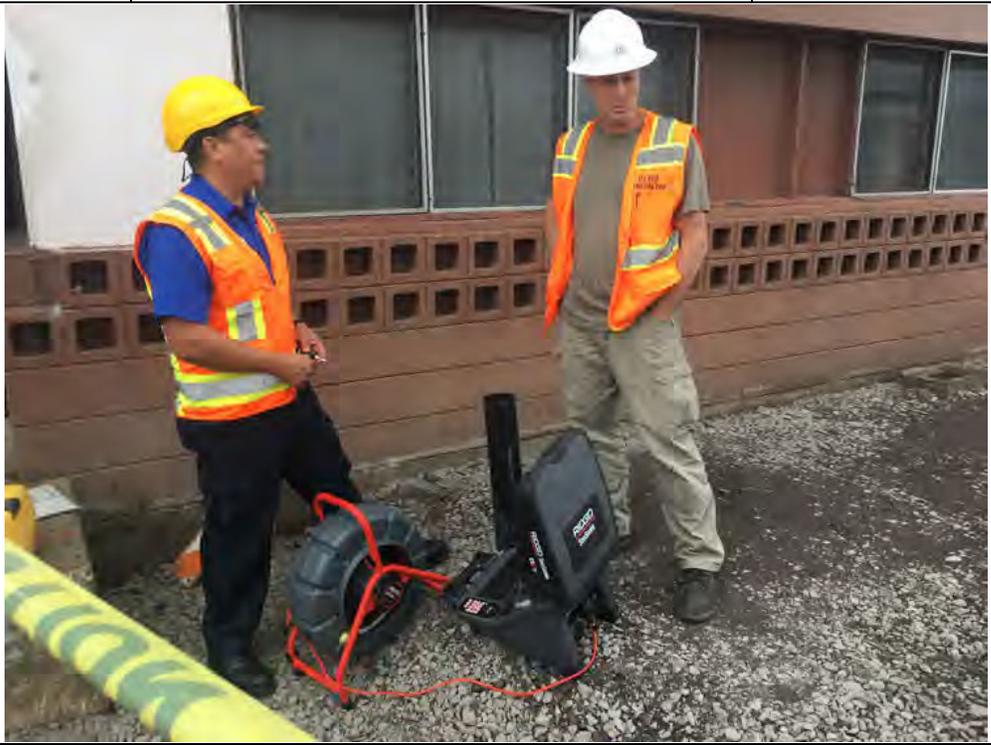
<b>Photo No.</b>	<b>Date:</b>
<b>132</b>	02/06/2020

**Description:**  
 During the Roto-rooter camera survey, the upgradient private sewer line was observed to be intact and fully operational.

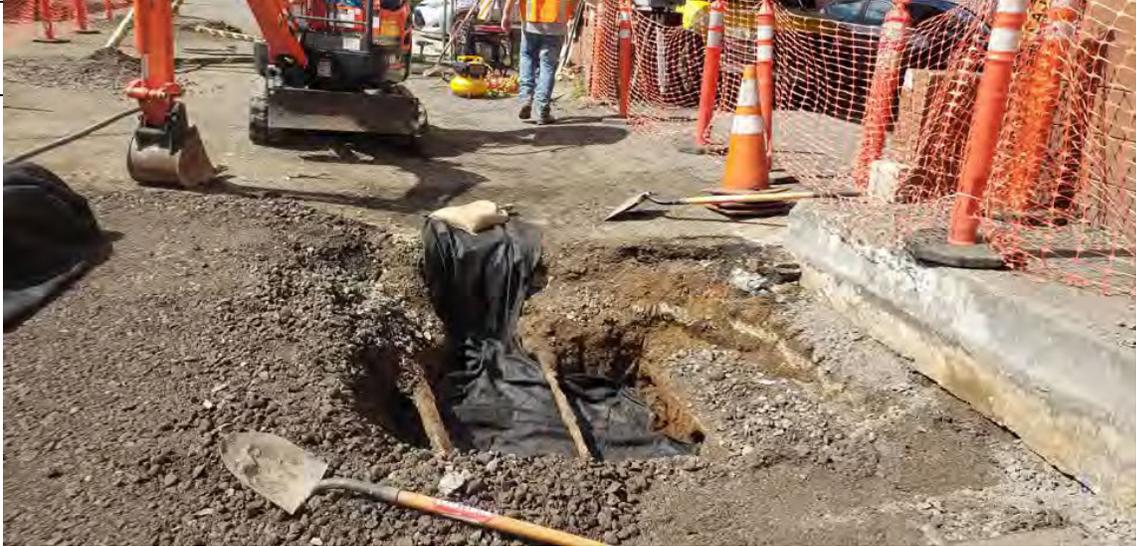
<b>Photo No.</b> <b>134</b>	<b>Date:</b> 02/07/2020
--------------------------------	----------------------------

**Description:**  
Fabric was placed on the northeast side only, as this was the location the void space was encountered on-site, and therefore the only side of the manhole with deep enough excavation to allow for placing the fabric.

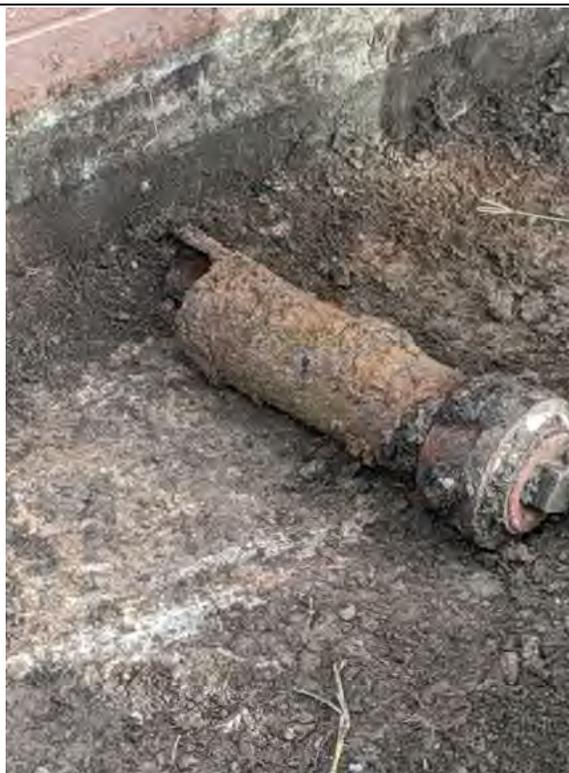
<b>Photo No.</b> <b>137</b>	<b>Date:</b> 02/08/2020
--------------------------------	----------------------------

**Description:**  
Water from broken sewer clean-out port backing up into DU-4.

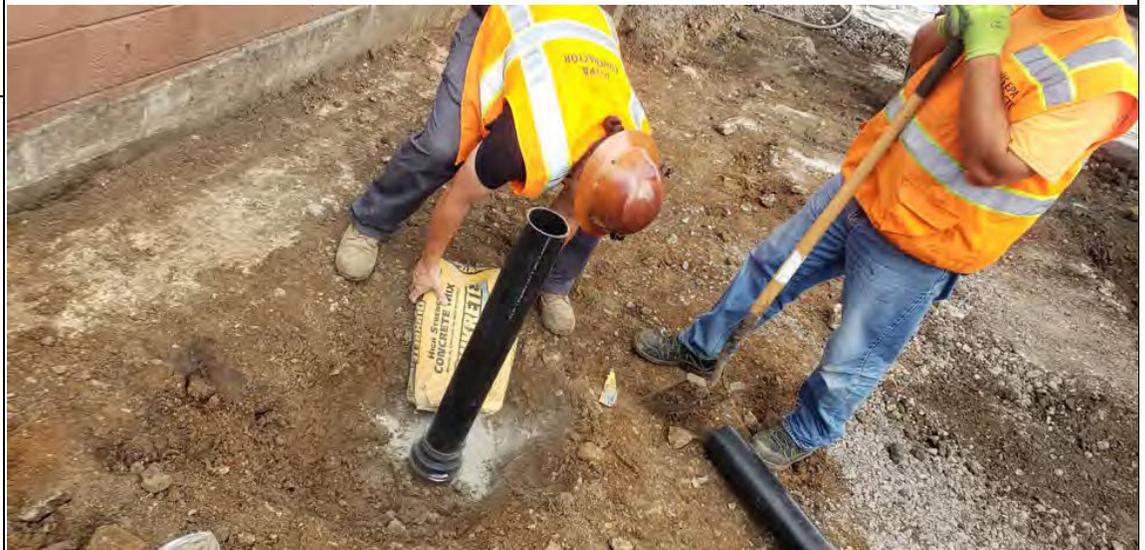
<b>Photo No.</b> <b>141</b>	<b>Date:</b> 02/08/2020
--------------------------------	----------------------------

**Description:**  
The repaired sewer clean-out port.

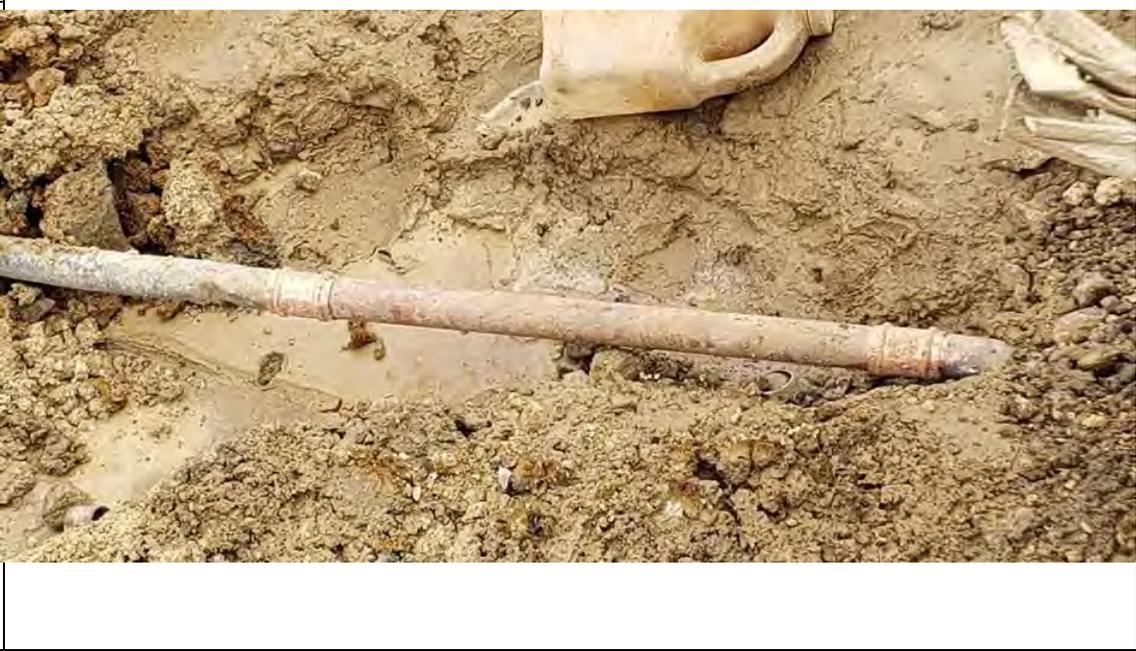
**Description:**  
The repaired water line.

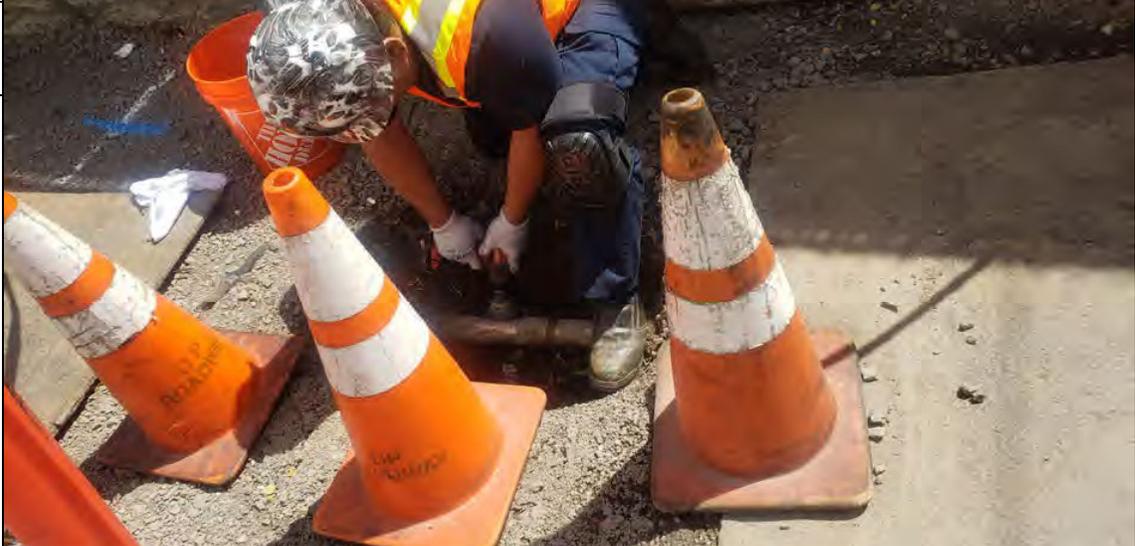
<b>Photo No.</b> <b>170</b>	<b>Date:</b> 02/18/2020	
<b>Direction Photo Taken:</b> N/A		
<b>Description:</b> A small leak was discovered in the 3 inch water line in DU-5 on February 18, 2020.

**Description:**  
A plumber from Roto-Rooter was called in to repair the water line.

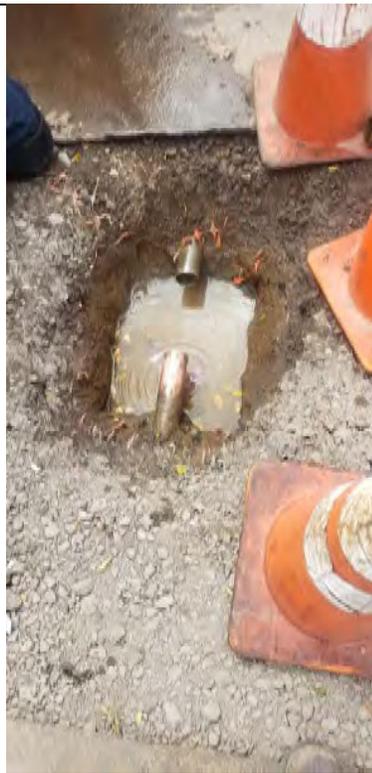
**Description:**  
A small section of the pipe was removed using a pipe cutter.

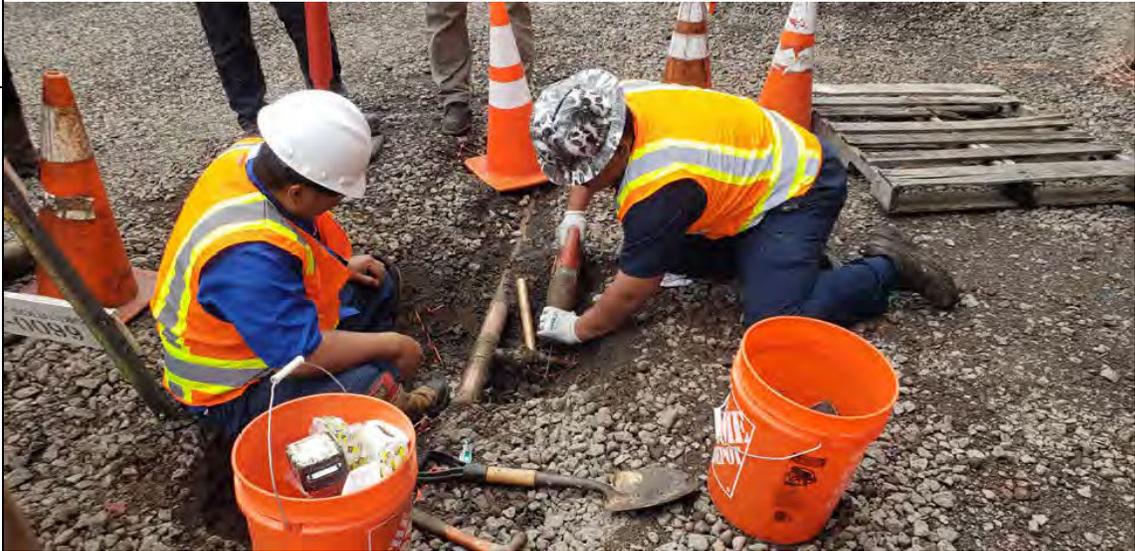
**Description:**  
Repairing leaking water line in DU-4 on February 19, 2020.

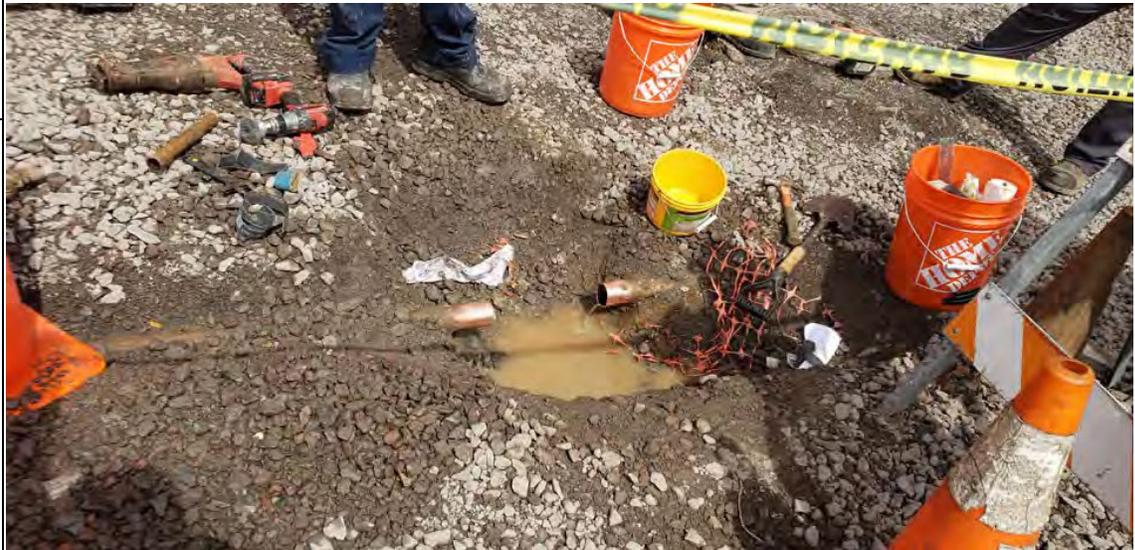
<b>Photo No.</b> <b>176</b>	<b>Date:</b> 02/19/2020
--------------------------------	----------------------------

**Description:**  
A section of the water line is removed in DU-4.
