# **FACTORY STREET LEAD SITE TIME-CRITICAL REMOVAL ACTION REPORT**

**Factory Street Lead Site Removal Action  
Honolulu, Honolulu County, Hawaii**

**Prepared for:  
U.S. Environmental Protection Agency  
Region 9, Emergency Response Section**

**December 2020**

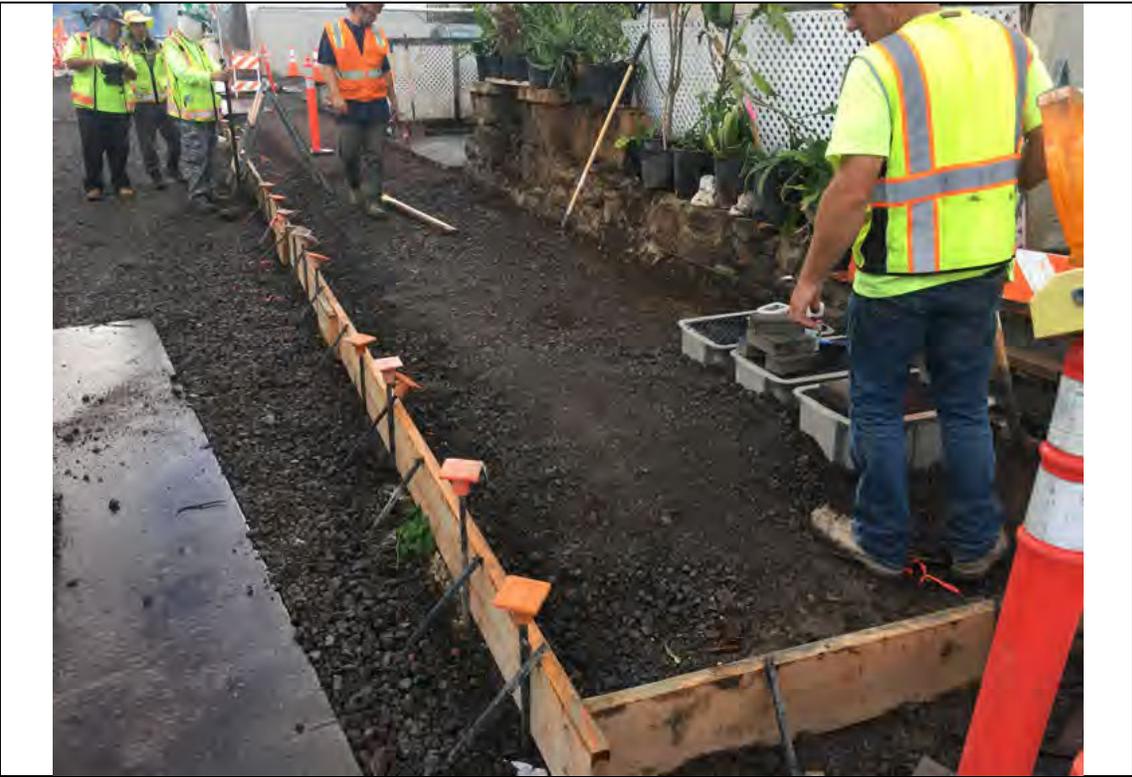
<b>Photo No.</b> <b>182</b>	<b>Date:</b> 03/02/2020
--------------------------------	----------------------------

**Description:**  
Construction of sidewalk framing.

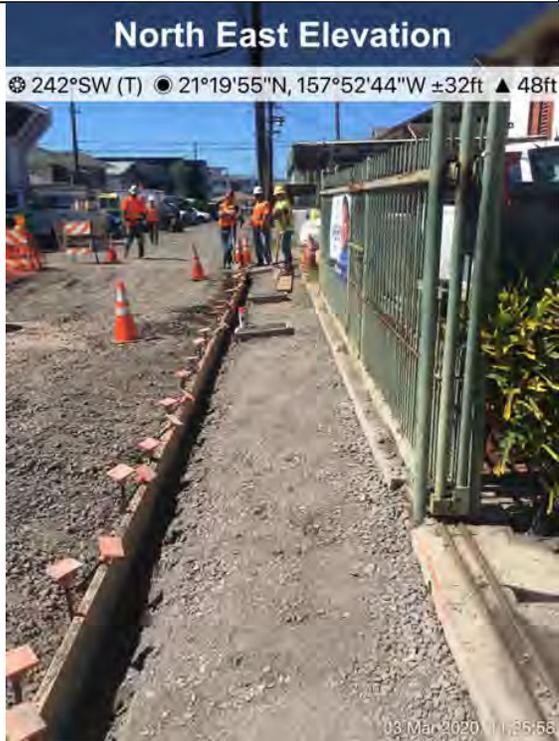
**Description:**  
 Framing of sidewalk on northern boundary of the Project Area.

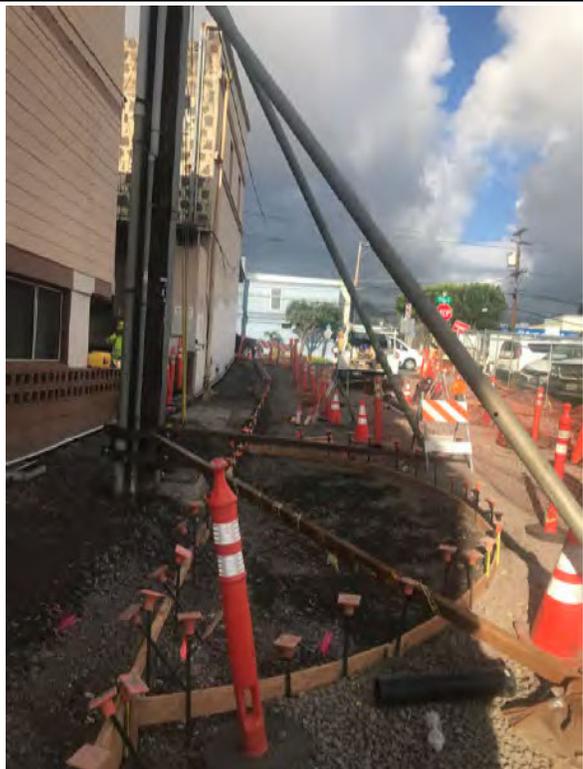
<b>Photo No.</b> <b>186</b>	<b>Date:</b> 03/07/2020
--------------------------------	----------------------------

**Description:**  
 Framing around utility pole for concrete to allow for removal of pole shoring ahead of asphalt pour on northeastern boundary of Project Area.

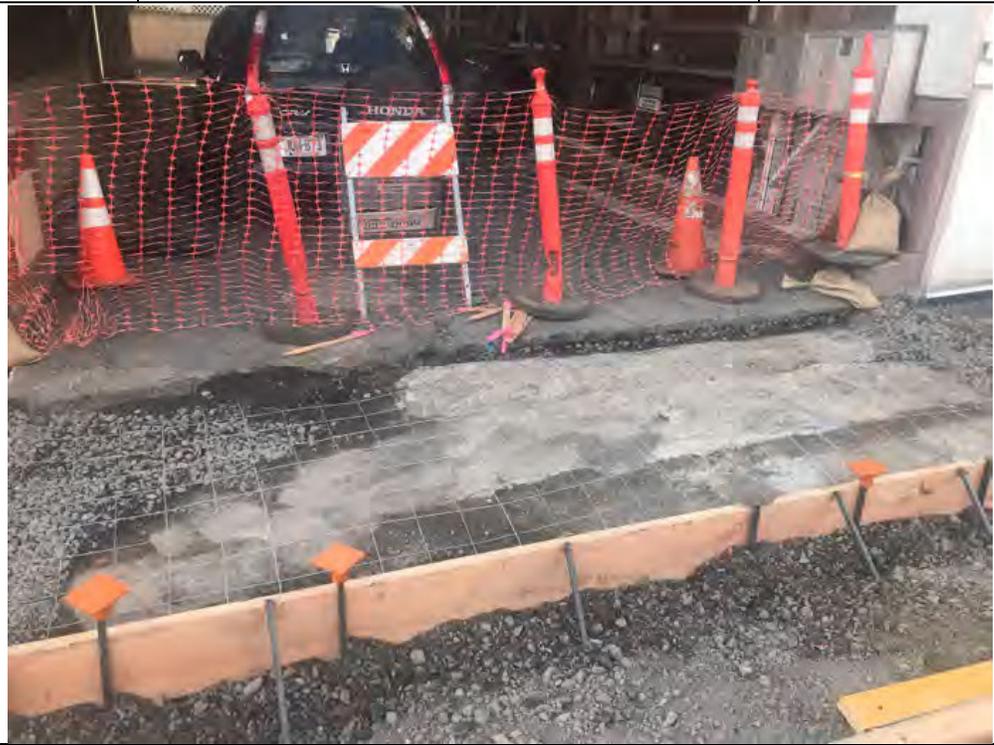
<b>Photo No.</b> <b>187</b>	<b>Date:</b> 02/26/2020
--------------------------------	----------------------------

**Description:**  
Reinforcing wire laid for the sidewalk to add structural integrity to the driveway entering the 922 Factory Street building.

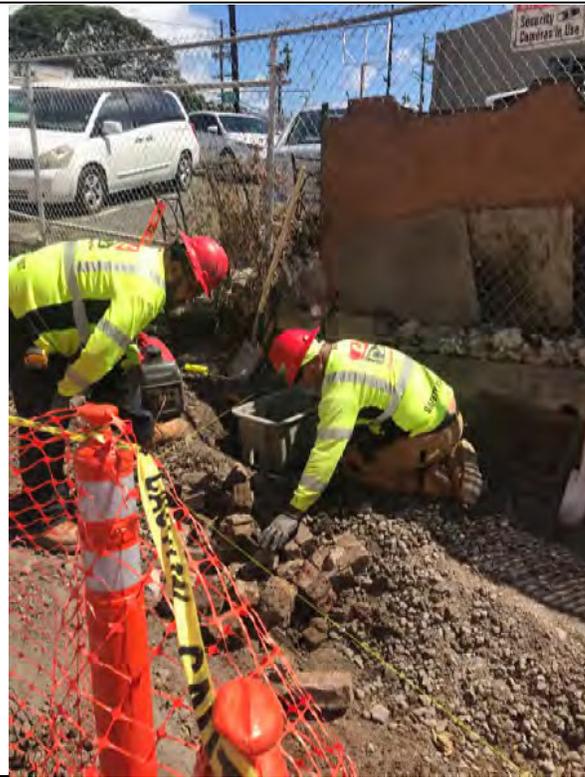
<b>Photo No.</b> <b>188</b>	<b>Date:</b> 02/25/2020
--------------------------------	----------------------------

**Description:**  
Replacing water meter boxes in Project Area.

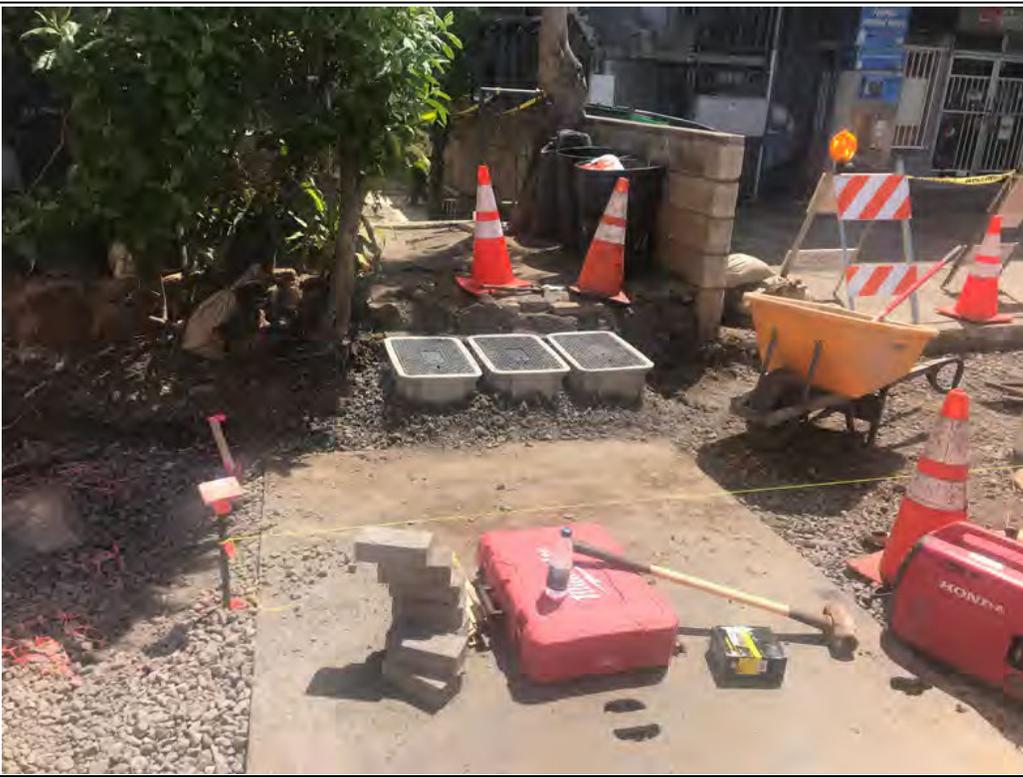
**Description:**  
 Replaced series of three utility boxes in DU-3.

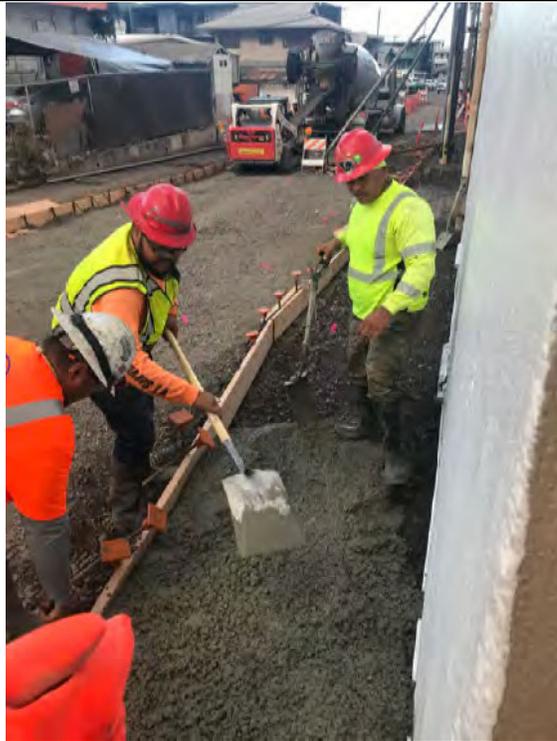
<b>Photo No.</b> <b>191</b>	<b>Date:</b> 02/28/2020
--------------------------------	----------------------------

**Description:**  
 Pouring concrete for the sidewalk on the northern boundary of the Project Area.

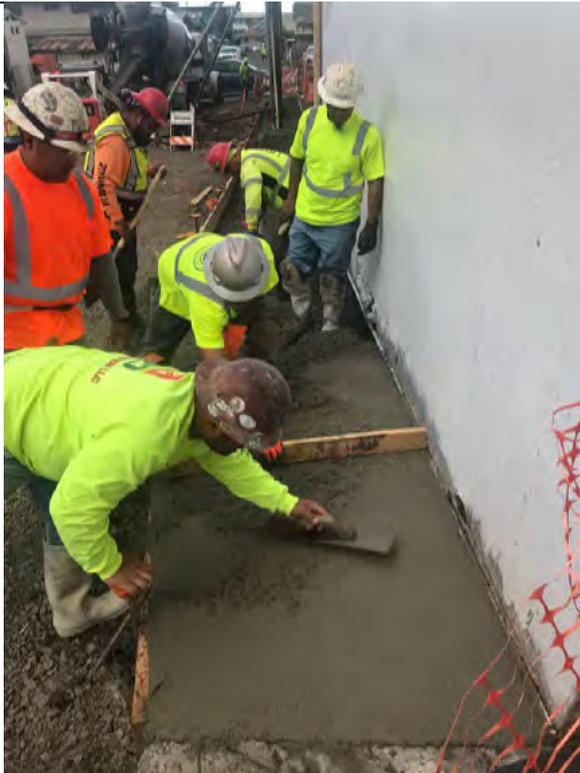
<b>Photo No.</b> <b>192</b>	<b>Date:</b> 02/28/2020
--------------------------------	----------------------------

**Description:**  
 Smoothing sidewalk concrete.

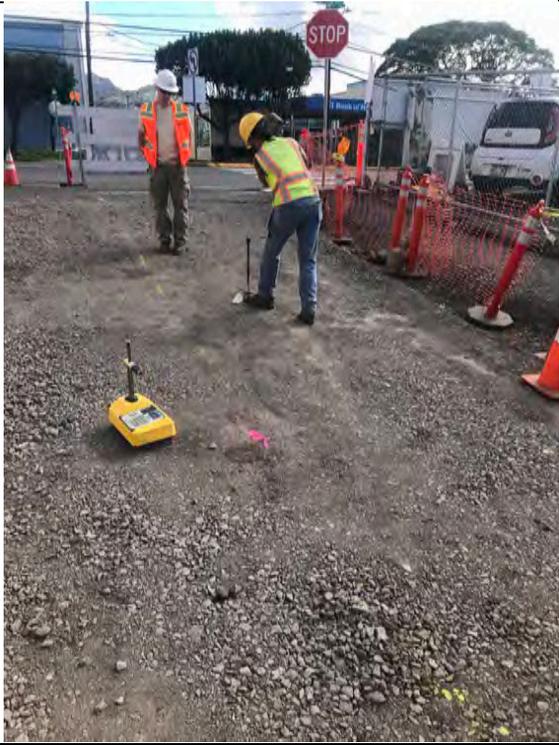
**Description:**  
 Compaction testing in DU-5.

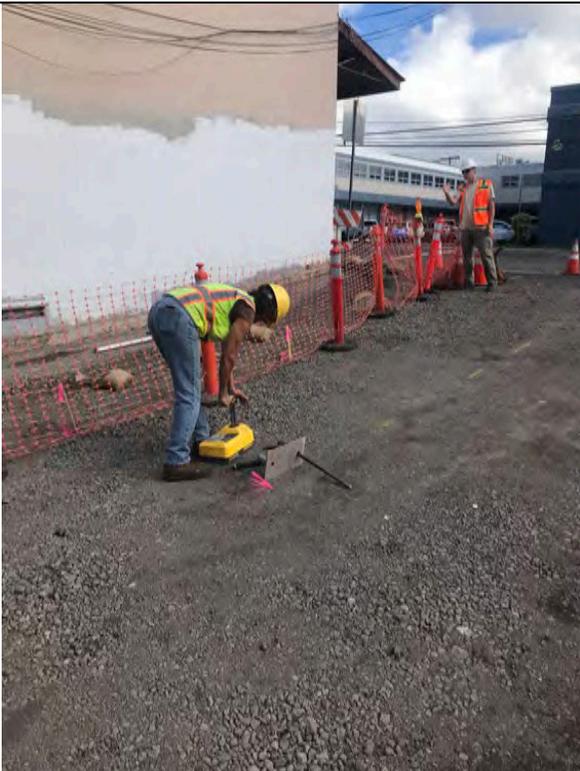
<b>Photo No.</b> <b>202</b>	<b>Date:</b> 02/25/2020
--------------------------------	----------------------------

**Description:**  
 Compaction testing at the project site.

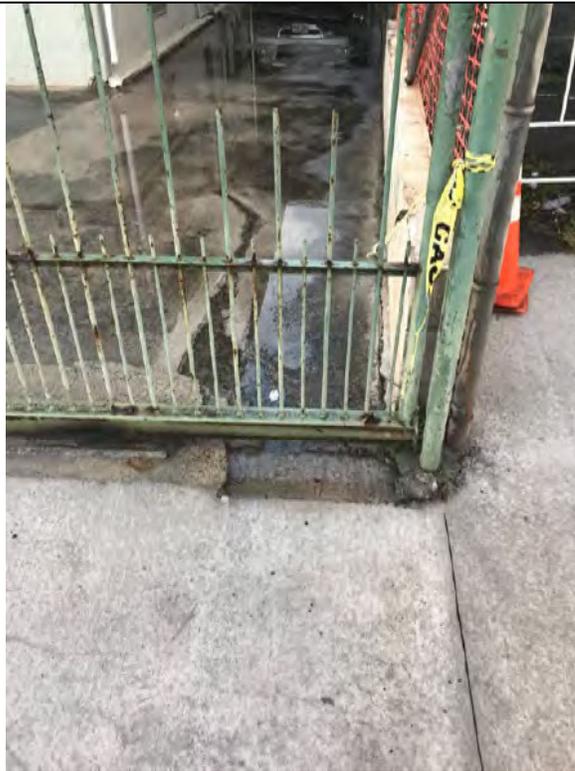
<b>Photo No.</b> <b>210</b>	<b>Date:</b> 03/06/2020
--------------------------------	----------------------------

**Description:**  
 A feature was engineered on the eastern edge of 914 Factory Street to improve drainage.

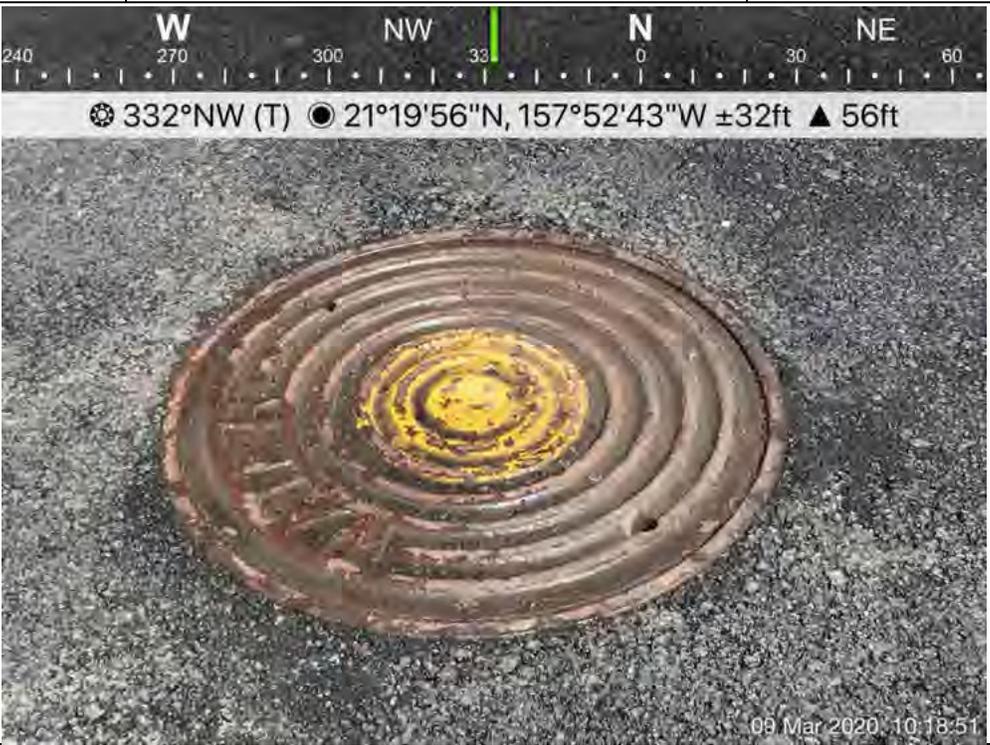
**Description:**  
Resurfaced pavement surrounding manhole cover on Factory Street.

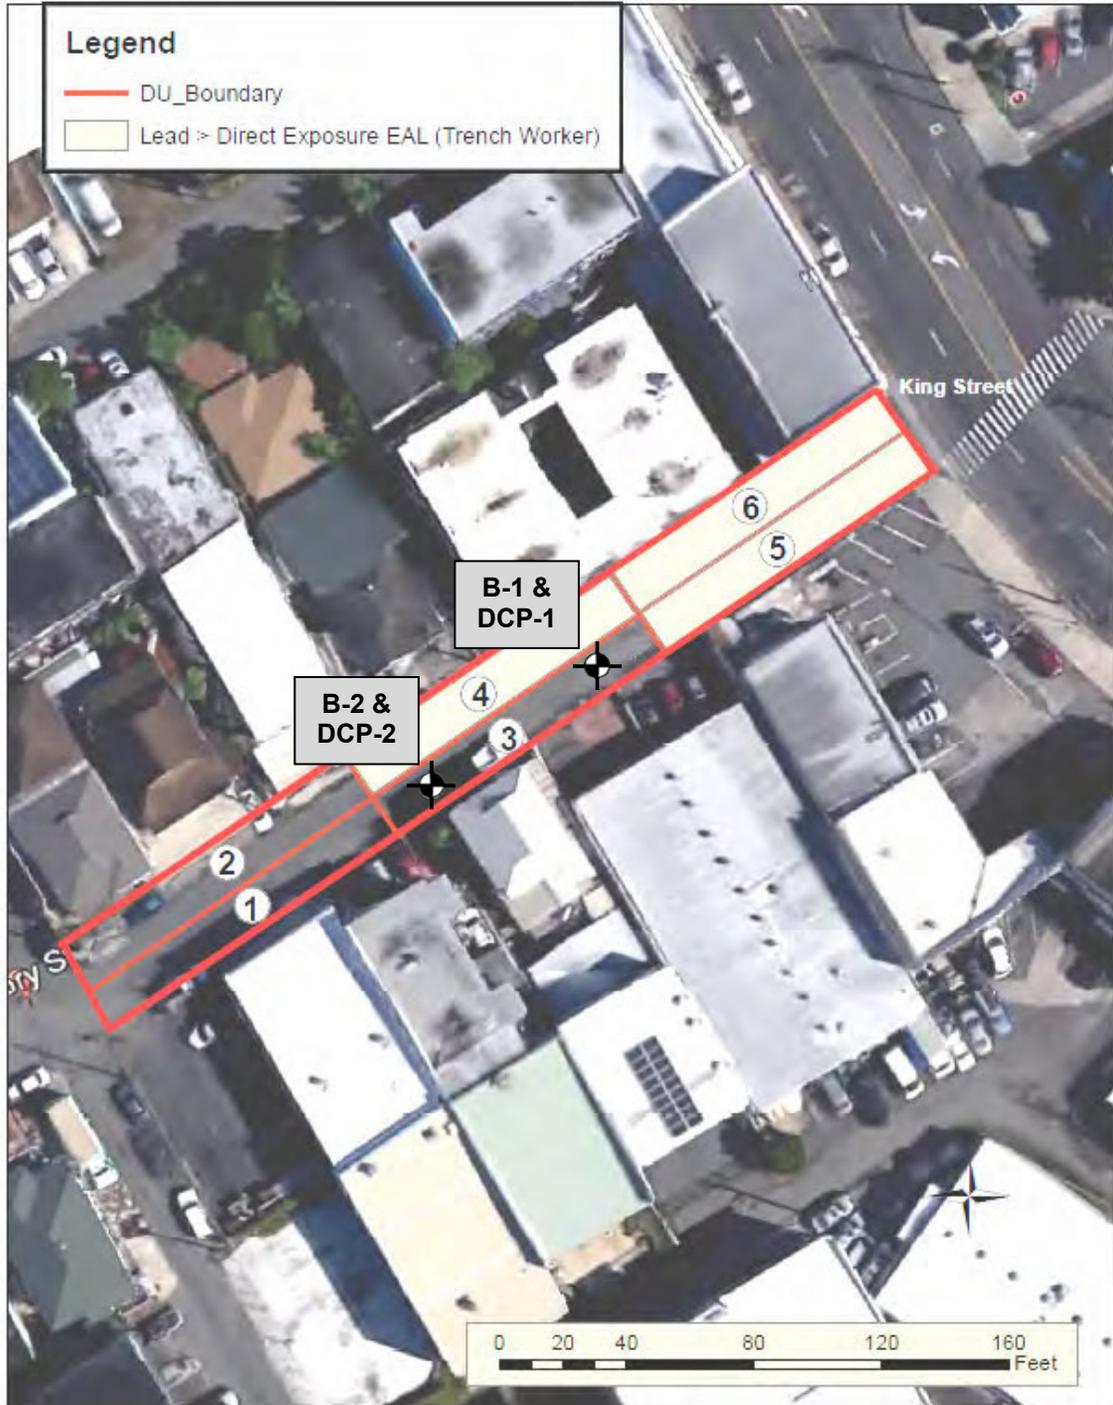
**PLOT PLAN**  
SCALE: 1" = 60'

The subsurface condition at the site was explored by drilling 2 test borings to depths of 4.0 and 5.0 feet below existing grade. The locations of the borings are shown on the Plot Plan, Plate 2. Detailed logs of the borings are presented in the Log of Borings, Plates 3 and 4.

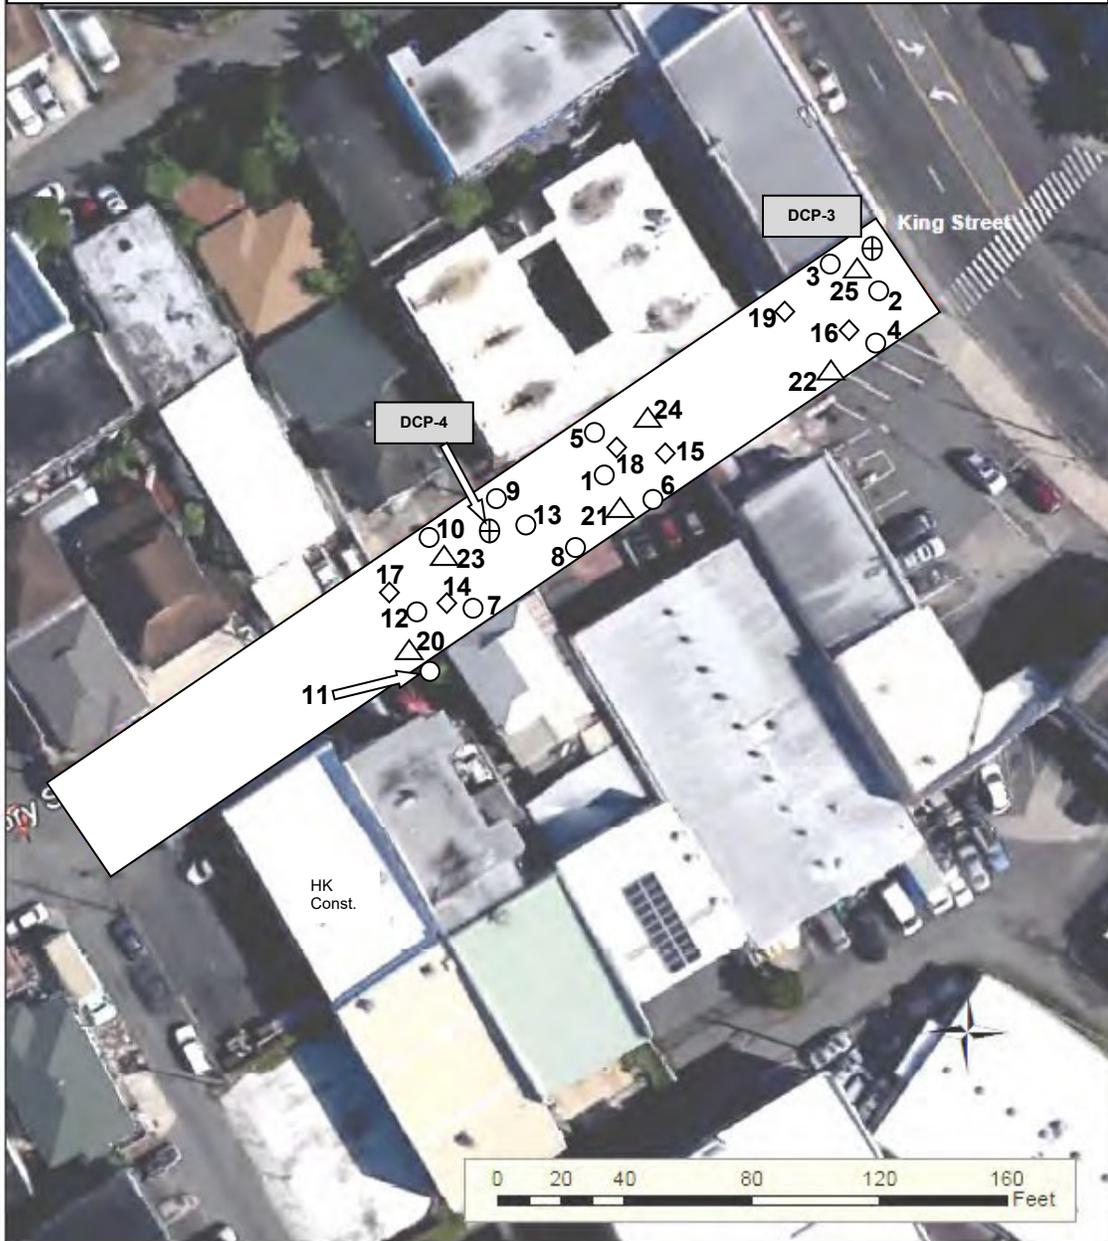
**PLOT PLAN: LOCATIONS OF FIELD TESTS**

Approximate Field Density Test Locations: ○ UTB Tests 1 through 13; ◇ ATB Tests 14 through 19; △ AC Tests 20 through 25

Date	Test No.	Location (see plan)	Approx. Elev.	Max. Dry Density (pcf)	Field Moisture %	Field Dry Density (pcf)	Min. Comp. Req'd	% of Max. Dry Density	Remarks
2/25/2020	1	Pavement	UTB	136	5.4	129.8	95	95.4	Pass
2/25/2020	2	Pavement	UTB	136	5.3	126.4	95	92.9	Fail; See Test 2A for retest
2/25/2020	3	Sidewalk	UTB	136	6.5	114.9	95	84.5	Fail; See Test 3A for retest
2/25/2020	4	Sidewalk	UTB	136	4.5	107.9	95	79.3	Fail; See Test 4A for retest
2/25/2020	2A	Retest	UTB	136	5.0	132.9	95	97.7	Pass
2/25/2020	3A	Retest	UTB	136	9.3	128.3	95	94.3	Pass/RR
2/25/2020	4A	Retest	UTB	136	5.7	128.0	95	94.1	Pass/RR
2/25/2020	5	Sidewalk	UTB	136	6.8	130.1	95	95.7	Pass
2/25/2020	6	Sidewalk	UTB	136	5.9	127.8	95	94.0	Pass/RR
3/2/2020	7	Sidewalk	UTB	136	6.6	127.4	95	93.7	Pass/RR
3/2/2020	8	Sidewalk	UTB	136	5.6	129.8	95	95.4	Pass
3/2/2020	9	Sidewalk	UTB	136	6.1	130.3	95	95.8	Pass
3/2/2020	10	Sidewalk	UTB	136	5.5	128.6	95	94.6	Pass/RR

Date	Test No.	Location (see plan)	Approx. Elev.	Max. Dry Density (pcf)	Field Moisture %	Field Dry Density (pcf)	Min. Comp. Req'd	% of Max. Dry Density	Remarks
3/5/2020	14	Pavement	ATB	161.6	4.3	157.0	95	97.2	Pass
3/5/2020	15	Pavement	ATB	161.6	4.2	152.6	95	94.4	Pass/RR
3/5/2020	16	Pavement	ATB	161.6	3.3	155.3	95	96.1	Pass
3/5/2020	17	Pavement	ATB	161.6	3.9	159.7	95	98.8	Pass
3/5/2020	18	Pavement	ATB	161.6	3.5	156.7	95	97.0	Pass
3/5/2020	19	Pavement	ATB	161.6	3.4	155.2	95	96.0	Pass
3/5/2020	20	Pavement	AC	167.5	4.0	151.9	91	90.7	Pass/RR
3/5/2020	21	Pavement	AC	167.5	3.8	153.6	91	91.7	Pass
3/5/2020	22	Pavement	AC	167.5	3.8	151.7	91	90.6	Pass/RR
3/5/2020	23	Pavement	AC	167.5	3.5	151.7	91	90.6	Pass/RR
3/5/2020	24	Pavement	AC	167.5	3.8	151.6	91	90.5	Pass/RR
3/5/2020	25	Pavement	AC	167.5	3.9	152.4	91	91.0	Pass

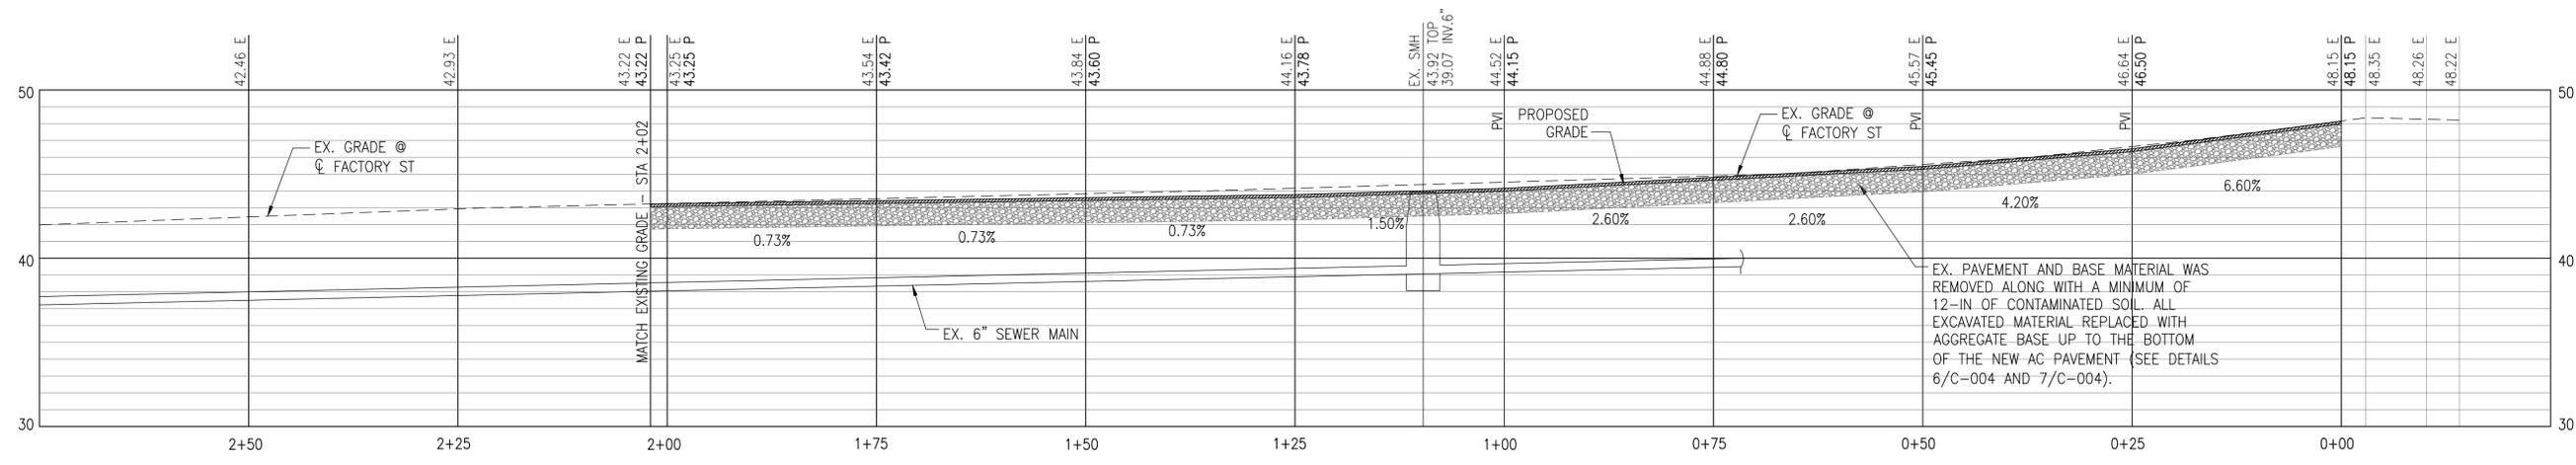
**2 PROPOSED STREET PROFILE**  
C-003 SCALE: 1" = 10' (HORZ.) 1" = 5' (VERT.)

**NOTE:**  
ALL EXISTING UTILITY BOXES, MANHOLES, ETC. SHALL BE ADJUSTED OR REPLACED TO MATCH PROPOSED GRADES.
