Telluride Valley Floor

## Overview

U.S. Environmental Protection Agency, in conjunction with U.S. Forest Service, is conducting a joint Removal Action at the Telluride Valley Floor Site, which is located in Telluride, CO.

This Story Map will provide an up to date summary of work progress during the Phase 2 Time Critical Removal Action.

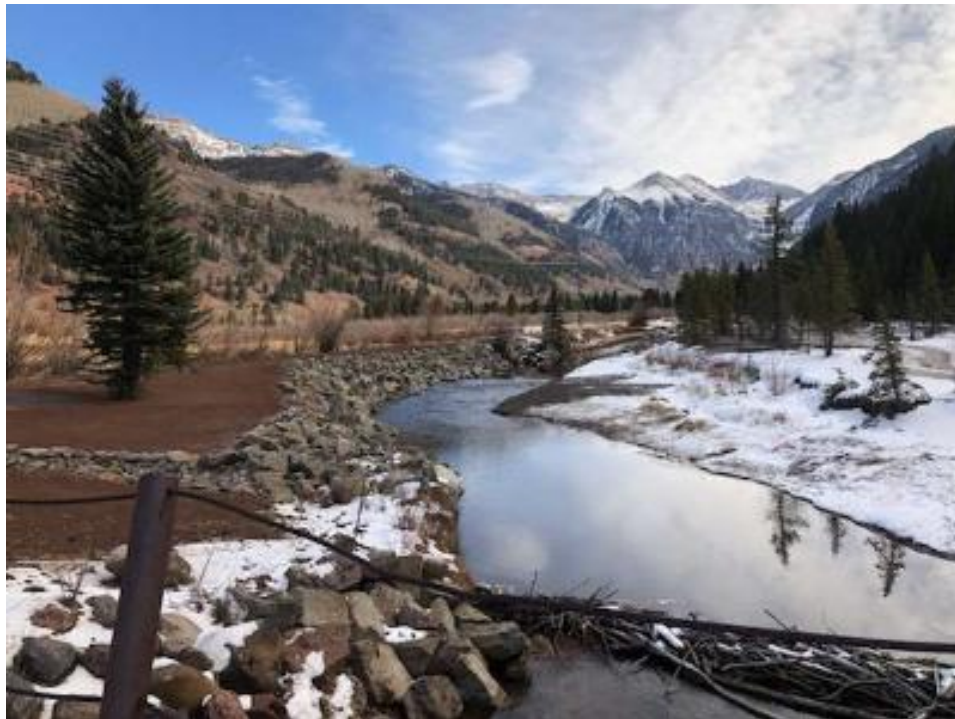
Installed Drainage Controls

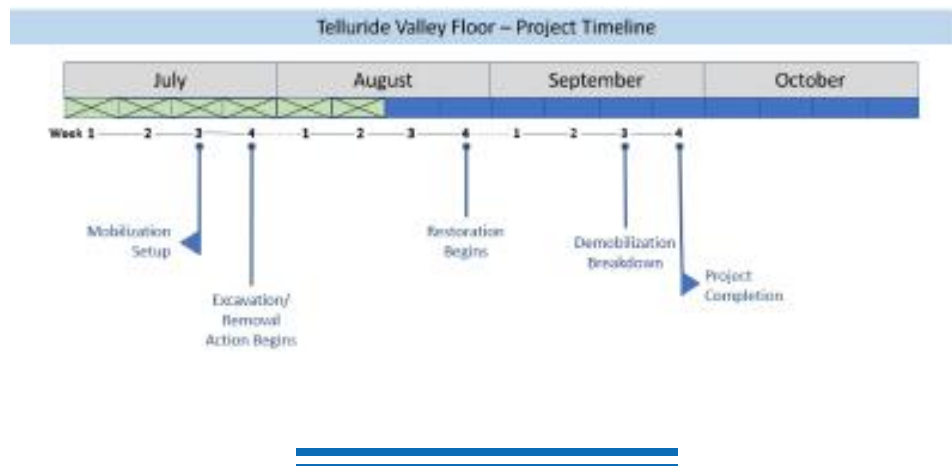
NOTE: Timeline may change due to weather and/or other constraints.
