Utility Disconnection Summary
Vo-Toys Site – Harrison, New Jersey

**Attachment A - Photograph Log
Vo-Toys Utility Disconnection Summary**

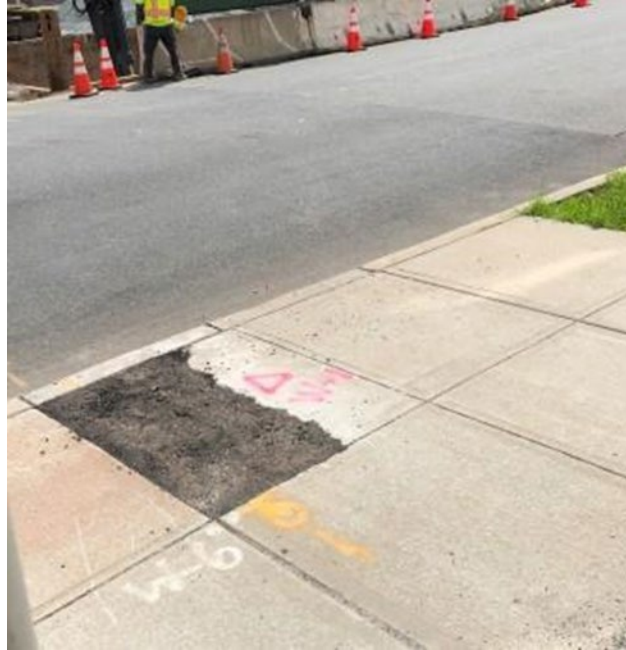
Building C Patch in Sidewalk at Location of Gas Line Disconnection - 7/2019 (#1)

Utility Type	Utility Owner	Location of Disconnect	Map/Photo Reference Number ^(1,2)	Method of Disconnect	Entity Performing Disconnect	Date of Disconnect	AQ and EPA Personnel on-site day of disconnect	Documentation
Building C								
Natural Gas	PSEG	Beneath sidewalk adjacent to southeast corner of Building C	1	Cut and capped the gas service line for Building C. Gas meter abandoned in-place on the first floor.	PSEG	Late-May 2019	Performed as part of fire prevention activities for Building C prior to RA field work.	<ul style="list-style-type: none"> Letter Confirming Disconnection from PSE&G (page 15 of the Building C demolition Permit package) Photograph of sidewalk patch after work performed
Cable	Comcast/Verizon	Southwest and southeast corners of Building C	2	Cut at pole	Comcast/Verizon/ Brandenburg	12/30/2020	<u>Anchor QEA:</u> Jeffs, Bleichner <u>EPA:</u> Byk, Rosoff	<ul style="list-style-type: none"> Photograph

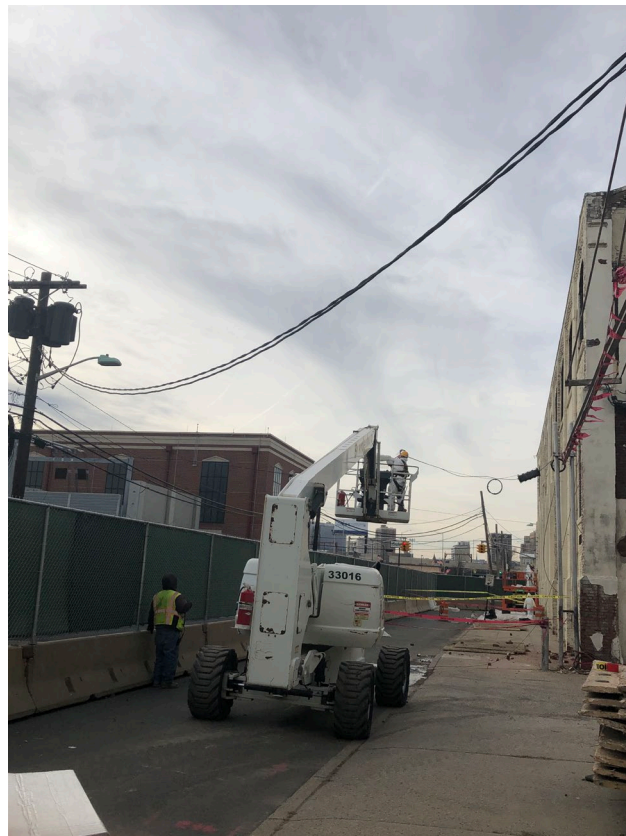
Buildings C and B Cable Disconnection – 12/30/2020 (#2 and #6)

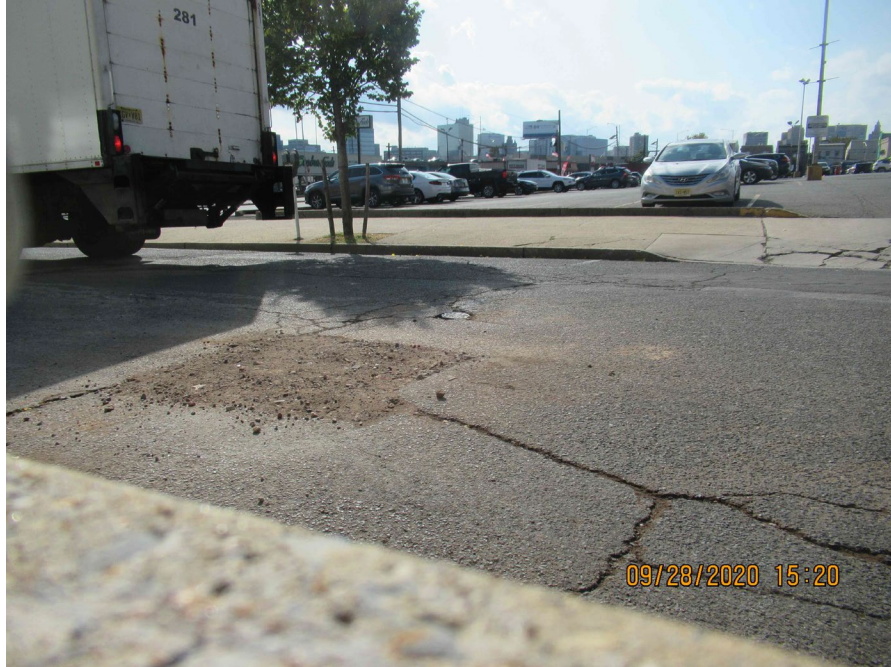
Building C Waterline Disconnection located in 5th Street – 9/28/2020 (#3)

Water	Town of Harrison	Northwest corner of Building C (5 th Street)	3	Physical separation of service pipe. Sleeve to be installed on main by Harrison Department of Public Works (HDPW)	HDPW (associated with water pipe/valve break in first floor)	9/28/2020	<u>Anchor QEA:</u> Nowak, Bleichner <u>EPA:</u> Byk, Rosoff	<ul style="list-style-type: none"> Weekly report (10/2/2020) Letter of Disconnection from Town of Harrison (Page 16 of Building C Demolition Permit package) Photograph
Sanitary Sewer	Town of Harrison	Vault in Building C	4	Service Disconnection: Cut, installed plug, and grouted over plug at property line	Brandenburg	3/24/2021	<u>Anchor QEA:</u> Nowak, Bleichner <u>EPA:</u> Byk	<ul style="list-style-type: none"> Weekly Report (3/26/2021) Building C demolition permit package
		5 th Street		Disconnection at main: Sewer line cut at building footprint and in center of street. Filled with flowable fill and abandoned in place.	Brandenburg's subcontractor, Underground Utilities Corp.	11/30/2021	<u>Anchor QEA:</u> Yumiguano, Bleichner <u>EPA:</u> Byk, Rosoff, D'Onofrio	<ul style="list-style-type: none"> Weekly Report (12/3/2021) Photograph

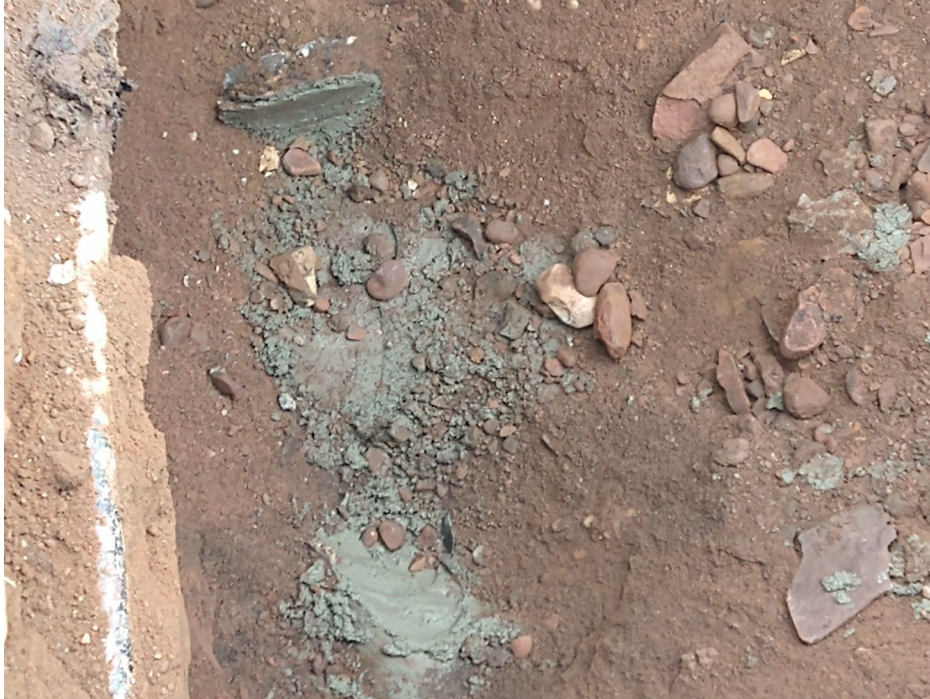
Building C Sanitary Sewer Disconnection located in 5th Street – 11/30/2021 (#4)

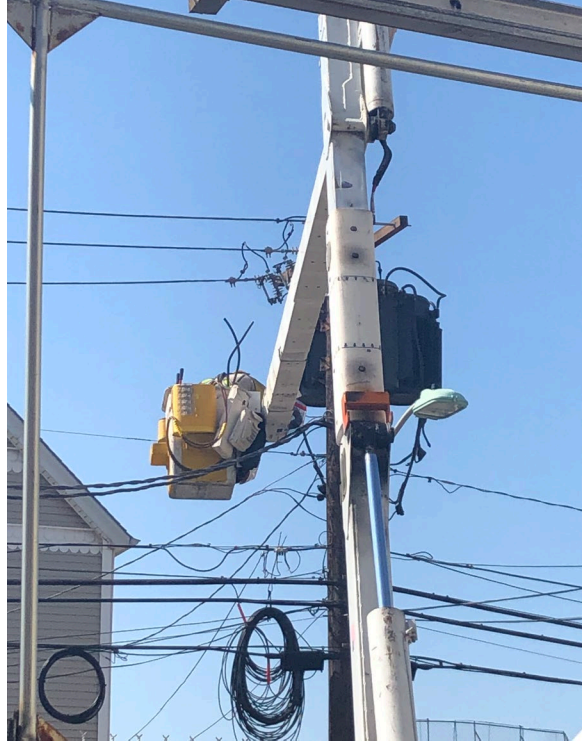
Building C Electric Disconnection at Utility Pole on Bergen Street - 8/2019 (#5)

Electric	PSE&G	Utility pole on South side of Bergen Street near southeast corner of Building C	5	Disconnected at utility pole. Electrical meters abandoned within building.	PSE&G	8/19/2019	<u>Anchor QEA:</u> Musser. Performed as part of fire prevention activities for Building C prior to RA field work	<ul style="list-style-type: none"> Letter Confirming Disconnection from PSE&G (page 15 of the Building C demolition Permit package) Photograph
Building B								
Natural Gas	No natural gas piping in Building B							
Cable	Comcast/Verizon	Southwest corner of building	6	Cut at pole	Comcast/Verizon/ Brandenburg	12/30/2020	<u>Anchor QEA:</u> Jeffs, Bleichner <u>EPA:</u> Byk, Rosoff	
Water	Town of Harrison	4-inch and 2-inch waterlines entering Building B from Bergen Street	7	Cut and capped 4-inch and 2-inch water service lines	Brandenburg's subcontractor, Underground Utilities Corp.	11/9/2021 and 11/10/2021	<u>Anchor QEA:</u> Yumiguano <u>EPA:</u> Byk, Rosoff (11/10)	<ul style="list-style-type: none"> Weekly Report (11/12/2021) Photographs

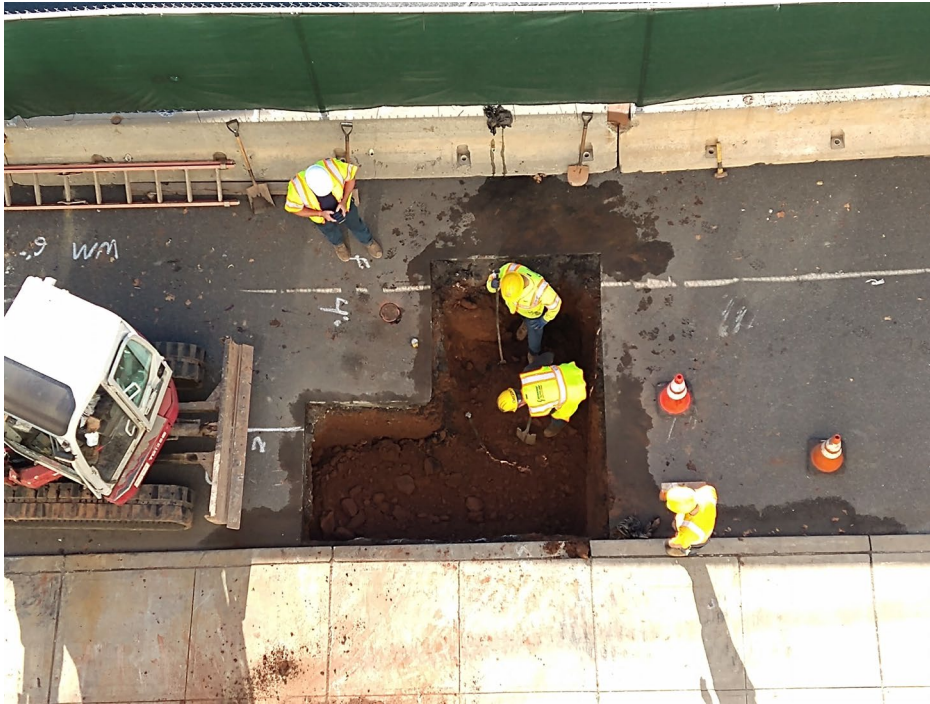
Building B Excavation for Waterline Disconnection at Bergen Street – 11/9/2021 (#7)

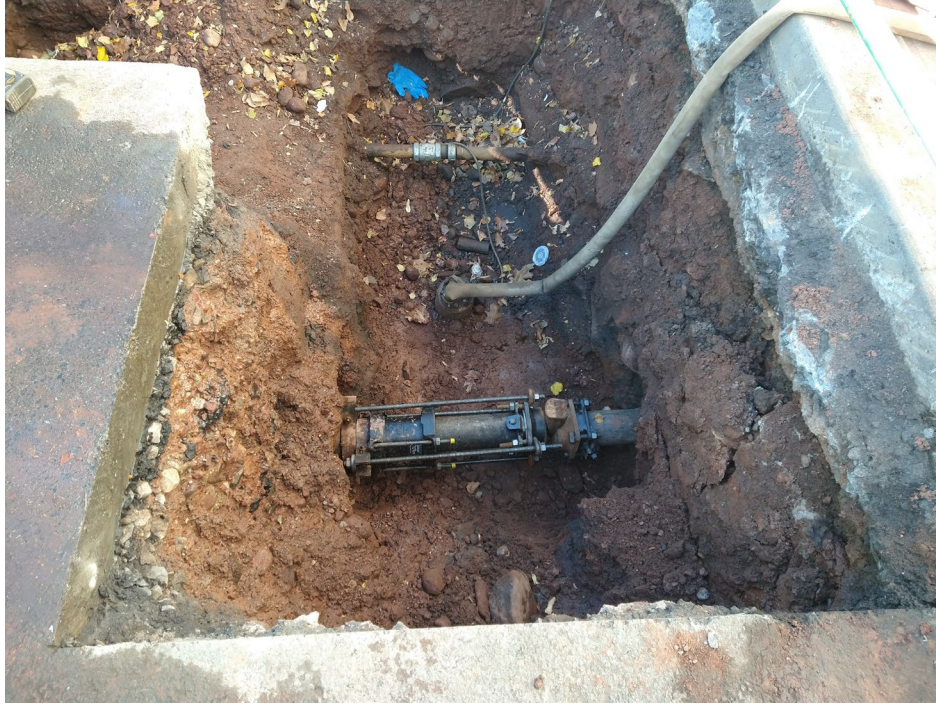
Building B Waterline Disconnections - 11/10/2021 (#7)

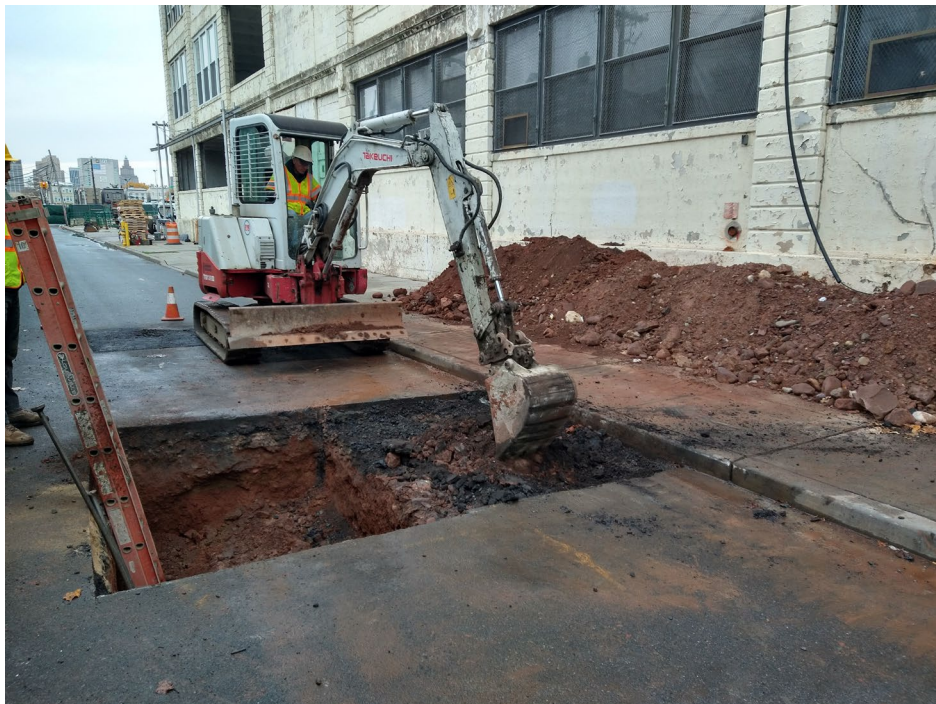
Building B Preparation to Disconnect 6-inch Waterline on Bergen Street – 11/22/2021 (#7)

6-inch fire suppression line entering Building B from Bergen Street		Cut and capped 6-inch line	Brandenburg's subcontractor, Underground Utilities Corp.?	11/22/2021	<u>Anchor QEA:</u> Yumiguano, Bleichner <u>EPA:</u> Byk, Rosoff, D'Onofrio	<ul style="list-style-type: none"> Weekly Report (11/26/2021) Photographs

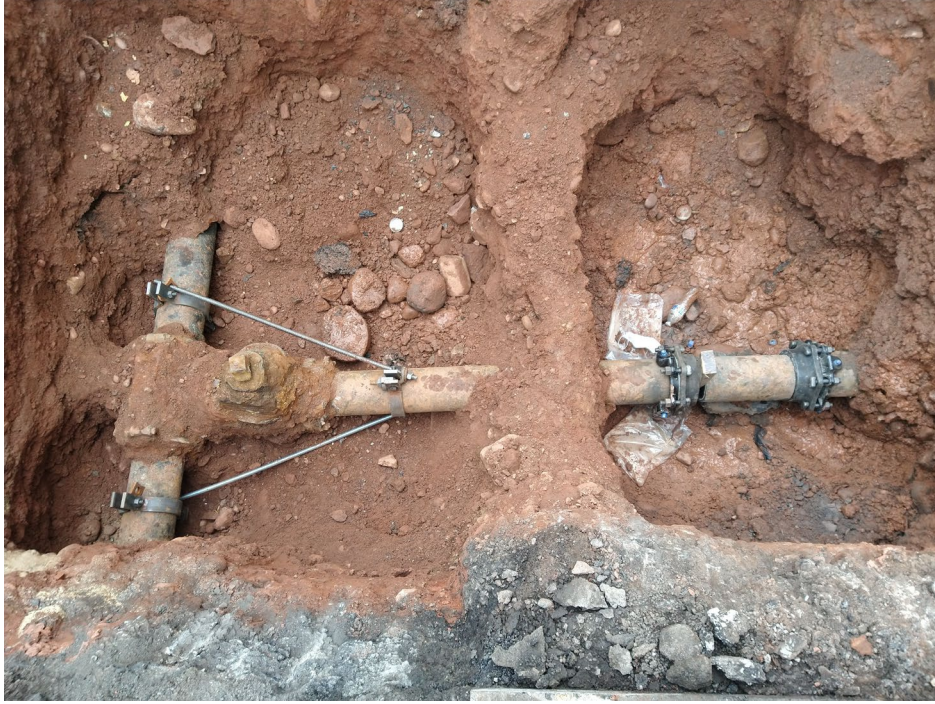
Building B 6-inch Waterline Disconnection at Bergen Street – 11/22/2021 (#7)

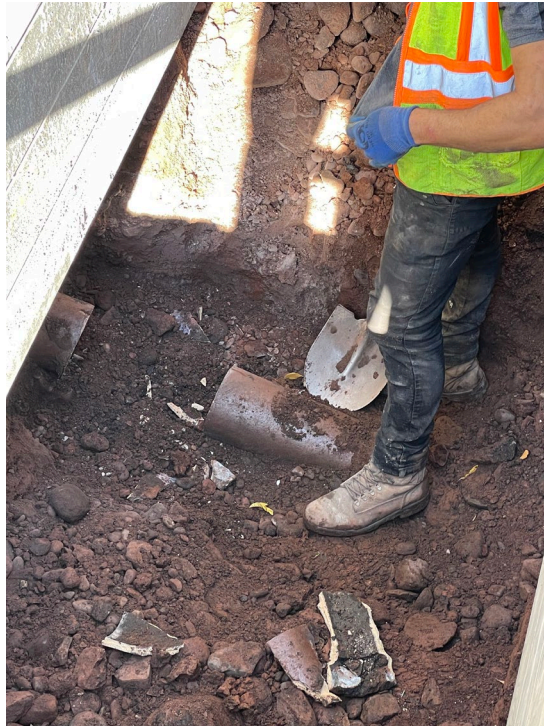
Building B Sanitary Sewer Disconnection 6th street – 11/10/2021 (#8)

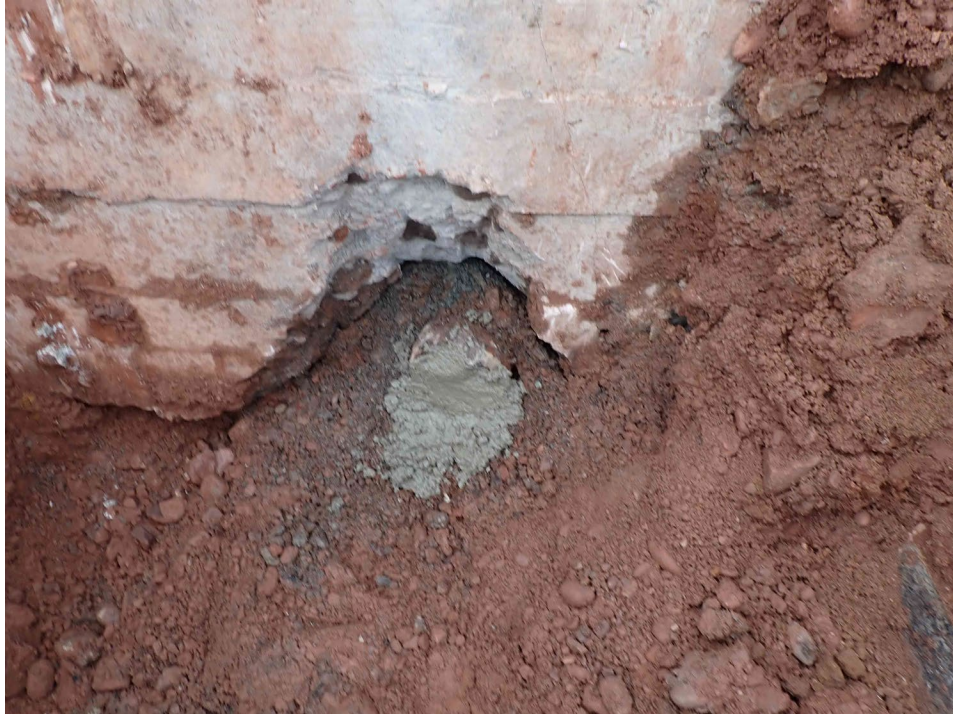
Building B Sanitary Sewer Disconnection – 5/24/2022 (#9)

Building B perimeter (6 th Street and Bergen Street cut/caps)	9	Sewer pipes observed in subsurface post-demolition cut and capped at the foundation wall and filled with concrete (16 locations).	Brandenburg	May and June 2022	<u>Anchor QEA</u> : Bleichner <u>EPA</u> : Various	<ul style="list-style-type: none"> Photographs
Electric	PSE&G	Utility pole on South side of Bergen Street near southwest corner of Building B	10	Disconnected at utility pole. Electrical meters abandoned within building.	PSE&G	6/22/2021	<u>Anchor QEA</u> : Jeffs, Bleichner <u>EPA</u> : D'Onofrio	<ul style="list-style-type: none"> Weekly report (6/25/2021)
Building A								
Natural Gas	PSE&G	5 th street sidewalk east of Building A/C Courtyard	11	Cut and cap	PSE&G	8/2/2021	<u>Anchor QEA</u> : Yumiguano, Bleichner <u>EPA</u> : Byk	<ul style="list-style-type: none"> Weekly report (8/6/2021) Photograph
Water	Town of Harrison	6 th Street	12	Removed valve and sleeved line.	Brandenburg's subcontractor, Underground Utilities Corp.	11/30/2021 and 12/1/2021	<u>Anchor QEA</u> : Yumiguano, Bleichner <u>EPA</u> : Byk, Rosoff, D'Onofrio	<ul style="list-style-type: none"> Weekly report (12/3/2021) Photograph

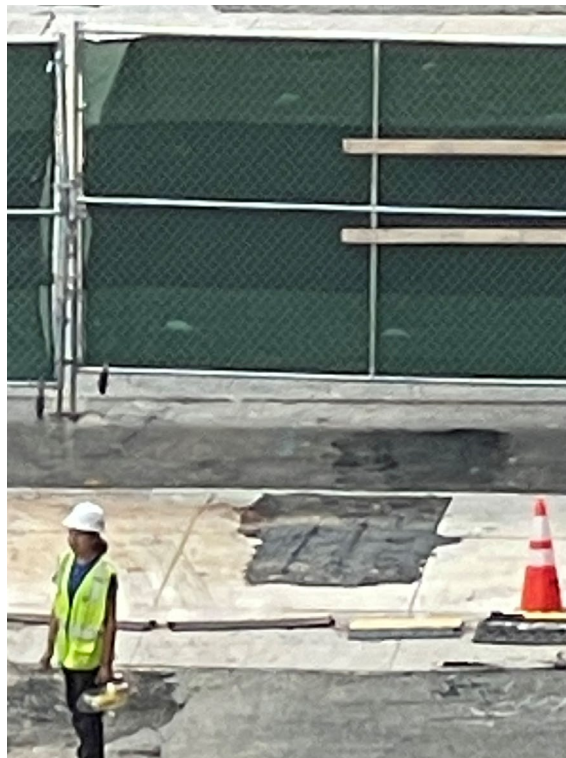
Building A Gas Disconnection Location on 5th Street – 8/2/2021 (#11)

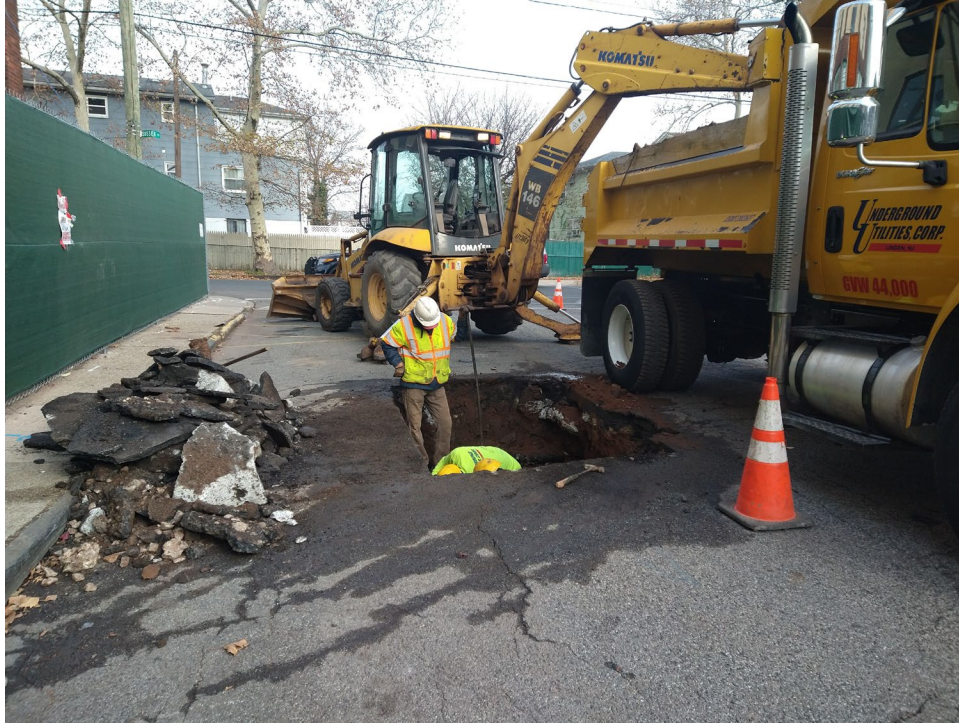
Building A Waterline Disconnection located in 6th Street – 11/30/2021 (#12)

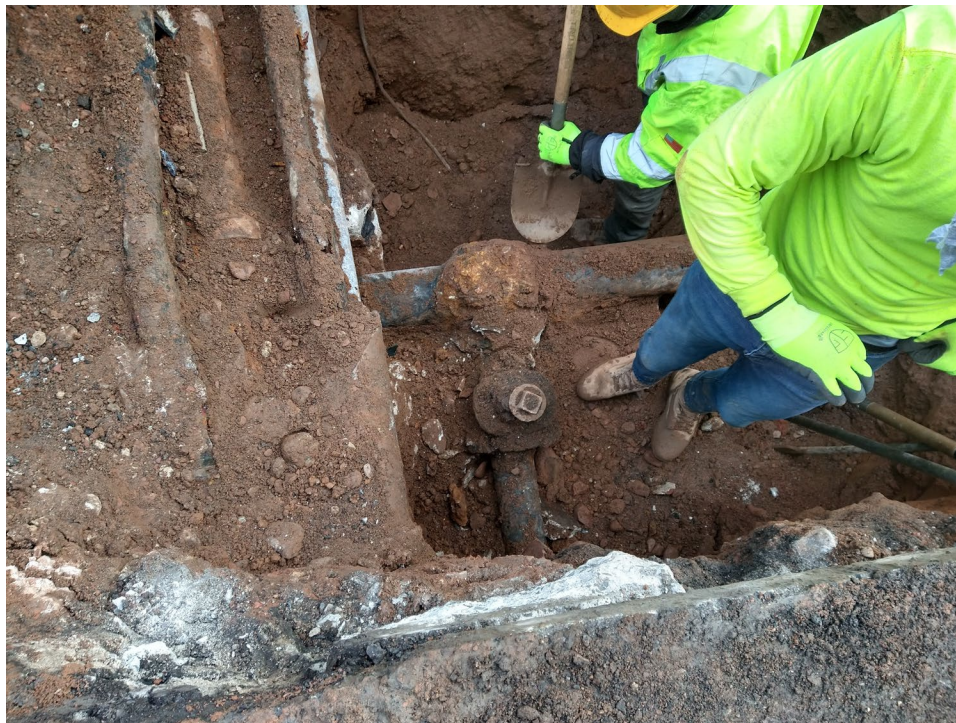
Building A Waterline located in 6th Street – 11/30/2021 (#12)

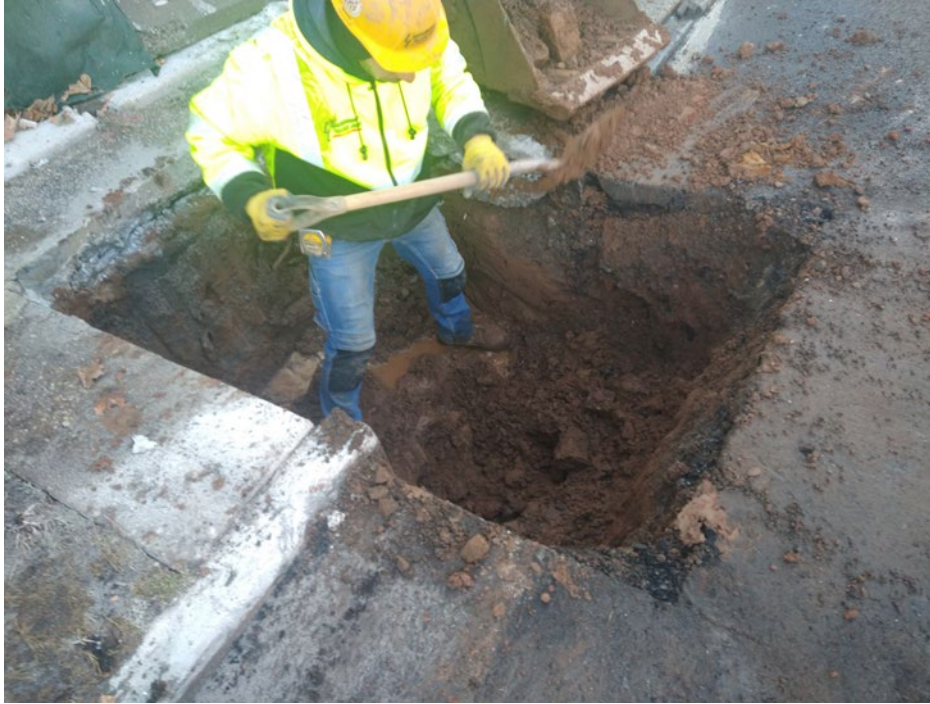
Building A – Excavate for 6-inch Waterline Disconnection – 2/8/2022 (#13)

6-inch and 8-inch waterlines on West side of Building A in 5 th Street	13 & 14	6-inch waterlines cut and capped. 8" waterlines traced back to main valve located at Sussex and 5 th Street intersection and the main valve was closed as temporary disconnection measure. HDPW will replace valve and perform final disconnection in the future.	Brandenburg's subcontractor, Underground Utilities Corp	2/8/2022	<u>Anchor QEA</u> : Yumiguano, Bleichner <u>EPA</u> : Byk, Rosoff, D'Onofrio	<ul style="list-style-type: none"> Weekly report (2/11/2022) Photographs
		Courtyard at 5 th Street	15	Waterline was cut and capped with mega-lug fitting and concrete thrust block.	EWMI	8/8/2023 and 8/25/2023	<u>Anchor QEA</u> : Colquhoun, Patterson <u>EPA</u> : Rosoff, Byk	<ul style="list-style-type: none"> Photograph
Sanitary Sewer	Town of Harrison	8-inch sanitary line east-west in the Building A/B courtyard disconnected at property boundary on 6 th Street	16	Sewer line cut, filled with concrete, and abandoned in place	Brandenburg's subcontractor, Underground Utilities Corp.	11/29/2021	<u>Anchor QEA</u> : Yumiguano, Bleichner <u>EPA</u> : Byk, Rosoff, D'Onofrio	<ul style="list-style-type: none"> Photograph

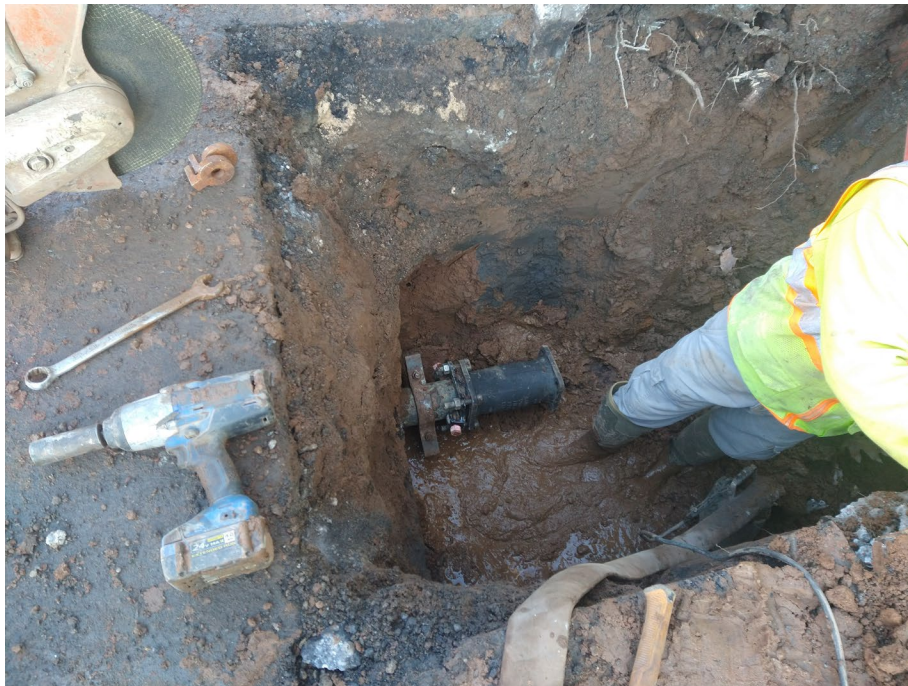
Building A 6-inch Waterline Disconnection – 2/8/2022 (#13)

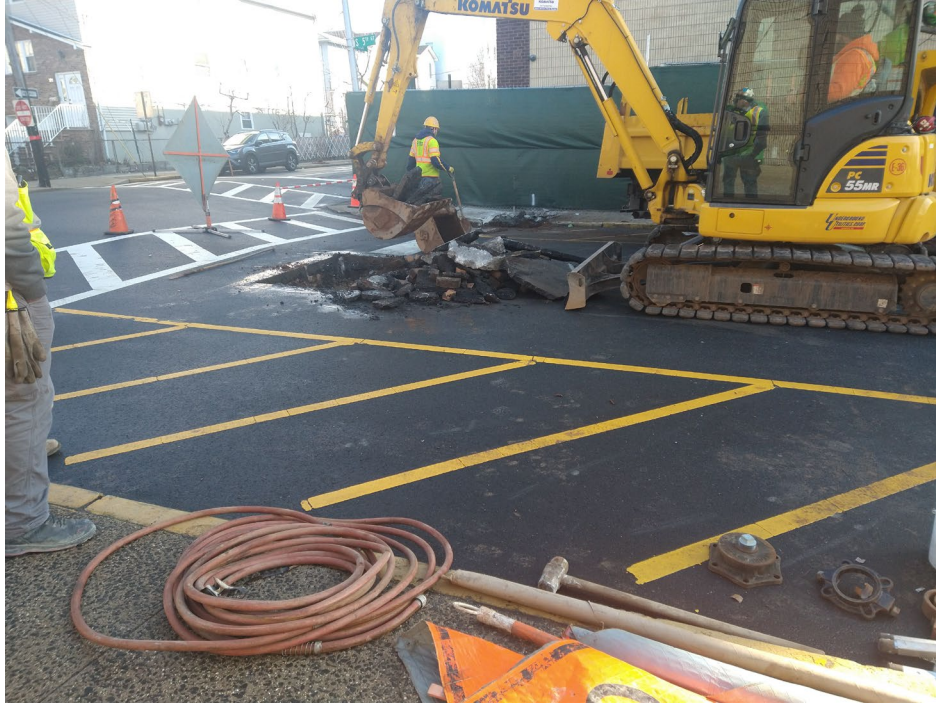
Building A Excavate for 8-inch Waterline Disconnection at Sussex and 5th – 2/8/2022 (#14)

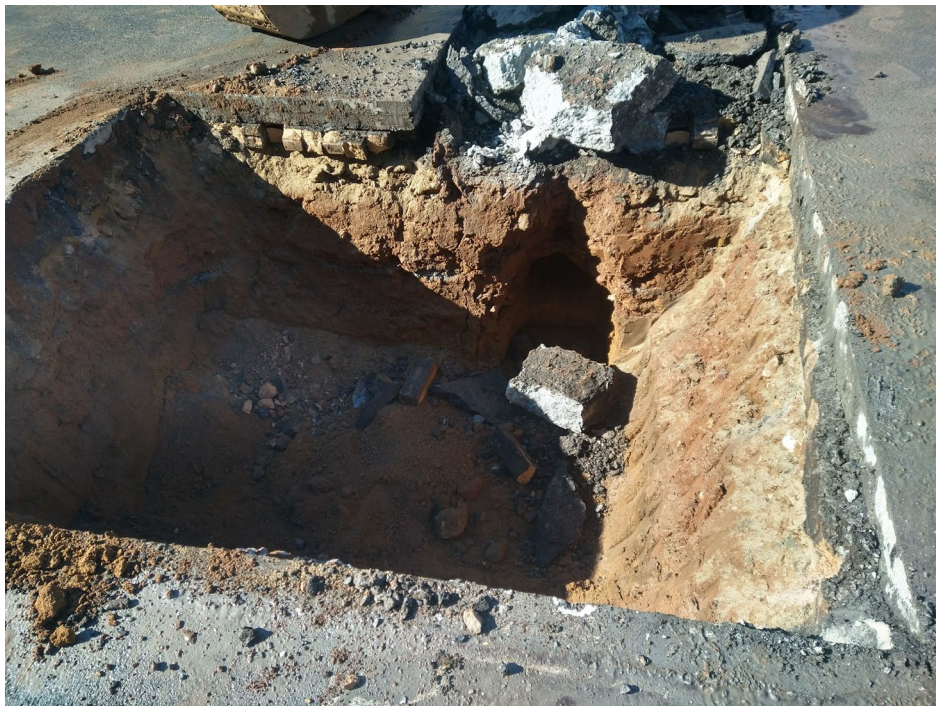
Building A 8-inch Waterline Disconnection Location – 2/8/2022 (#14)

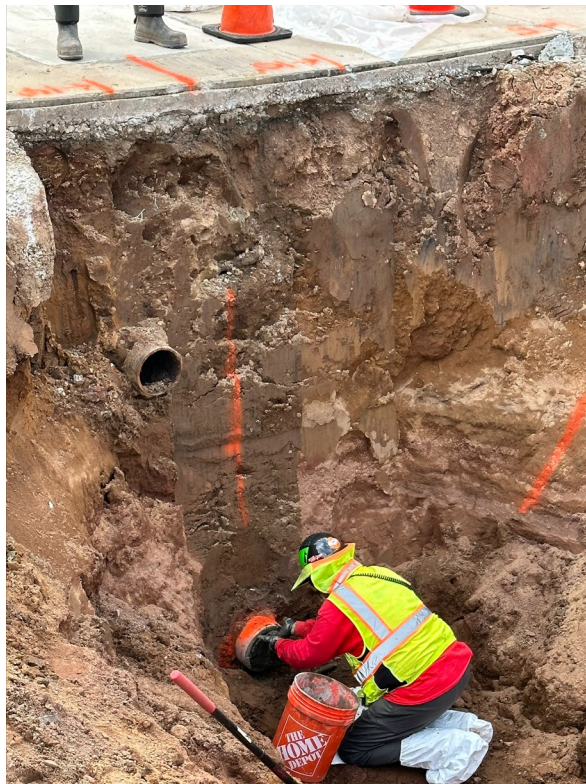
Courtyard at 5th Street Water and Sewer Disconnection – 8/8/2023 (#15 and #18)

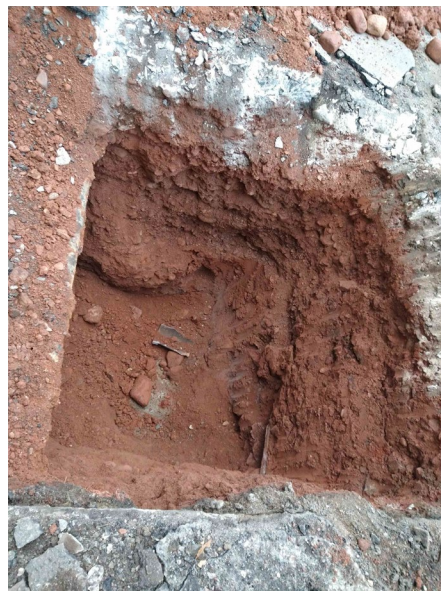
Courtyard at 6th Street Sewer Disconnection – 11/29/2021 (#16)

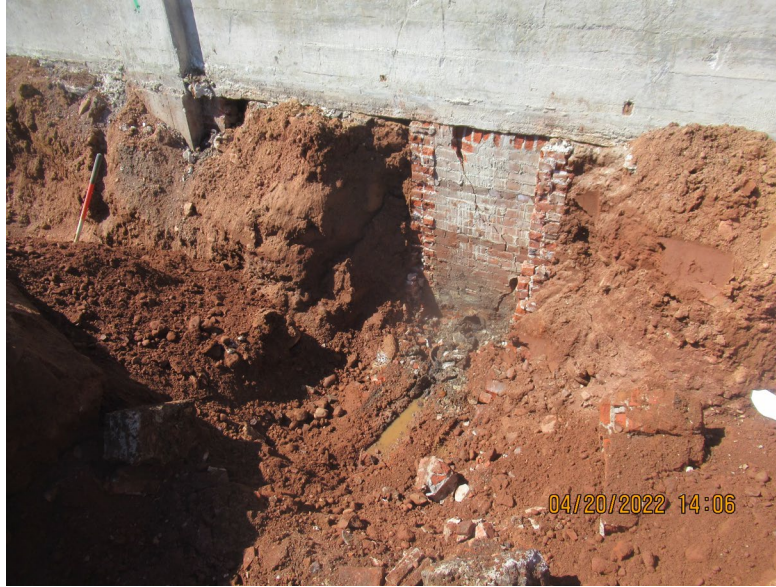
Building A Sewer Disconnection at North Wall – 5/2022 (#17)

Utility Type	Utility Owner	Location of Disconnect	Map/Photo Reference Number ^(1,2)	Method of Disconnect	Entity Performing Disconnect	Date of Disconnect	AQ and EPA Personnel on-site day of disconnect	Documentation
		Building A perimeter (F3.5, F9.5, A22)	17	Sewer pipes observed in subsurface post-demolition cut and capped at the foundation wall and filled with concrete.	Brandenburg	4/20,2022, 5/3/2022, 5/17/2022	<u>Anchor QEA:</u> Bleichner <u>EPA:</u> Various	• Photograph
		8-inch sanitary line east-west in the Building A/C courtyard disconnected at property boundary at South 5 th Street	18	Sewer line cut at property line and filled with concrete	EWMI	8/8/2023	<u>Anchor QEA:</u> Colquhoun, Patterson <u>EPA:</u> Rosoff, Byk	• Photograph
Electric	PSE&G	3 of 4 electric meters in Building A	18	Disconnected	PSE&G	6/21/2021	<u>Anchor QEA:</u> Jeffs, Bleichner <u>EPA:</u> None (Holiday)	• Weekly report (6/25/2021)

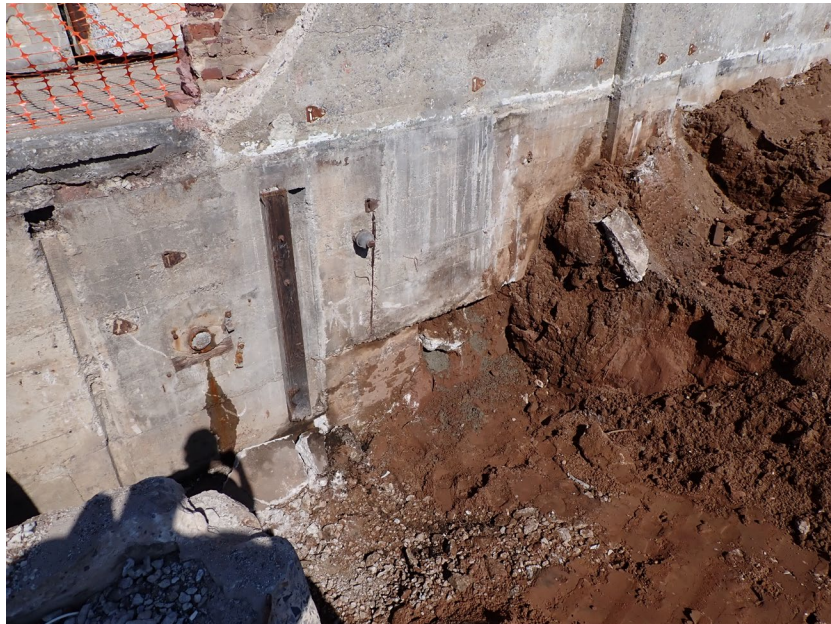
Building A Sewer Disconnection at West Wall – 5/2022 (#17)

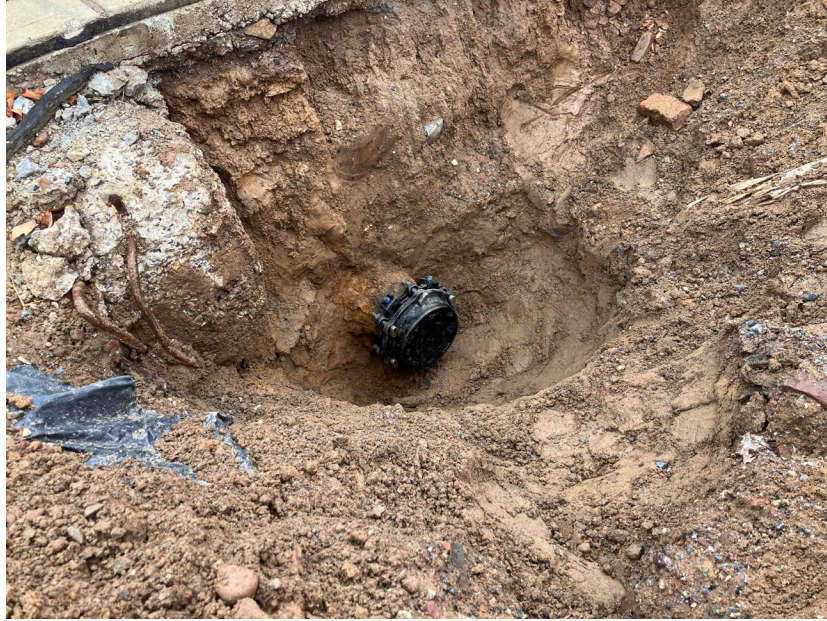
Courtyard at 5th Street Water Disconnection – 8/25/2023 (#15)
