UNITED STATES ENVIRONMENTAL PROTECTION AGENCY
REGION 8

ACTION MEMORANDUM

SUBJECT: Approval and Funding for a Removal Action and Exemption from the 12-month and \$2-million Statutory Limits for a CERCLA Removal Action at the Nelson Tunnel/Commodore Waste Rock Pile Superfund Site in Mineral County, Colorado

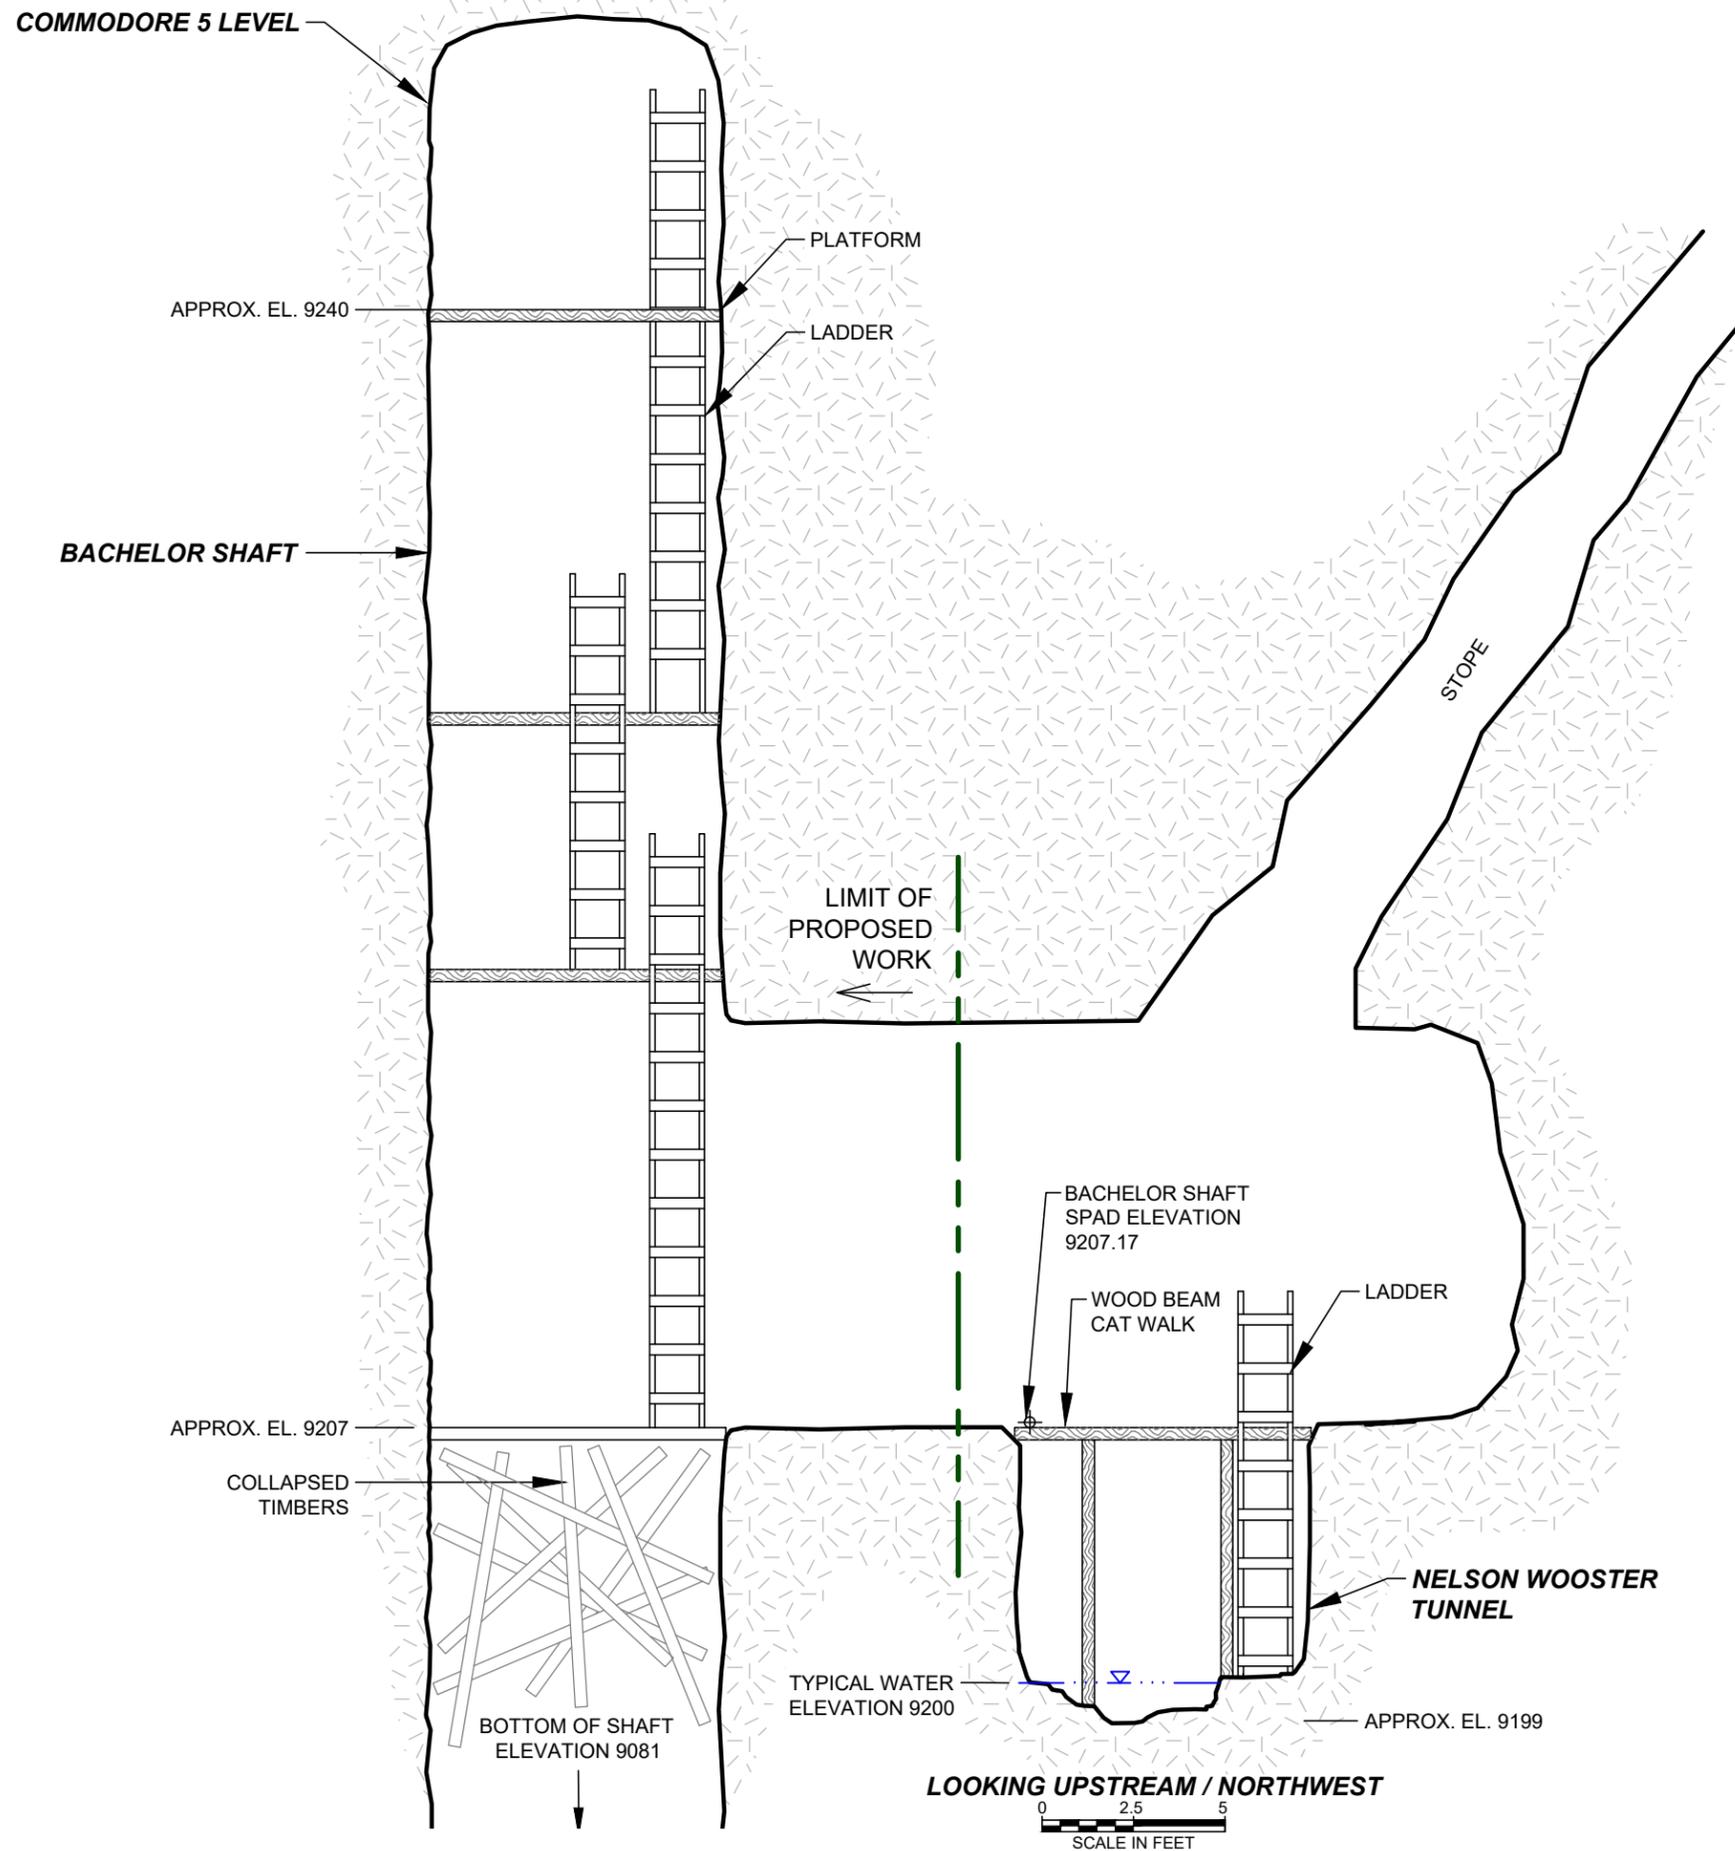
NELSON TUNNEL / COMMODORE 5	
BACHELOR SHAFT CROSS SECTION	
DEERE & AULT	FIGURE NO.
CONSULTANTS, INC.	5
DATE: FEB. 2018	SCALE: AS NOTED

The rock in the McClure Crosscut, in the hanging wall, consists of massive rhyolitic tuff, specifically the Campbell Mountain Member of the Bachelor Mountain Tuff. It was dry during our site visit and contained some ore chutes from upper levels. No ground support was noted but there was a moldy wood canopy possibly providing protection from small debris. See Photos 20-31.

Based on our observations, only minimal cleanup work will be required in the McClure Cross Cut area. The moldy canopy may have to be removed and replaced with bolts and wire mesh, depending on the ground conditions behind it. The bulk of the work will be in the Bachelor Shaft where the untreated wood ladders and landings should be replaced with fiber glass reinforced plastic ladders and landings, anchored into the rock wall. Figure 5 shows the Bachelor Shaft in cross section. Note that the work would be limited to the Bachelor Shaft and landing, without impacting or accessing the Nelson Tunnel.
