Telluride Valley Floor

U.S. Environmental Protection Agency, in conjunction with U.S. Forest Service, is conducting a joint Removal Action at the Telluride Valley Floor Site, which is located in Telluride, CO.

Telluride Valley Floor/Boomerang Road Time-Critical Removal Action Site Work
Update

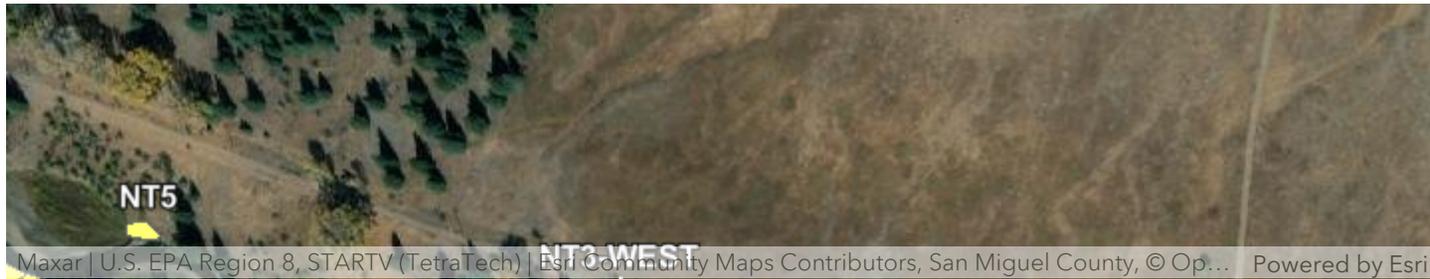
Excavation progress from the tailings piles is displayed here. The tailings areas are depicted in yellow to indicate that excavation progress has not yet started, blue to indicate that excavation is in progress, and green indicates it is complete.
