ACTION MEMORANDUM

SUBJECT: Combined Phase II Removal and \$2 Million Exemption Request Special Circumstances Action Memorandum to conduct a Time Critical Removal Action at the Colville Post and Poles Site, Colville, Stevens County, Washington

**Colville Post and Poles
Action Memorandum**

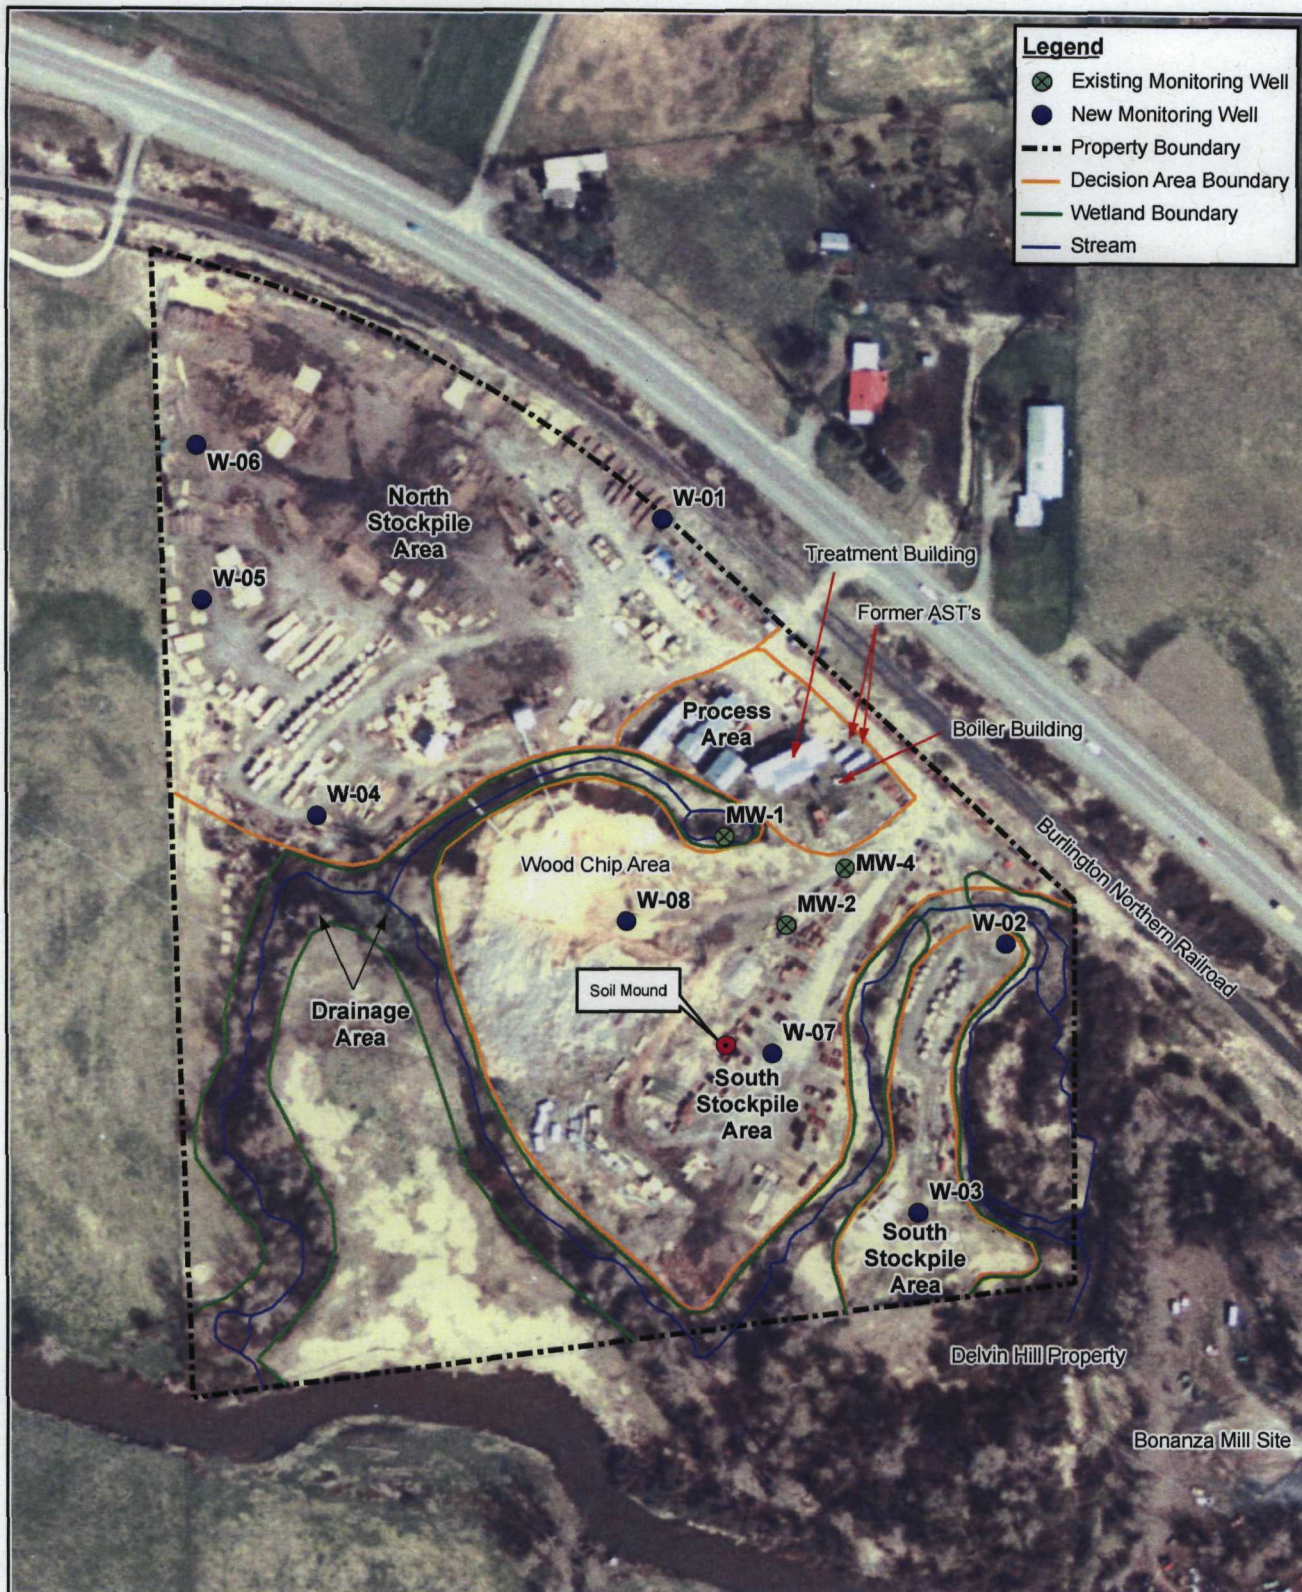
COLVILLE POST & POLE SITE

Colville Post and Poles, Inc. (Site) is a 23-acre wood treating facility surrounded by rural and semi-rural properties, located approximately 4 miles northwest of Colville, Washington, population 4,988 (Figure 1). The CERCLIS ID No. is WAN001002608, and the Site ID No. is 10CL. The Site is bordered by the Kettle Falls International Railway, LLC (formerly Burlington Northern Railroad line) and US Highway 395 on the north and by the Delvin Hill property and the Colville River on the south. No known schools or day-care facilities are located adjacent to the site (Figure 2).

Refer to Figure 1 for Colville Post and Poles Site location map; Figure 2 depicts the existing site layout, features, and decision areas; Figure 3 depicts the PCP and dioxins in Surface Soil and Sediment Sample Locations; Figure 4 depicts the PCP and Dioxins in Subsurface Soil Sample Locations; Figure 5 depicts the Maximum PCP Concentrations in Groundwater Sample locations.
