# Havertown PCP Superfund Site *Community Update*

**Haverford Township, Delaware County, Pennsylvania**

**November 2019**

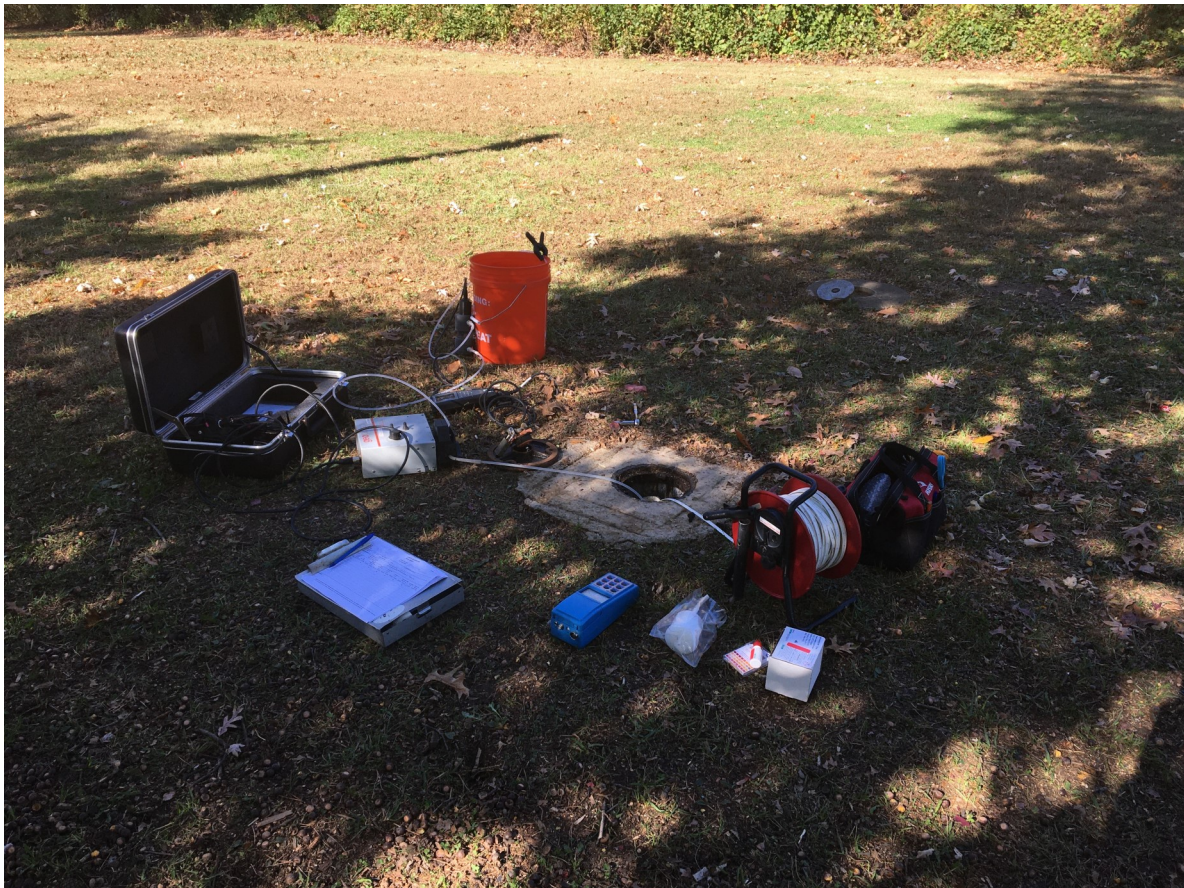
Example of groundwater sampling and equipment near the Havertown PCP Superfund Site.

Between February and June 2019, EPA and PADEP conducted various tests and collected samples from residential sumps, soil and groundwater seeps in yards that were near the Havertown PCP Superfund Site.

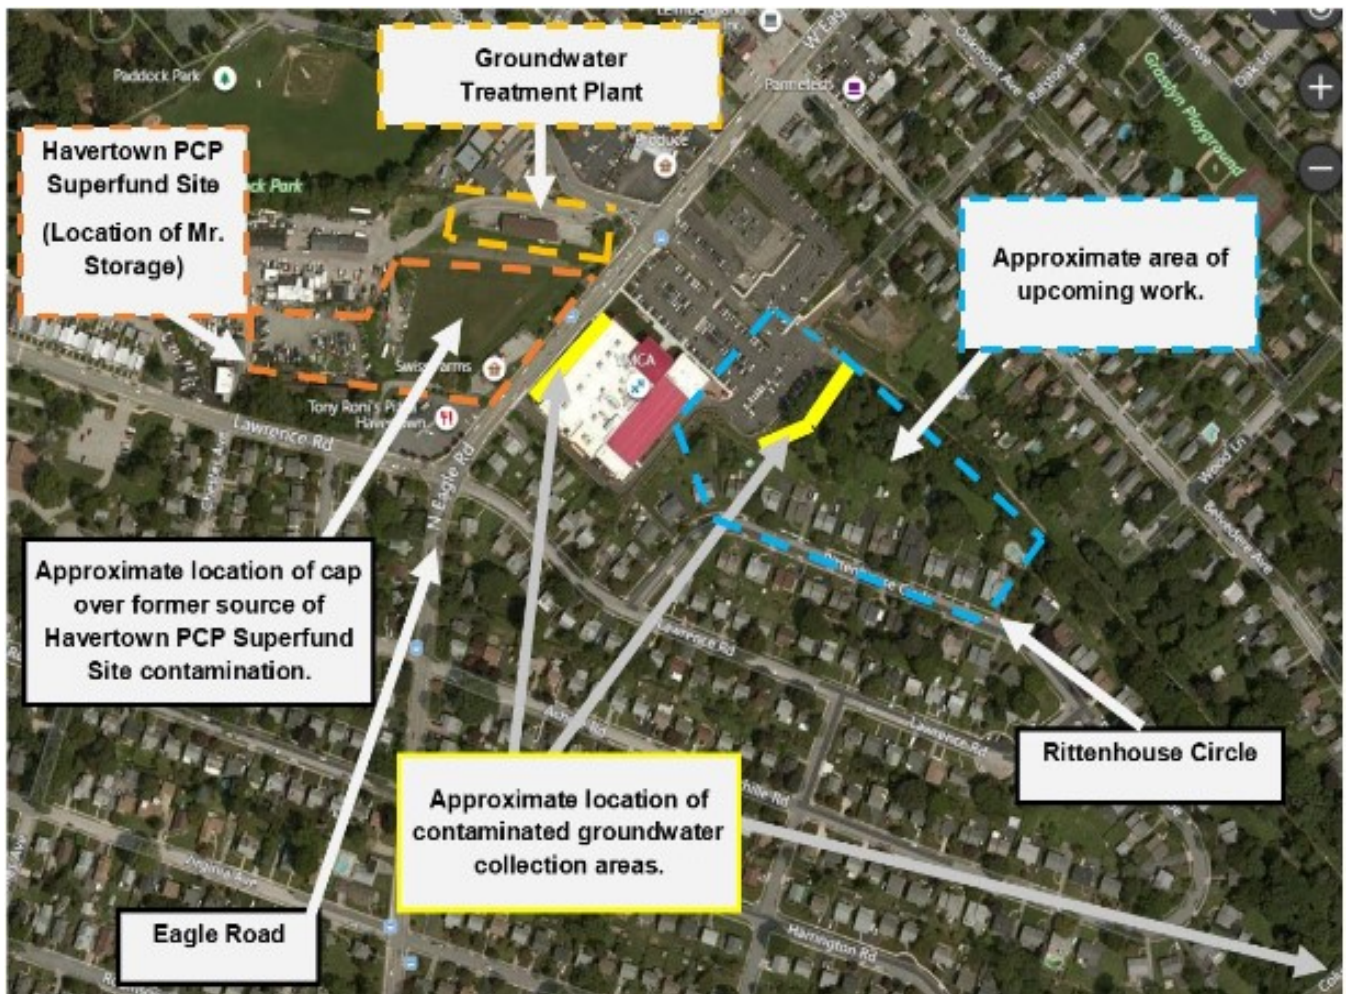
Map of the Superfund Site and impacted areas.

The contamination appears to have been transported from the groundwater into residential yards and structures between the YMCA and Rittenhouse Circle. This likely occurred when the water table was elevated and seeping out of the ground in 2018-2019.
