EPA, EGLE and Monroe County Daily Update: Pilot Diesel Spill, Ottawa Lake, MI

Daily Site Update

Thursday, April 4, 2024

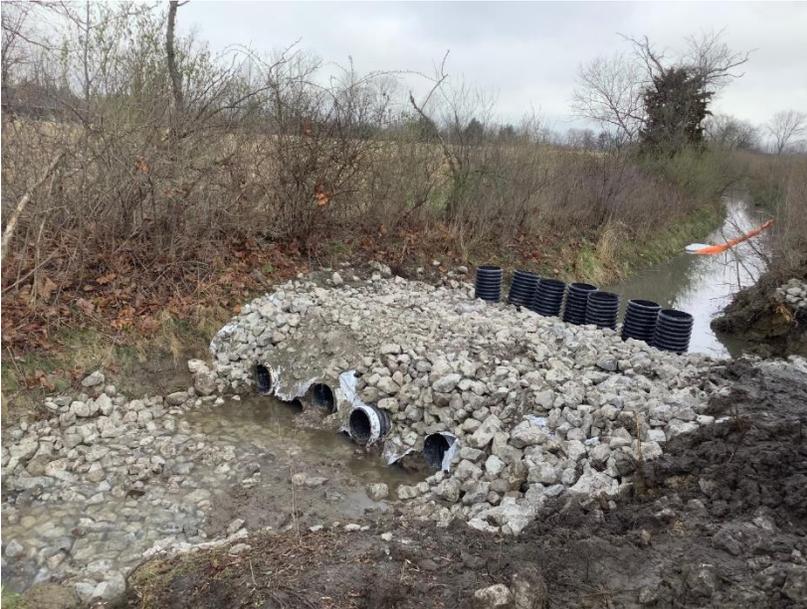
Underflow dam installed at Erie Road.

- Installation of underflow dam in North Tenmile Creek at Erie Street was completed.
- Sewer flushing started to remove sediment and diesel from the offsite sewer. Sediment and liquids are being collected and contained for treatment and/or disposal.

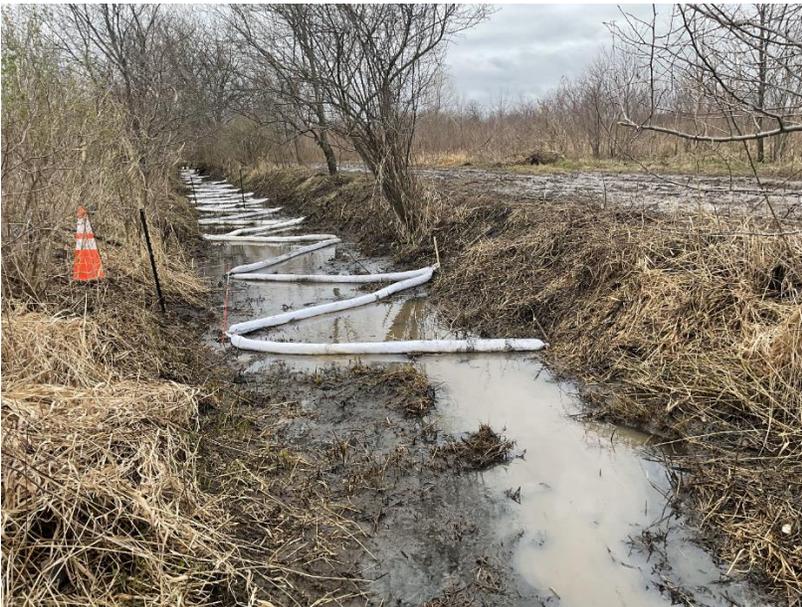
Boom placed between Sunoco and US-23 along North Tenmile Creek.

- Boom has been redeployed at seven locations along North Tenmile Creek, south of the outfall (Sunoco, Erie Road, Bibb Road, Temperance Road, Consear Road, Jeff's Road, and Yankee Road).
